SAFETY INVESTIGATION REPORT

REPORT NO.: 14/2019

MT SANAR-8
Equipment failure leading to
the serious injuries to two crew members
and subsequent loss of life of a crew member
in position 40° 50.35' N 29° 16.17' E
31 July 2018

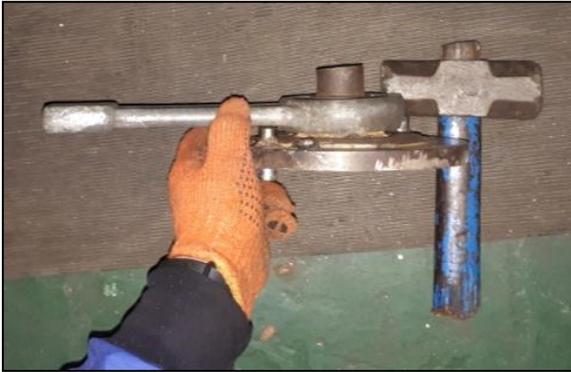
Figure 1: Hammer and tool used by the crew members

The information available to the safety investigation indicated that before the task was initiated, the second engineer had cautioned against the use of a hammer to tighten the sight glass. Moreover, evidence suggested that a hammer had actually been used to tighten the sight glass.

It was a fact that a hammer had been used, even if the second engineer had specifically cautioned against its use². The performance of the two crew members in a team depended on, *inter alia*, the team members' personal traits and how they managed the perceived risks.

The use of a hammer was a risk that had been accepted by the crew members. In the absence of a toolbox meeting or a similar risk assessment exercise, this may be taken to be a situation where the crew members involved may have considered the use of a hammer as a necessary risk which had to be accepted, especially if the sight glass still leaked following the hand tightening of the sight glass.

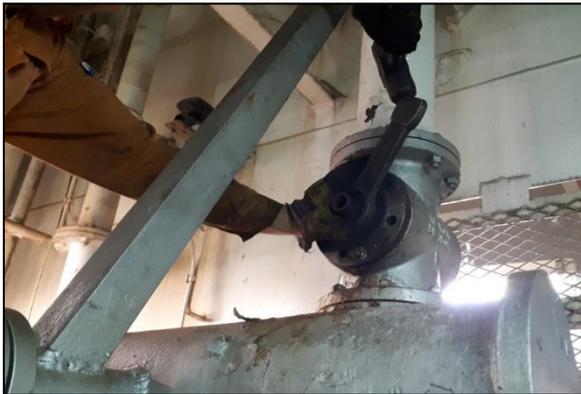
Upon completion of the safety rounds in the engine-room, the second engineer made his way to the engine control room deck. From there, he could observe the area of the sight glass. From this position, he noticed the fourth engineer using a hammer to tighten the sight glass (Figures 1 and 2).

Figure 2: Simulation to show how the sight glass was being tightened

The safety investigation is of the view that the crew member was unable to stop the leak and resorted to the use of a hammer to further tighten the flange. It was therefore clear that the potential failure of the sight glass had not been anticipated by the crew members (even if cautioned against the use of the hammer) and possibly, the crew members did not analyse what other options could have been available.

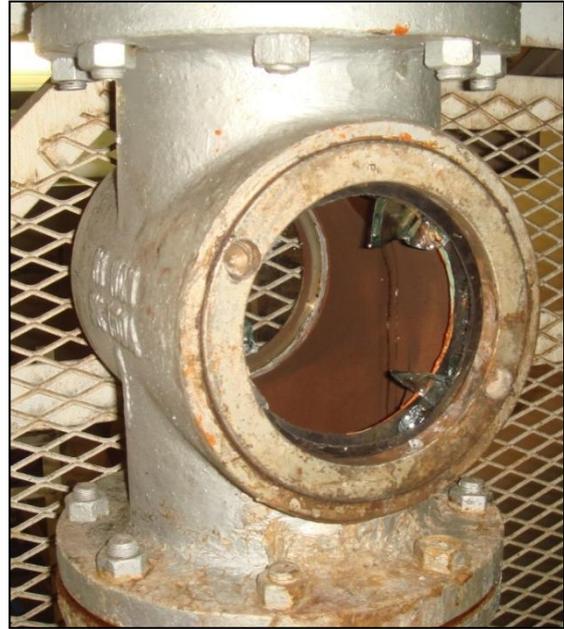
It was at this time that the second engineer observed the sight glass failing (Figure 3) without any warning. He also noticed hot water and steam leaking in the direction of both the fourth engineer and the motorman, who was standing close to the fourth engineer.

Figure 3: Damaged sight glass after the accident

The closing of both valves, however, meant that a part of the system, which included the leaking sight glass was under pressure. Whilst this may have not necessarily contributed to the failure of the glass, however, it was considered possible that this would have exacerbated the effects of leaking water and steam into the engine-room as soon as the sight glass failed.

1. Included a specific cautionary note in the engine-room training programme on the hazards related to potential residual pressure release from pipes and joints;
2. Additional warning signs have been posted in the engine-room to caution about pressurised systems and pressure relief before repairs and maintenance are carried out.

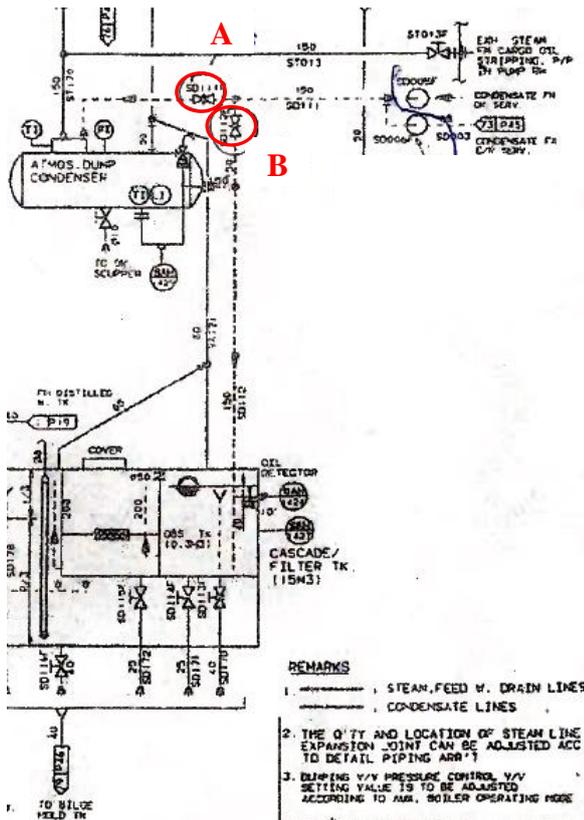
The sight glass was of the conventional type, fitted on the condensate line of the system. Condensate from the fuel oil settling and service tanks flowed through the sight glass and eventually directed by two valves, either to an atmospheric dump condenser or the system's hotwell (Figure 4).

Figure 4: Part of the condensate system showing the sight glass and the two valves (A and B)

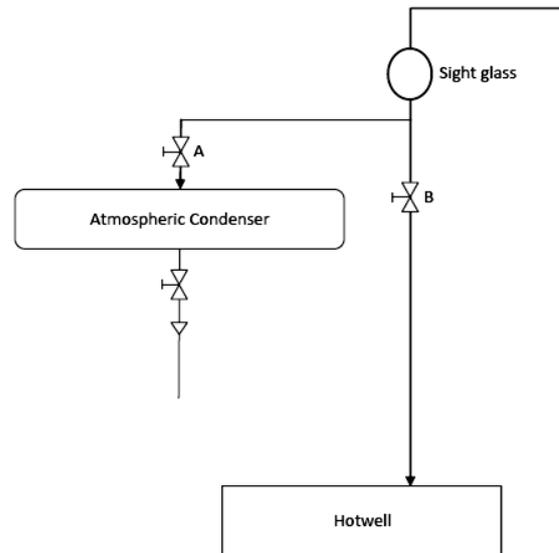
Figure 5: Simplified schematic drawing

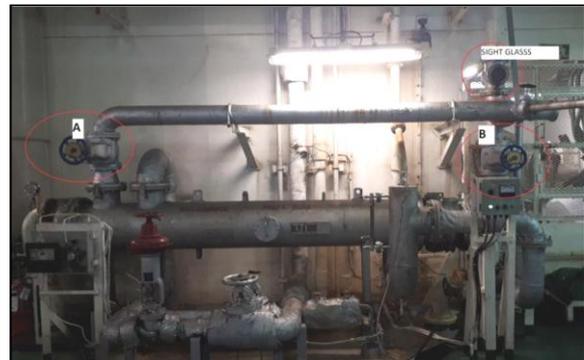
It was reported to the MSIU that following the accident, both valves 'A' and 'B' were found closed. The status of both valves was not normal and it was therefore hypothesised that these were closed prior to the tightening of the sight glass (Figure 6).

Figure 6: Location of the valves and sight glass

The safety investigation was of the view that the two crew members actually had two options which could have been adopted. The first option was to leave both valves 'A' and 'B' open. The flow of water and steam would have been unhindered, although it would still have been possible that the mixture could have leaked out into the engine-room in the eventuality of a sight glass failure.

The second option would have necessitated a complete shutdown of the boiler, closure of the main steam stop valve and draining the lines from steam and condensate. None of the above two options had been selected by the crew members. This matter is addressed further down.
