**REPORT OF  
INVESTIGATION INTO A  
FATAL INCIDENT  
INVOLVING THE FISHING VESSEL  
'BEAL SRUTHAN'  
OFF CRAUGH ISLAND,  
GALWAY BAY  
23rd MAY 2018**

**REPORT NO. MCIB/279  
(No.5 OF 2019)**

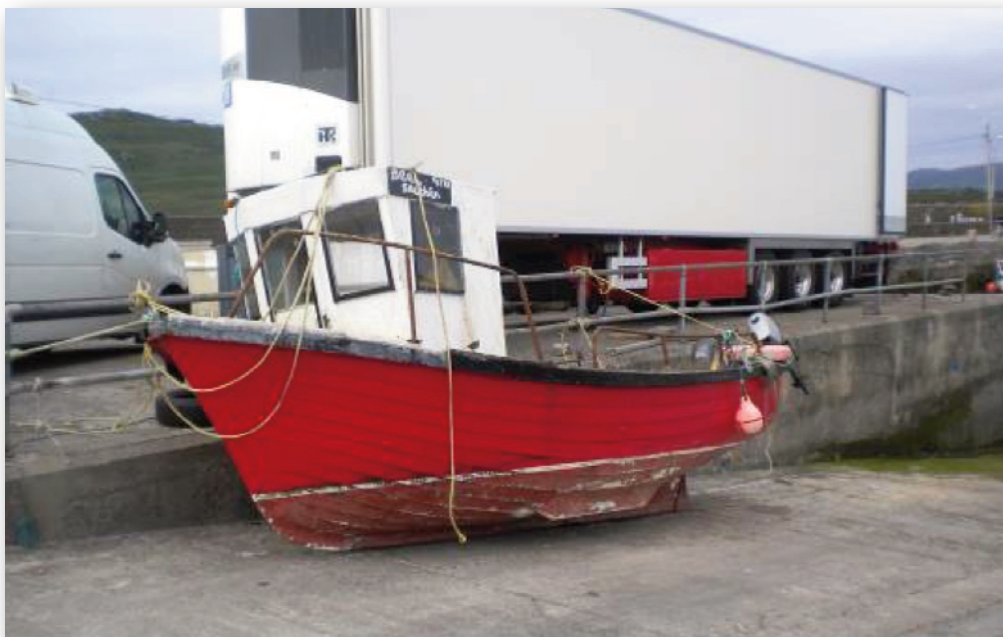
Photograph No. 1: Vessel on slipway at Cleggan with name and fishing number on board on port side of wheelhouse.

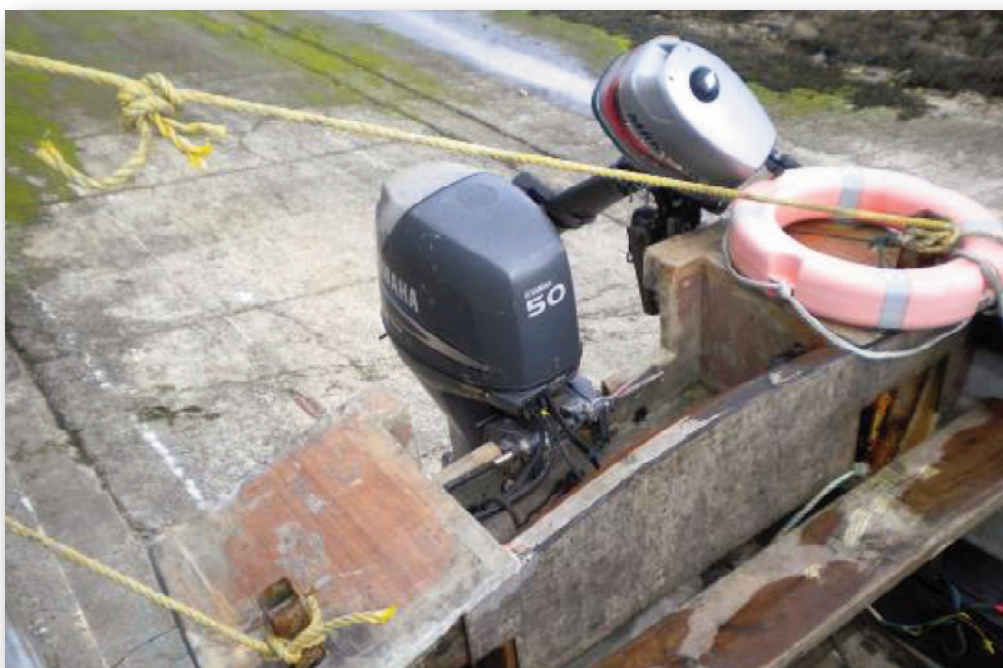
Photograph No. 2: Two engines mounted on transom and lifebuoy.

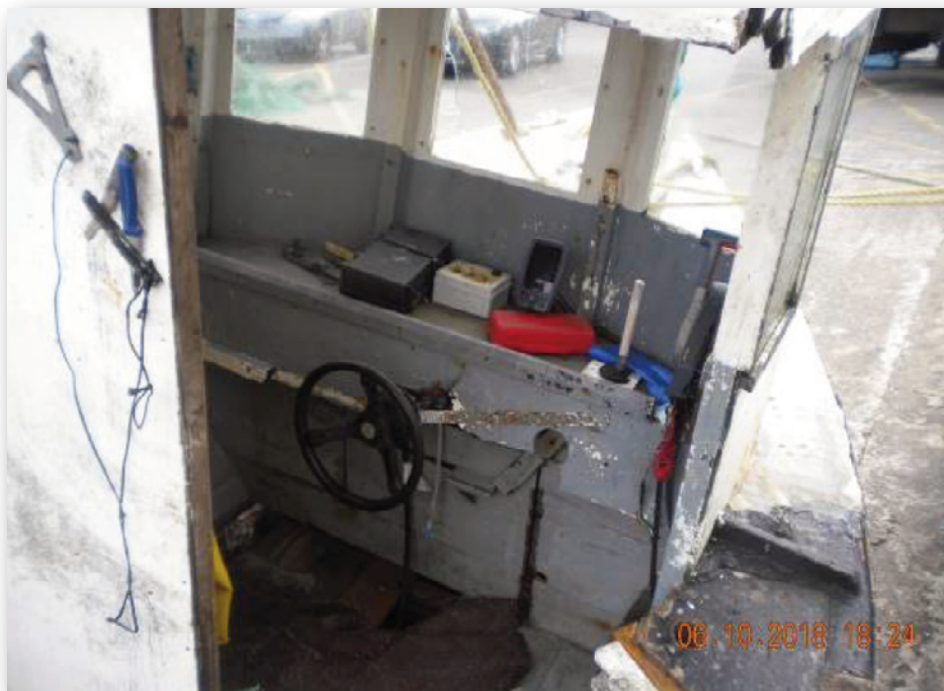
Photograph No.3: View of wheelhouse interior.

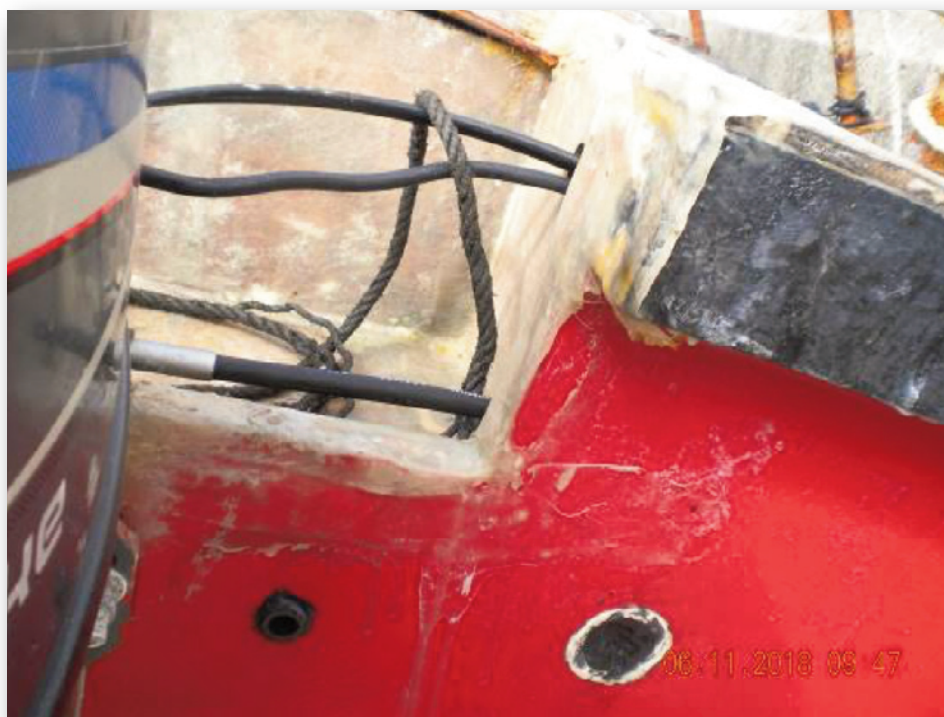
3.1.2 In late 2017 the Casualty purchased the vessel that foundered. He worked on the vessel over the winter period in preparation for the 2018 lobster fishing season. One modification undertaken was the removal of the inboard diesel engine that was installed in this vessel, cropping the transom and mounting a Yamaha 50 hp outboard motor on the transom (see Appendix 7.1 Photographs No.4 and No.5).

- 4.3 The transom section was examined. There was a 'high tide' mark clearly visible. The distance from the base of the keel section to the top of the mark was measured at approximately 862 mm. The bottom of the transom was 750 mm above the bottom of the keel. There were two holes in the transom, of approximately 18 mm diameter and spaced approximately 520 mm apart at a height of 450 mm above the base of the transom, or between 433 mm and 439 mm above the waterline. These holes were considered to have been for steering cables to the original rudder as fitted to the vessel (see Appendix 7.1 Photographs No. 4 and No.5).

Photograph No. 4: Hole is in starboard side of transom, one for steering cable and the other for original exhaust outlet.

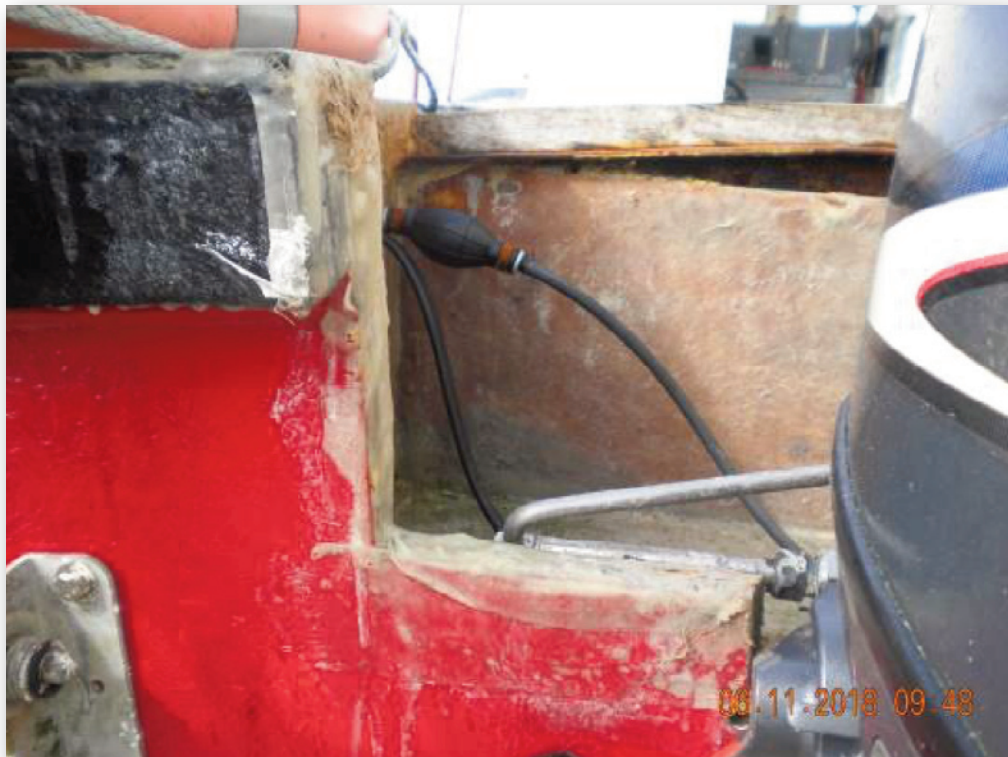
- 4.4 The transom had been cut back to a depth of 240 mm over a distance (width) of 720 mm. A well had been formed measuring 890 mm x 430 mm between the transom and an inner partial bulkhead. There were openings in the side of the well on both sides for the steering cable, the throttle cable (starboard side) for a battery connection and fuel line (port side). The battery was secured to the port side aft deck and exposed.

Photograph No. 5: Cut out section of transom with fibreglass used to seal joint.

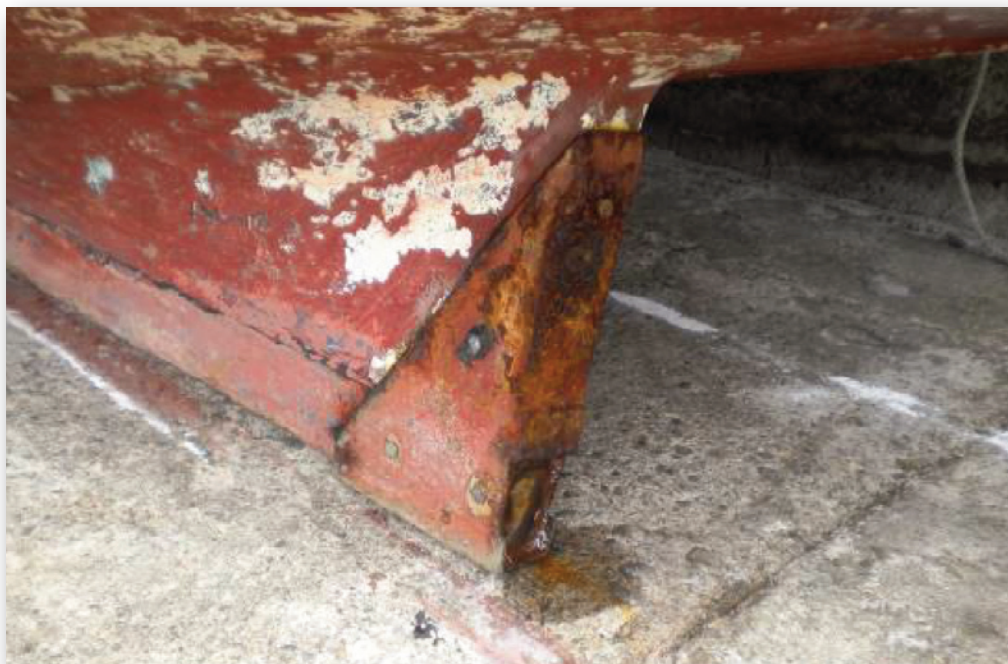
whilst the vessel was under water. The stem head fitting had been pulled off and the fixing screws were corroded. Safety rails were loose and the fixing screws were loose and corroded. The transom had been cropped to accommodate the outboard engine and the inboard engine had been removed leaving the mounting frame in place. The steel trailing skeg, which one would expect to find with a pintle bearing support for a rudder, was missing (see Appendix 7.1 Photograph No. 6).

- 4.5 The back of the keel was examined. The keel was partially encased by a steel keel band. At the aft end where the original propeller tube aperture was located the space was covered by steel. Internally, the inner end of the stern tube was blanked off with a fibre type material (believed to be GRP bandage tape). The trailing skeg had been removed (see Appendix 7.1 Photograph No.6).

- 5.4 The cause of the vessel's sinking has not been firmly established. The most probable cause was the failure to properly blank off the redundant stern tube by failing to properly seal both ends.

Photograph No. 6: Steel shoe covering stern tube opening.

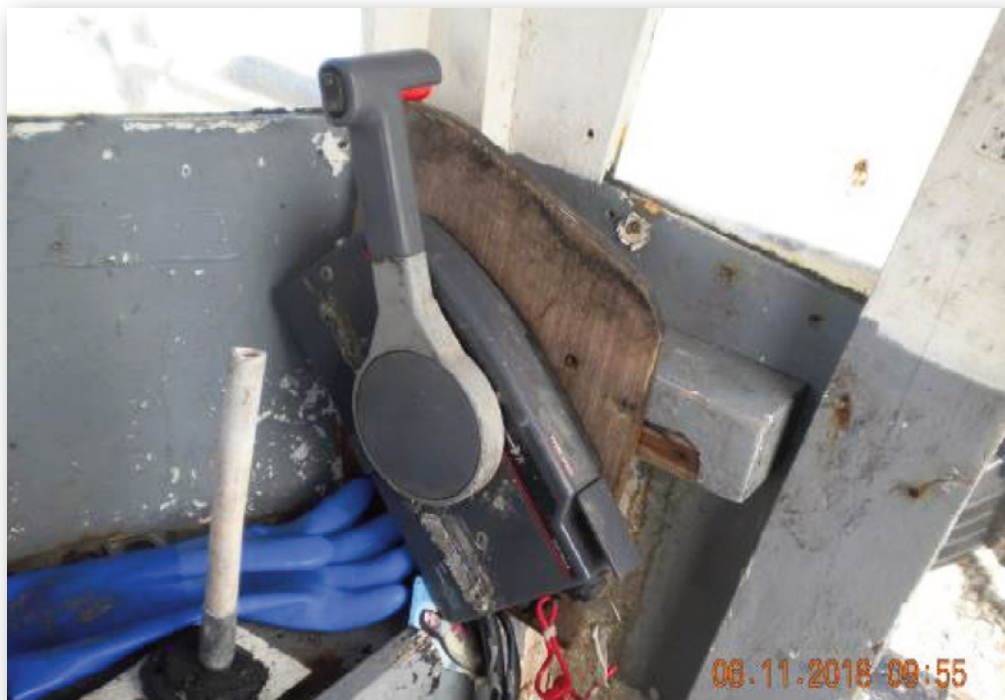
Photograph No. 7: Yamaha engine throttle as found.

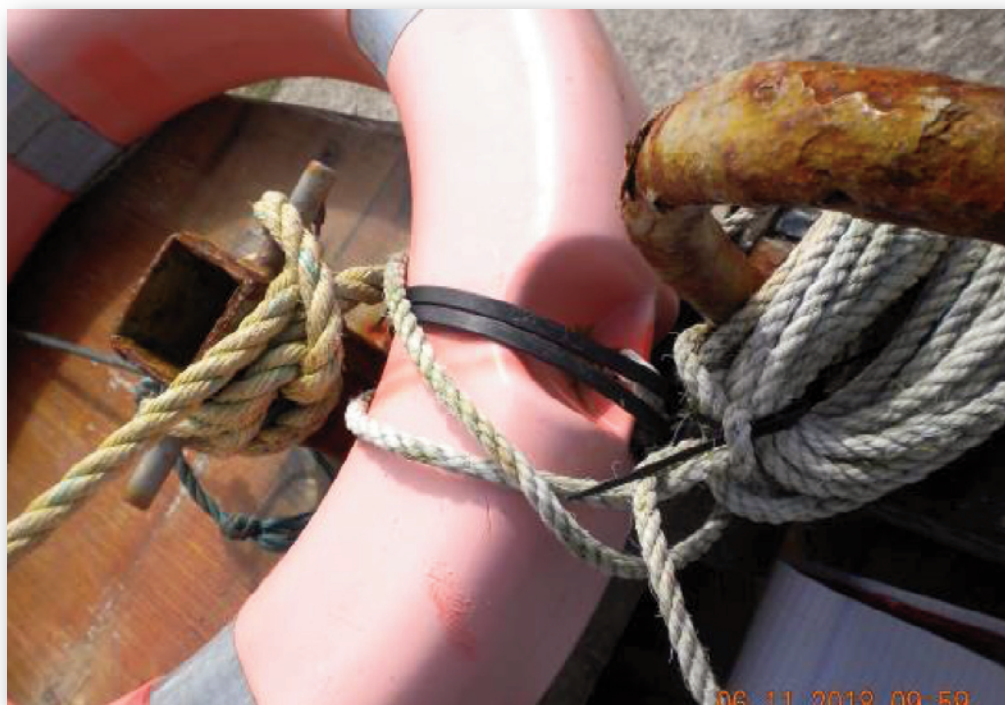
The only lifesaving appliance found on board was a non-approved lifebuoy. This was fitted with a length of heaving line but was found to be fixed to the vessel by cable ties and to be full of water (see Appendix 7.1 Photograph No.8). Lifebuoys should not be tied to a vessel as they should be readily to hand and also float free should the vessel sink and thus be available to persons in the water.

Photograph No. 8: Cable tie used to secure lifebuoy to vessel.
