**DEPARTMENT OF THE NAVY**  
**OFFICE OF THE CHIEF OF NAVAL OPERATIONS**  
**2000 NAVY PENTAGON**  
**WASHINGTON, DC 20350-2000**

Enclosure (1) Report on the Collision between USS FITZGERALD (DDG 62) and Motor Vessel ACX CRYSTAL

Enclosure (2) Report on the Collision between USS JOHN S MCCAIN (DDG 56) and Motor Vessel ALNIC MC

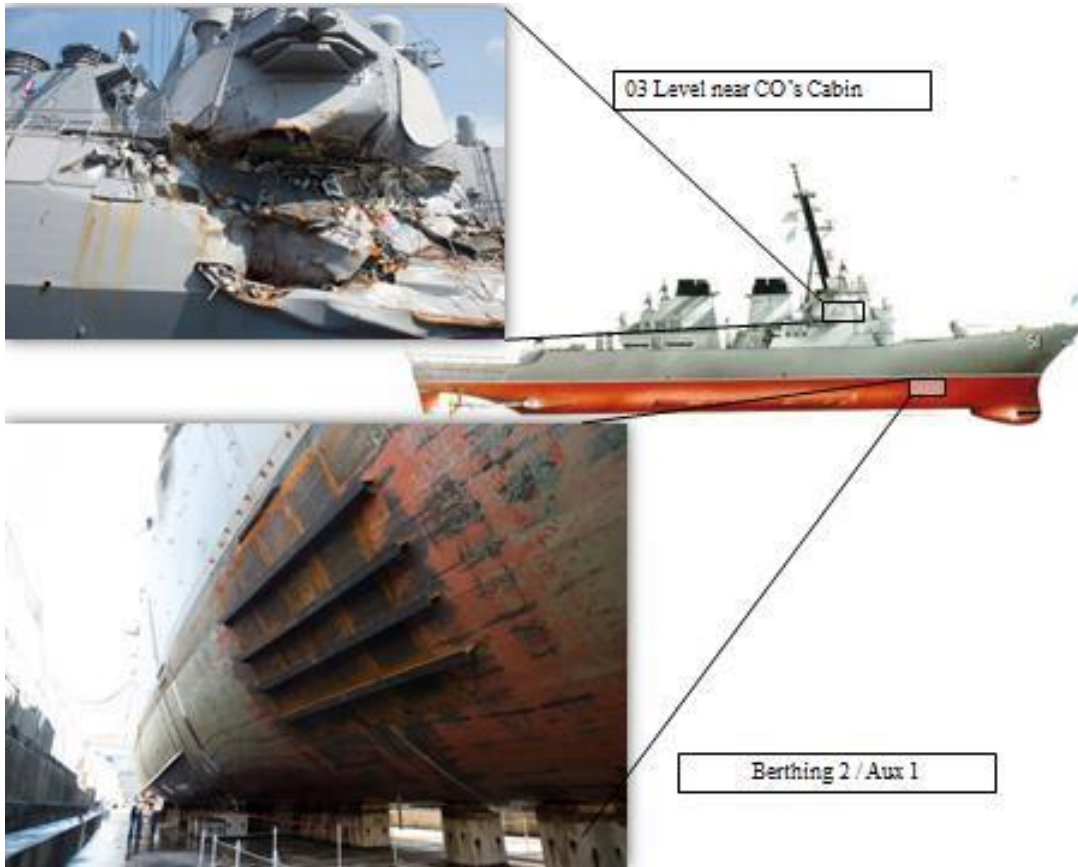
**Figure 8 - Starboard side of FITZGERALD**

The impact of the top of CRYSTAL's bow above the waterline crushed the false bulkhead (a non-structural steel wall that is the shipboard equivalent of a non-load bearing wall in a house, used to divide a space) and non-watertight door within the Commanding Officer's cabin. The Commanding Officer's cabin is composed of two small rooms: an office area with a desk, table, and couch with seating for several people; and his bedroom. The two rooms are separated by this false bulkhead and door. The outer wall was pushed in and torn open by the impact.

**Inset Above: Damage to FITZGERALD above the waterline at the 03 Level near CO's Cabin**

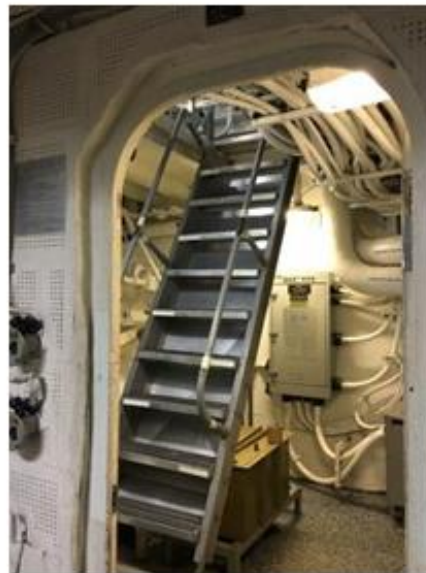
**Figure 9 – Non-watertight door frame from Berthing 2 to the ladder going up to Berthing 1 Access Trunk. There is no hatch at the top of this ladder to prevent water from flooding up into Berthing 1.**

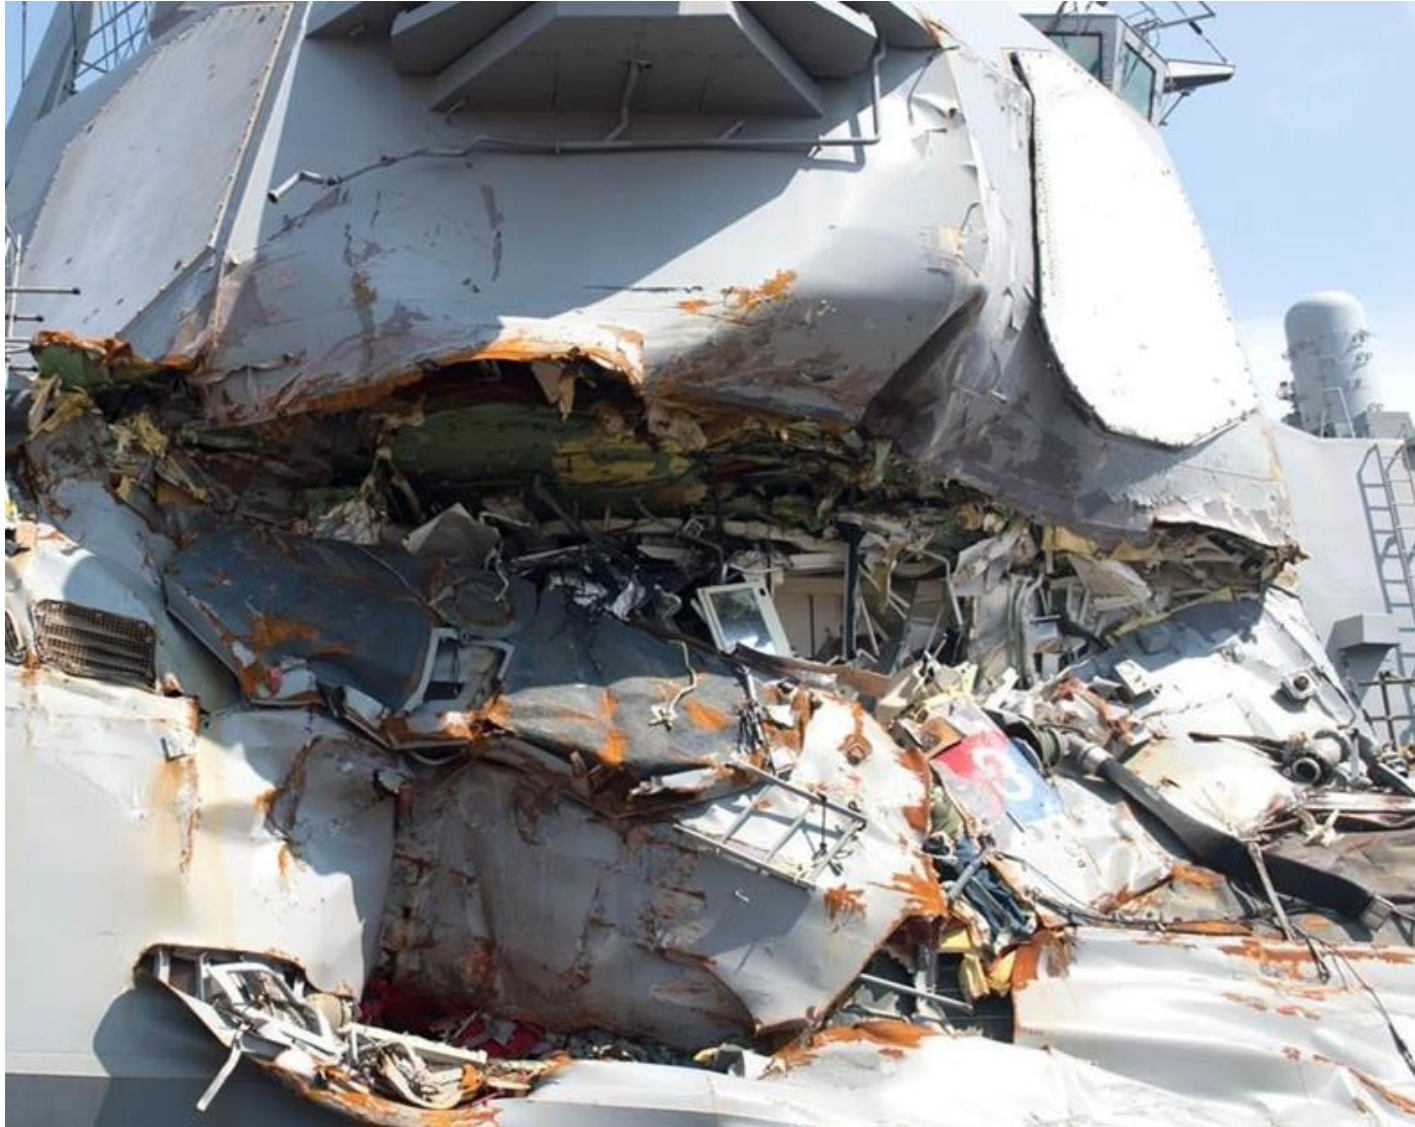
**B2: Commanding Officer's Stateroom on FTZ - Interior view**

The Commanding Officer was in his cabin at the time of the collision. The CRYSTAL's bow directly struck his cabin, located above the waterline. The impact severely damaged his cabin, trapping him inside. The CO called the bridge requesting assistance.

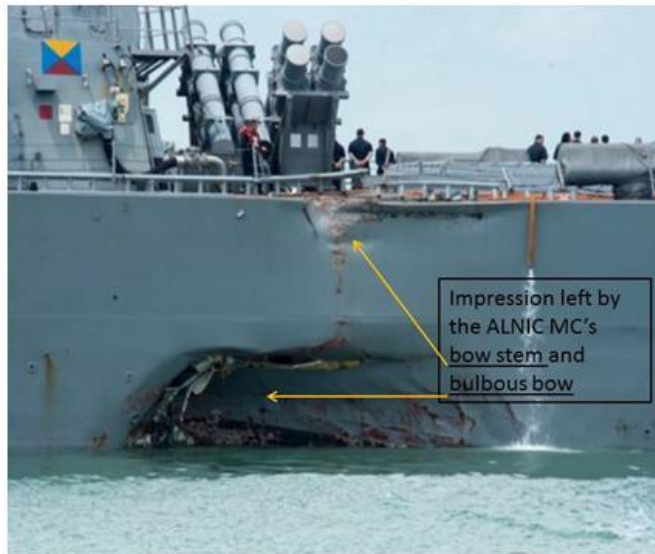
**Figure 9 – Point of impact on JOHN S MCCAIN from ALNIC MC**

The point of impact was centered on Berthings 3 and 5 as noted in Figure 9. All significant injuries occurred to Sailors that were in Berthing 3 at the time of the impact. All ten of the fallen Sailors were in Berthing 5 at the time of impact.

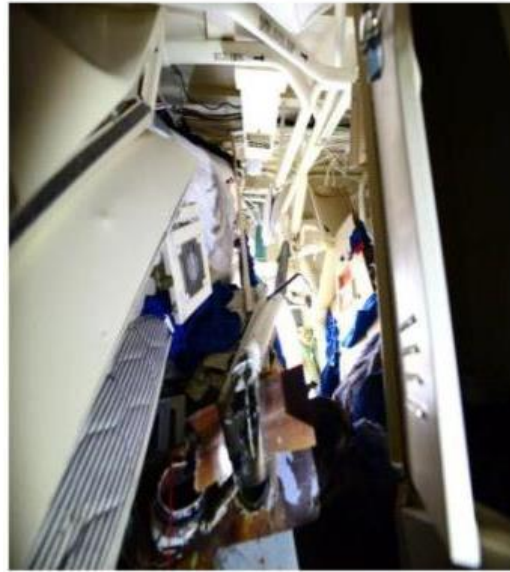
At 0530, the DCA began receiving reports of a ruptured fire main and water and fuel flooding into Berthing 3. The port side of Berthing 3 suffered substantial damage, including a large hole in the bulkhead. See Figure 13. Racks and lockers detached from the walls and were thrown about, leaving jagged metal throughout the space. Cables and debris hung from the ceiling.

**Figure 16 – Berthing 3 facing port after collision**

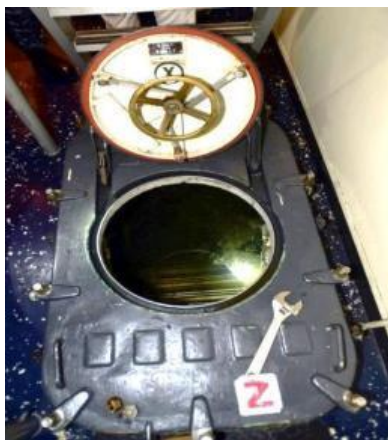
All Sailors in Berthing 4 were able to evacuate. At 0544, Sailors reported 4 inches of water on the deck in Berthing 4. Sailors in Berthing 4 were thrown about their racks by the force of the collision. By 0627, the berthing space was lost. See Figures 16 and 17.

**Figure 17—Scuttle and hatch into Berthing 4 showing the space completely flooded**

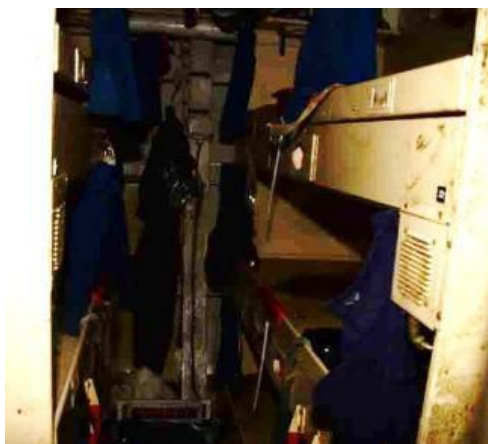
**Figure 18—Berthing 4 racks after dewatering**

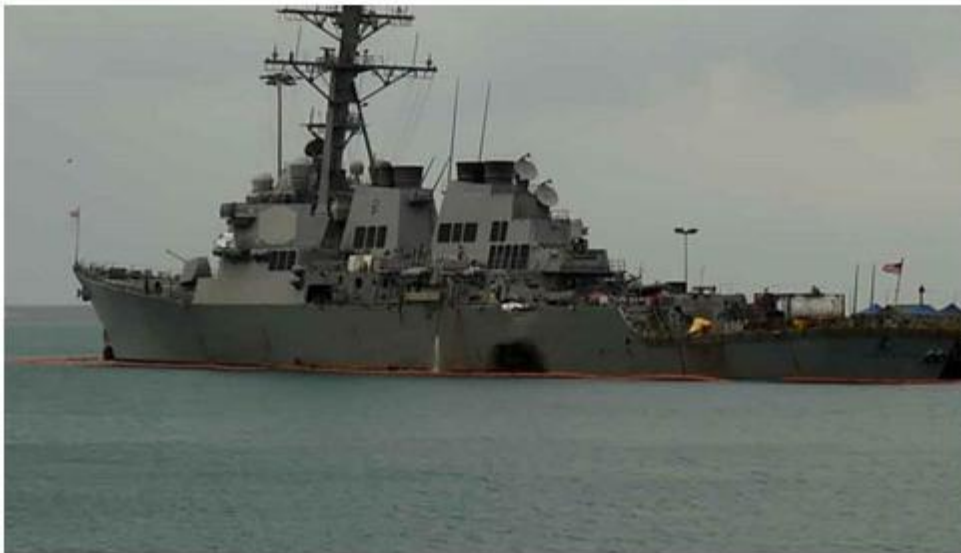
A team of Navy Divers arrived on JOHN S MCCAIN as the ship entered the harbor in Singapore at approximately 1200 on 21 August 2017. They began inspecting the ship to determine how best to proceed with a dive inside the ship. The leader of the dive team inspected Berthing 3 and saw waves breaking into the ship. The divers discovered the hole in the port side of JOHN S MCCAIN that was approximately 28 feet wide. See Figure 18.

**Figure 19 – Port side of JOHN S MCCAIN post-collision**

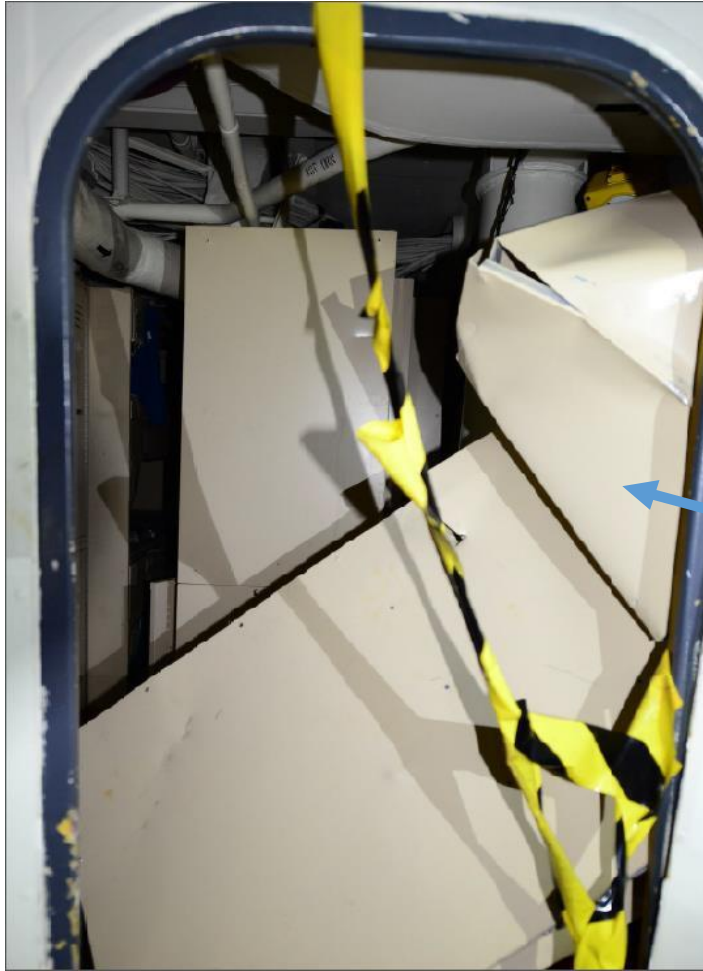
View through hatch into Berthing 3

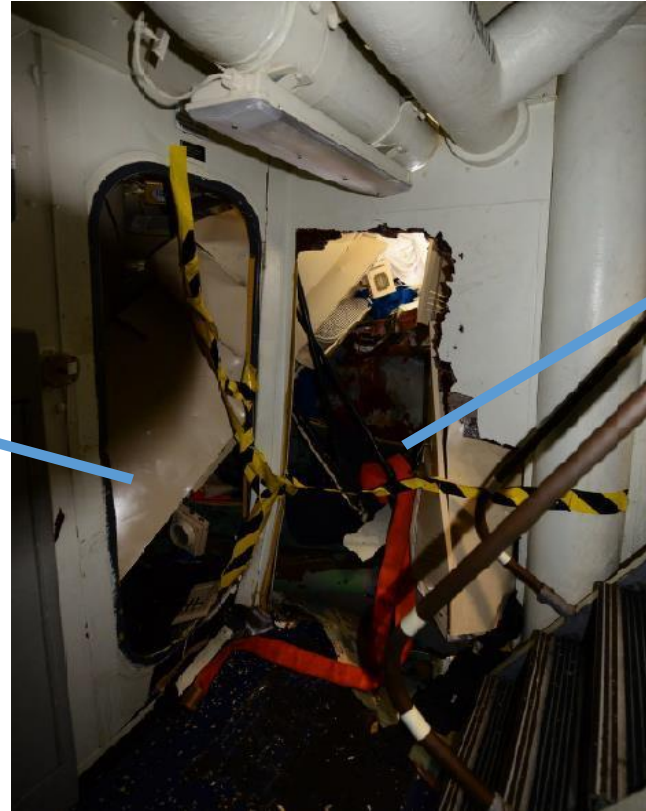
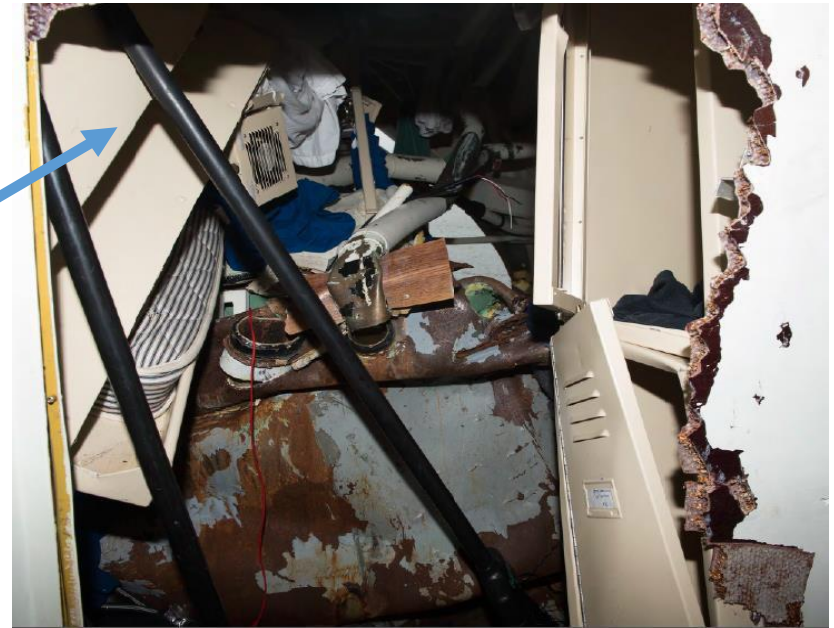
View through hole cut into bulkhead (wall)

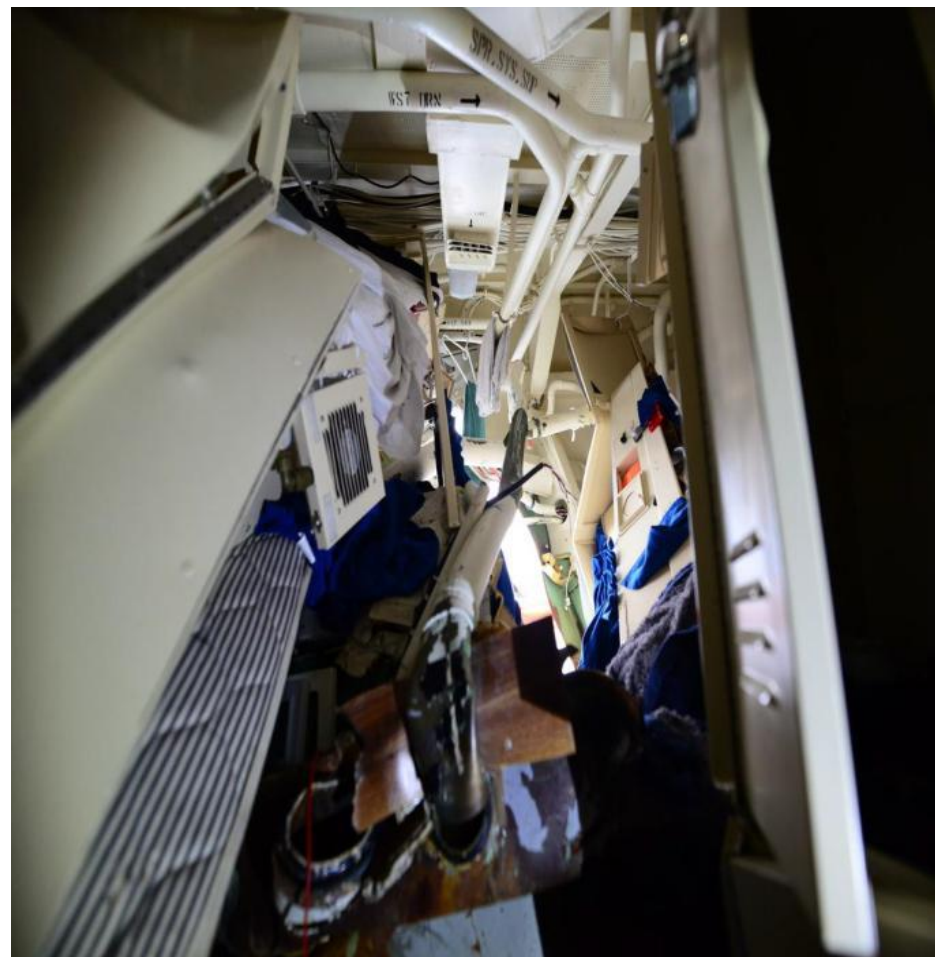
JOHN S MCCAIN, post-collision
