Report on the investigation of the  
grounding of the general cargo vessel

***Priscilla***

on Pentland Skerries, Pentland Firth, Scotland

on 18 July 2018

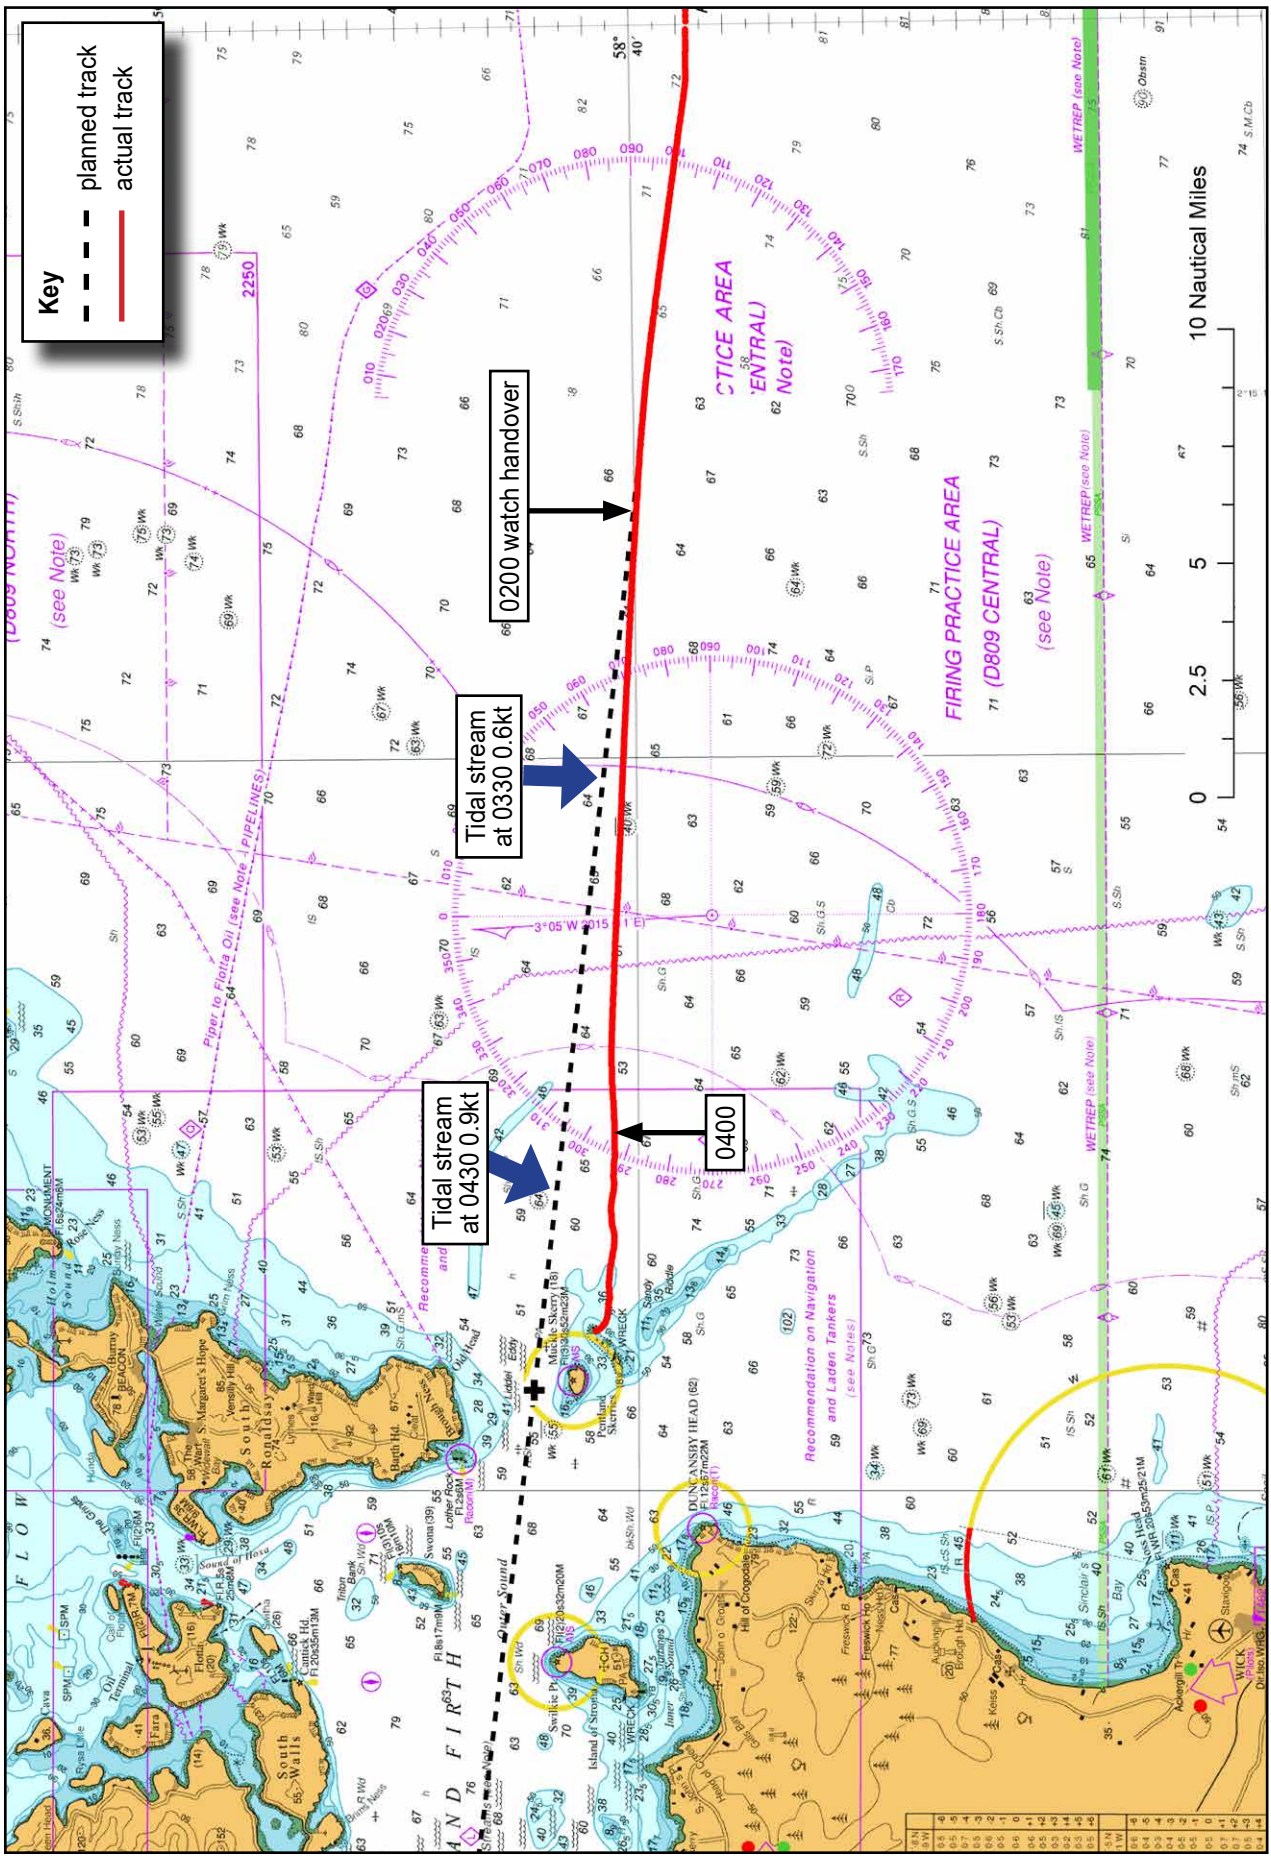
At about 0400, the maritime officer looked at the radar display on the port side of the bridge and realised that *Priscilla* was to port of the planned track (**Figure 3**). At the same time, he observed two small islands ahead of the vessel painting on the radar display and decided to proceed between them with a plan to alter course to starboard thereafter to regain the planned track.

Figure 3: Chart showing Priscilla's planned and actual tracks prior to grounding

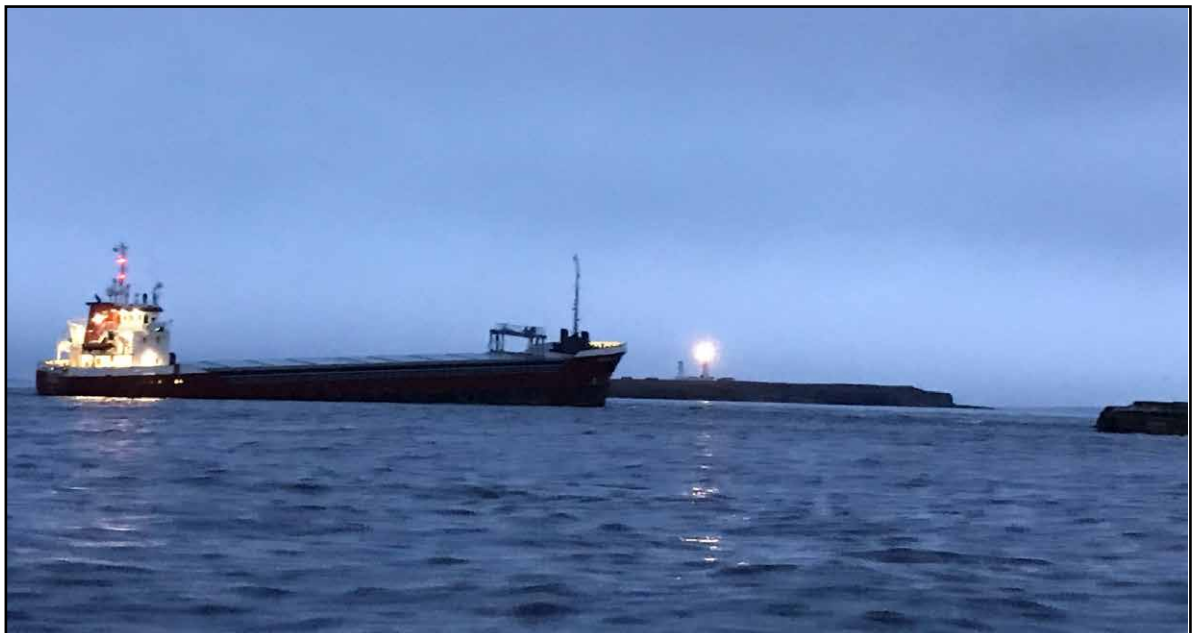
**Figure 4:** *Priscilla* aground with Pentland Skerries lighthouse visible in the background

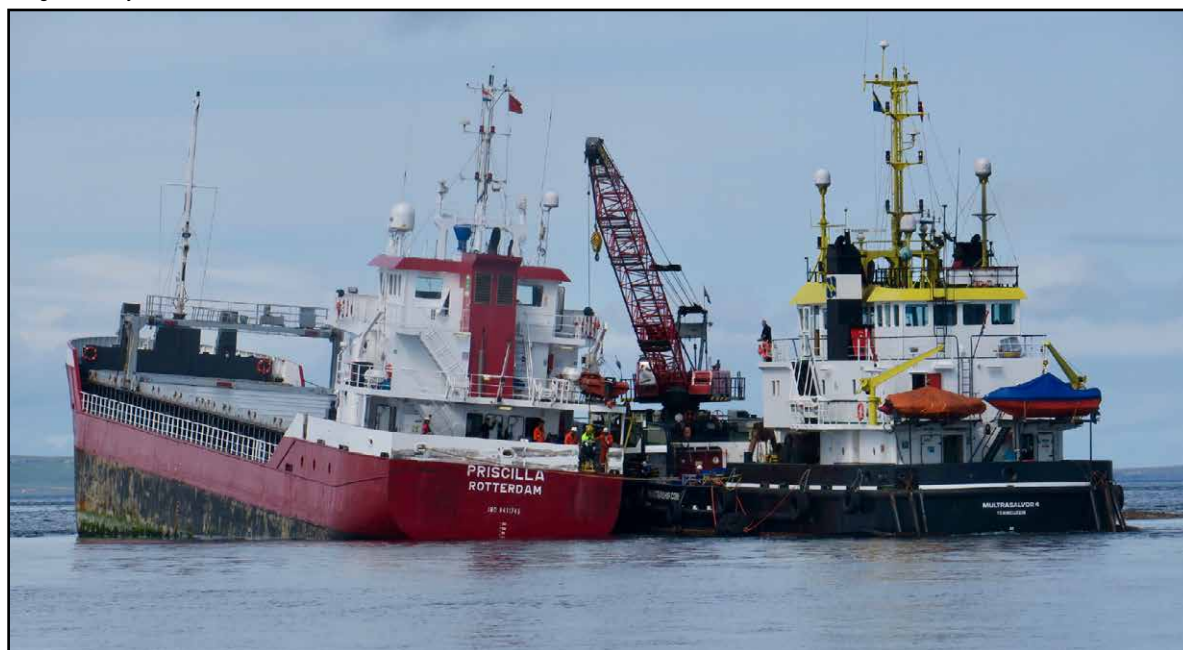
In the following days and at high water, two unsuccessful attempts were made to haul *Priscilla* off the rocks using tugs. On 20 July 2018, a salvage team arrived on board *Priscilla* and 3 days later, after a partial cargo discharge (**Figure 5**), the vessel was refloated and towed clear of Pentland Skerries. Following a diver inspection at Scapa Flow, *Priscilla* proceeded under its own power to Silloth to complete the cargo discharge. Thereafter, *Priscilla* proceeded to dry dock in Swansea, Wales where a full inspection revealed extensive structural damage throughout the forward section of the hull, including gouging and distortion to the shell plating (**Figure 6**).

**Figure 5:** Partial cargo offload from *Priscilla* when aground

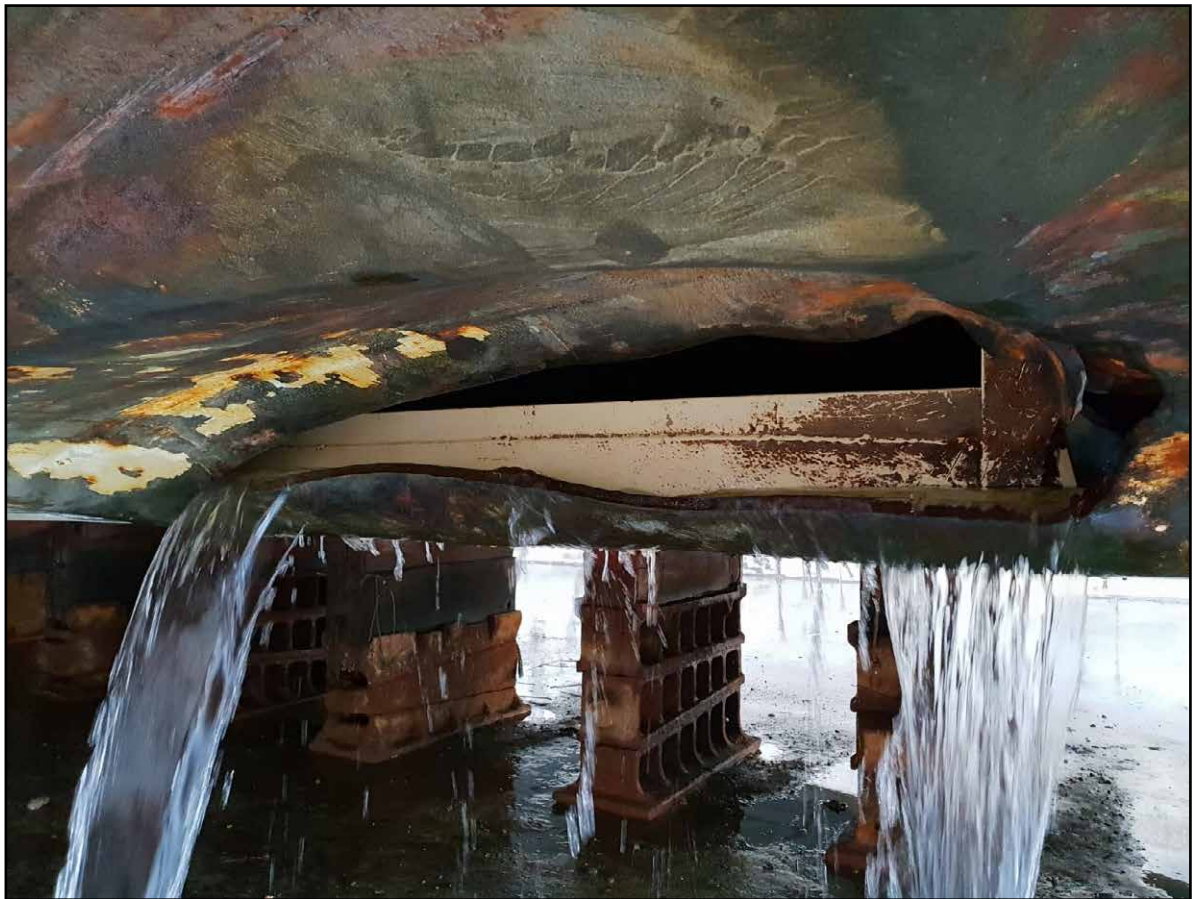
**Figure 6:** *Priscilla* - detail of hull damage

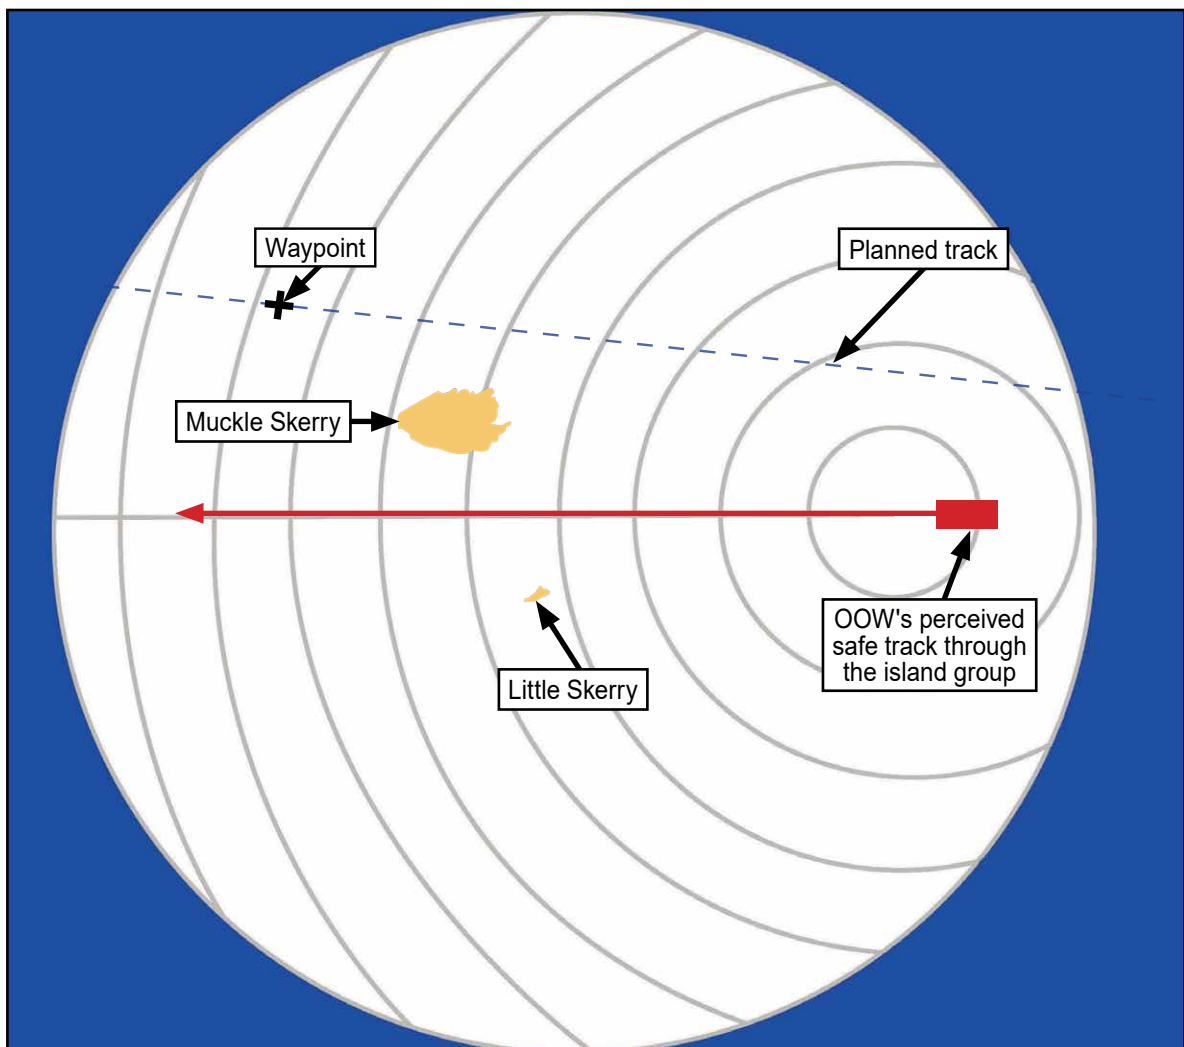
Therefore, and instead of immediately regaining the planned track, the OOW decided to steer between two islands that were painting on radar ahead. **Figure 10** is an illustration of a reconstructed radar display showing the OOW's intended passage between the islands. However, the OOW made no reference to the ECDIS display when making this decision, and the chart overlay function on the radar was not selected. This means that the decision to pass between the islands was based solely on radar data and not navigational information. As a result, the OOW was unaware that the islands ahead formed part of a shallow, dangerous reef and his revised plan was unsafe as it took *Priscilla* directly into this danger.

**Figure 10:** Reconstruction of the radar display to illustrate the OOW's perceived safe plan passing between the islands on radar

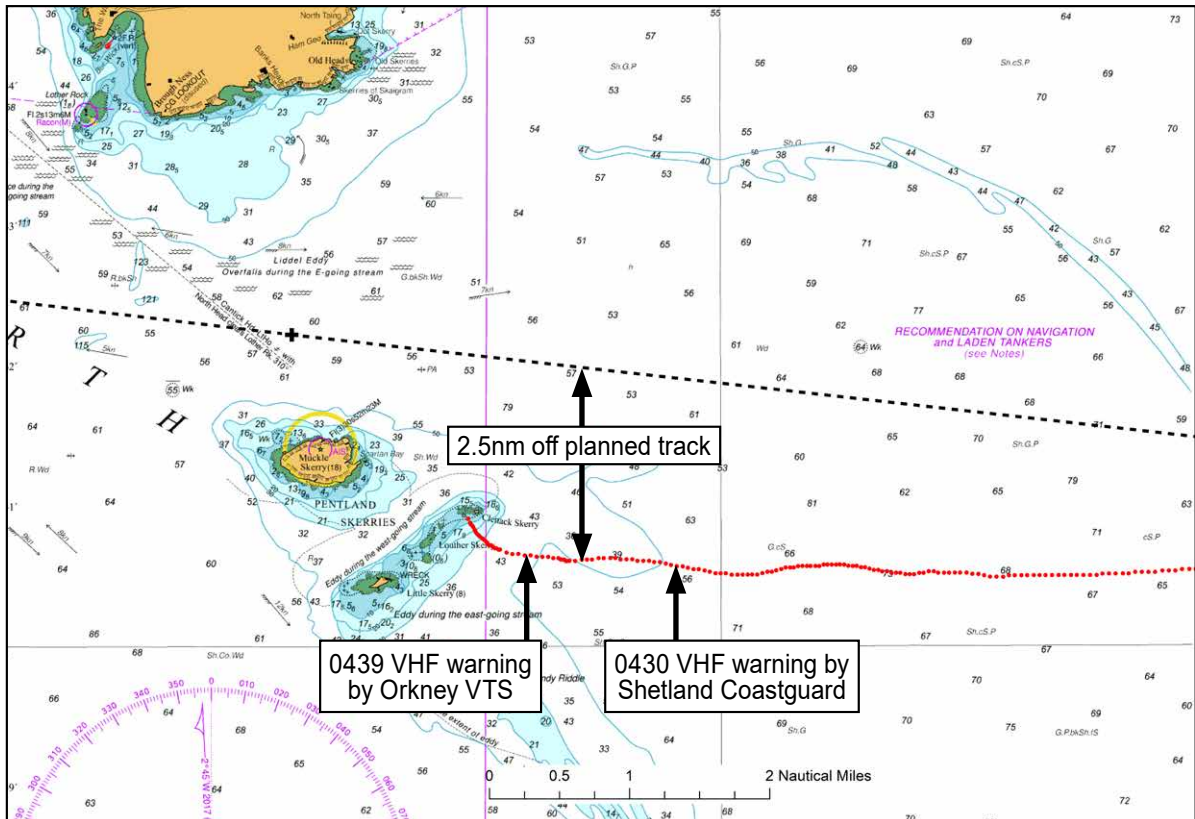
At 0430 and with Pentland Skerries about 2nm ahead of the vessel (**Figure 11**), Shetland CGOC contacted *Priscilla* by VHF radio. The OOW answered the call, acknowledged the situation and stated that an alteration of course would be made. When the coastguard officer sought confirmation that avoiding action would be taken, the OOW stated “*we will see later*” (**Table 1**). This response was vague and did not offer a categorical statement that action to avoid danger would be taken. This action by the OOW indicates that he was confident of the plan to pass between the islands ahead.

**Figure 11:** AIS track showing *Priscilla*'s position at the time of the VHF calls from Shetland Coastguard and Orkney VTS

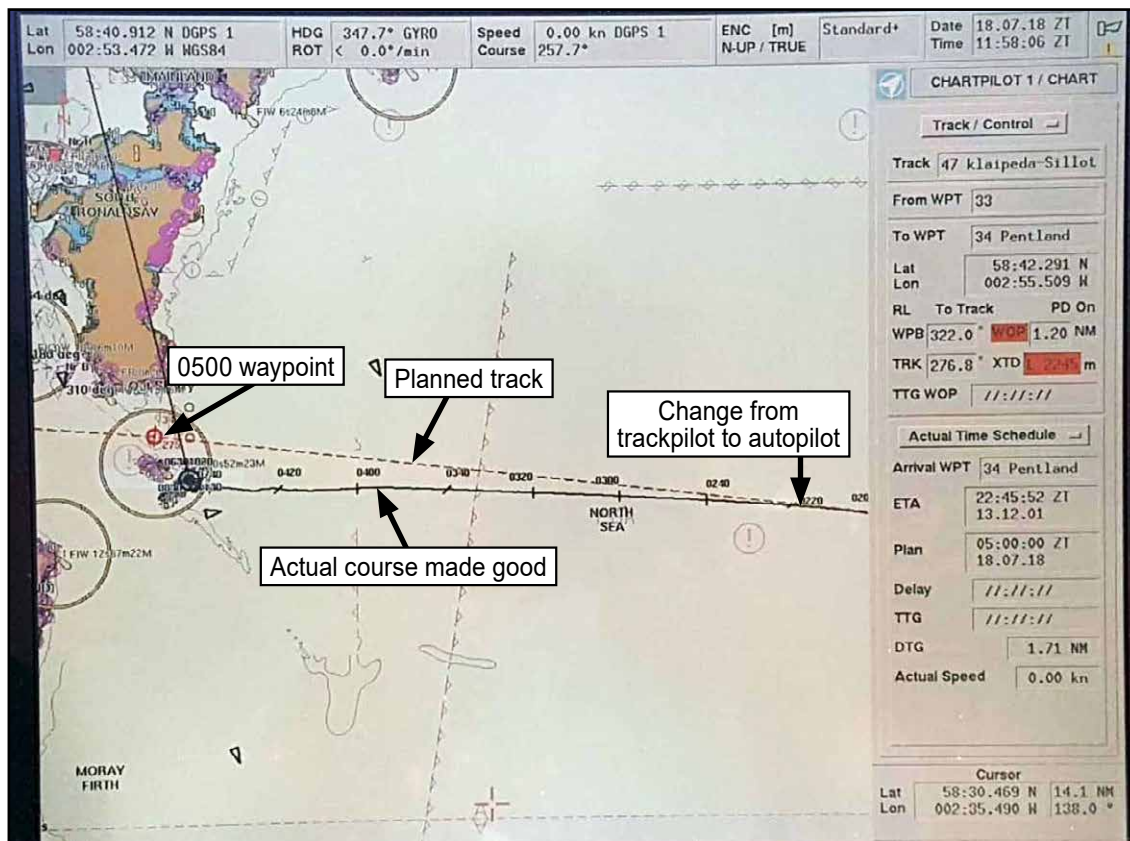
When *Priscilla* was in Klaipeda, the chief officer completed the SMS voyage planning checklist, which then formed the passage plan. However, the SMS contained no guidance on the use of ECDIS for passage planning, and the chief officer did not consider the use of an ECDIS safety corridor or warning sector settings. Ideally, the safety corridor and warning sector values should be tailored to the navigational hazards that might be encountered in order to give sufficient warning. However, this did not happen, primarily due to the lack of onboard guidance. The absence of a safety corridor or a warning sector was evident from a screenshot of the ECDIS display taken after the accident (**Figure 12**).

Figure 12: Screenshot of Priscilla's actual ECDIS showing the deviation from the planned track
