Issued November 2019

REPORT

Marine 2019/08

PART ONE REPORT ON THE COLLISION ON 8 NOVEMBER 2018 BETWEEN THE FRIGATE HNOMS HELGE INGSTAD AND THE OIL TANKER SOLA TS OUTSIDE THE STURE TERMINAL IN THE HJELTEFJORD IN HORDALAND COUNTY

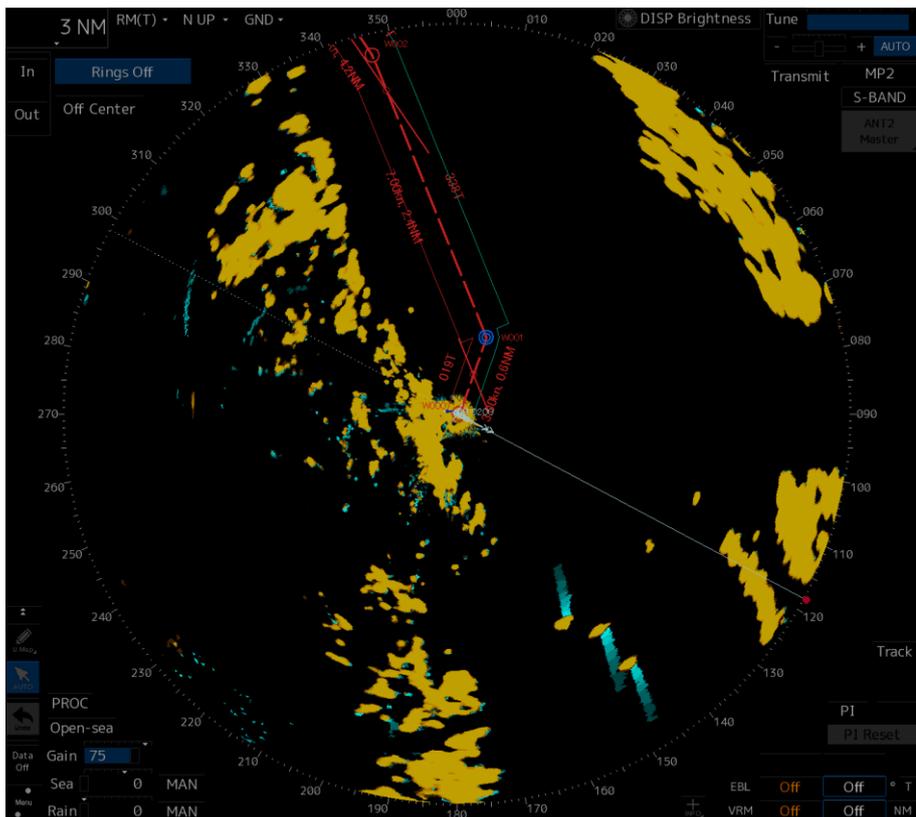
At this time none of the vessels approaching from the north could be observed on the S-band radar, which had been set to a 3 nm range scale since 03:27 (see Figure 10).

Figure 10: At 03:45, the S-band radar on Sola TS, set to a range scale of 3 nm, showed three vessels to the south and none to the north. Source: Tsakos Columbia Shipmanagement S.A.

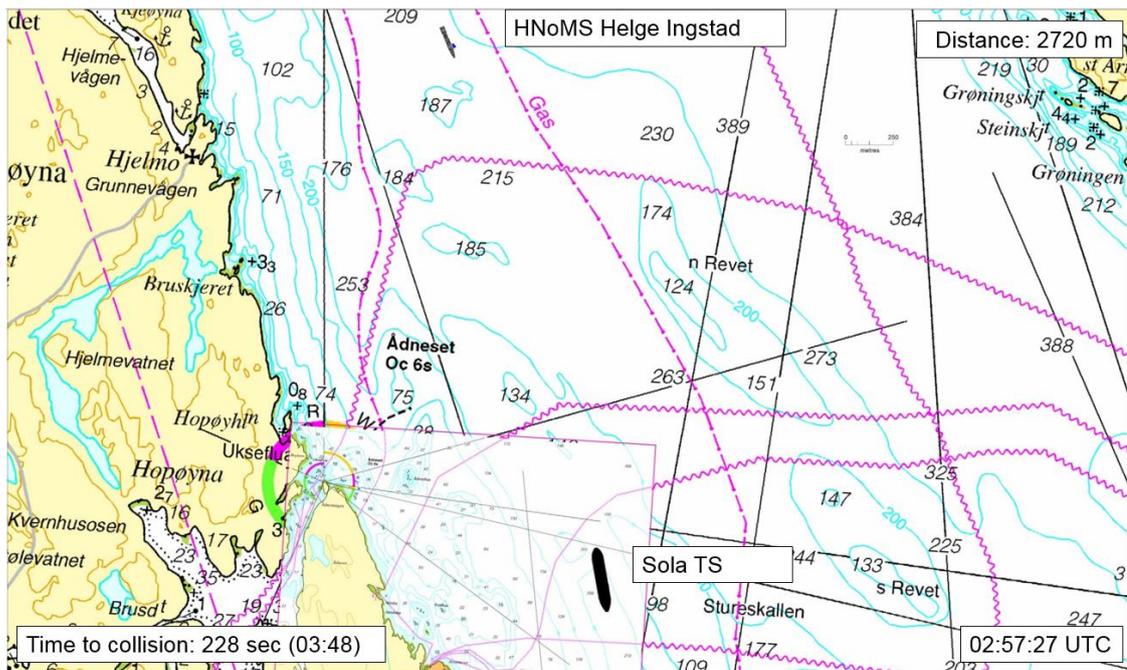
At 03:57:25,¹⁰ the speed of Sola TS had increased to 6.1 knots (SOG). At this point, there was a distance of approximately 2,720 metres between Sola TS and HNoMS Helge Ingstad (see Figure 13). The pilot was aware of the radar echo from a southbound vessel to the north in the fairway and had also observed the vessel's navigation lights visually. At that time, the southbound vessel was approaching at an angle of 10–12° on the port bow. The pilot saw only the vessel's green light and that the vessel would cross the tanker's course line. The pilot therefore requested AIS data about the vessel from the master on Sola TS, but the master replied that the vessel was not transmitting such data.

Figure 13: At 03:57:27, there was a distance¹¹ of approximately 2,720 metres between HNoMS Helge Ingstad and Sola TS. Illustration: Safetec/AIBN

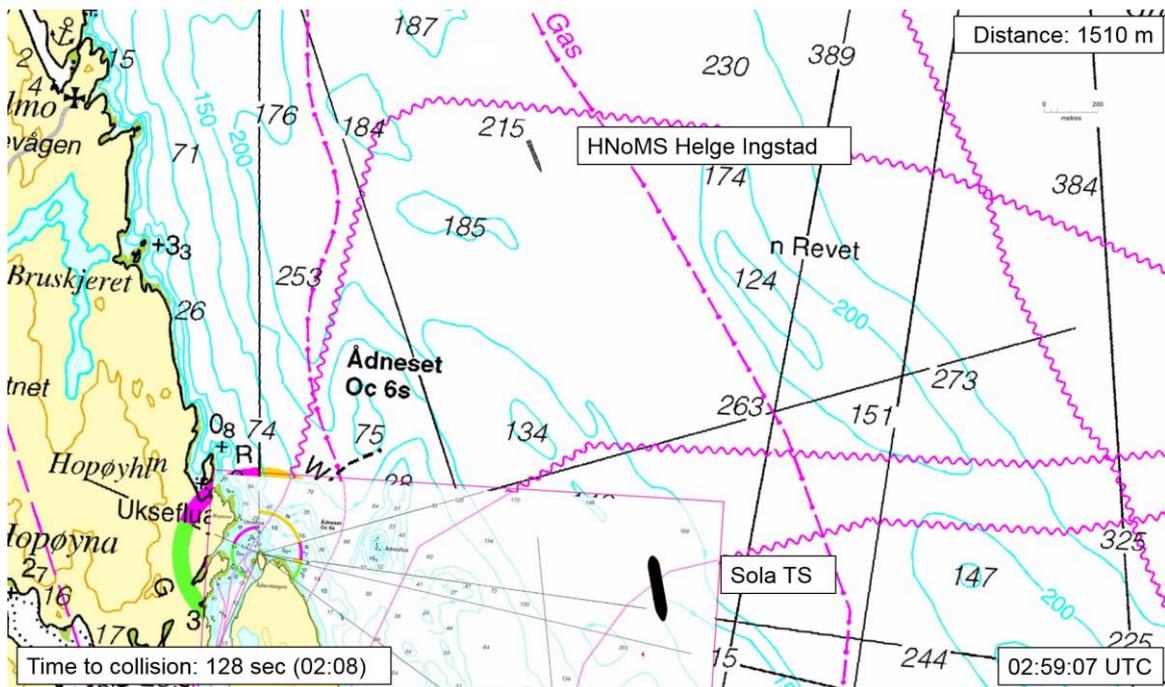
At 03:59:02, when there was a distance of approximately 1,510 metres between the vessels (see Figure 15), the pilot asked the master on Sola TS to use the Aldis lamp¹² to send out signals to the vessel. According to their statements, both the master and the pilot had, shortly after signalling with the Aldis lamp, observed both sidelights on HNoMS Helge Ingstad and thought that the vessel was turning to starboard. The master also observed that the two masthead lights on HNoMS Helge Ingstad were not in line and perceived the red sidelight to be clearer than the green sidelight. Shortly afterwards, they only saw the green light, and so they continued sending out light signals with the Aldis lamp.

Figure 15: At 03:59:07, there was a distance¹³ of approximately 1,510 metres between HNoMS Helge Ingstad and Sola TS. Illustration: Safetec/AIBN

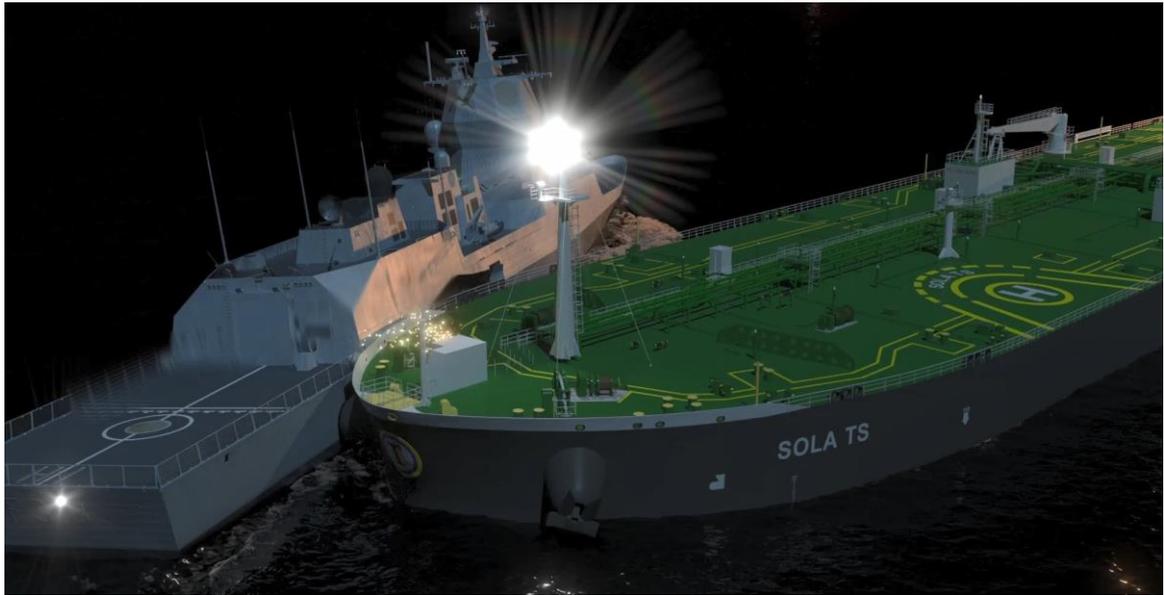
Figure 19: The point of impact when HNoMS Helge Ingstad and Sola TS collided outside the Sture Terminal in the Hjeltefjord at 04:01:15. Illustration: AIBN

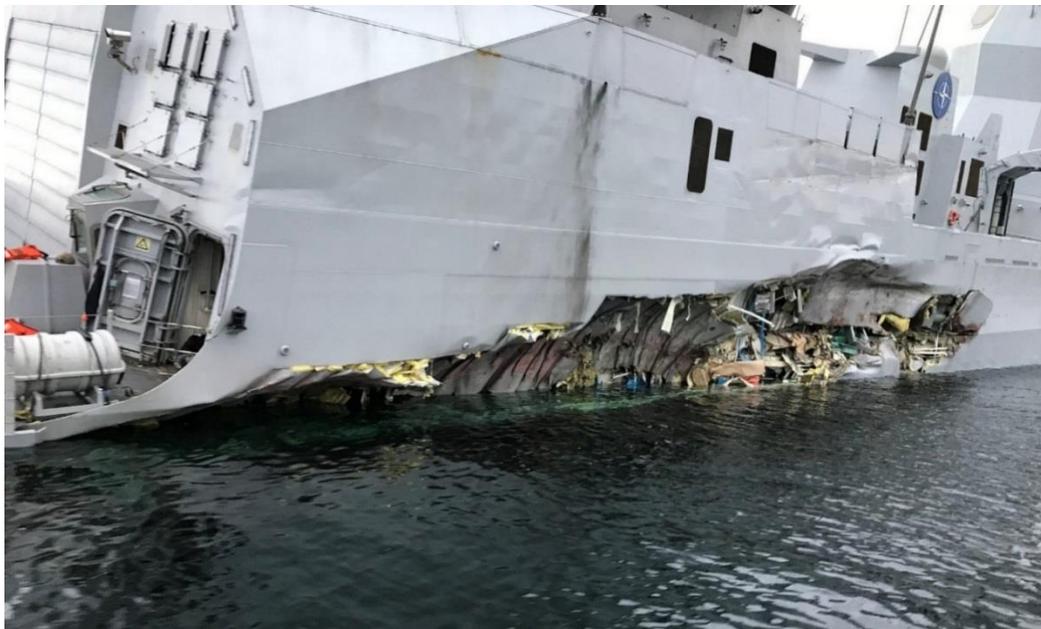
In the collision with Sola TS, HNoMS Helge Ingstad suffered extensive damage along the starboard side (see Figure 20). The damage caused flooding, a break in the starboard seawater line, severing of several electrical cables, extensive damage to the aft conscripts quarter, as well as damage to the torpedo magazine. Detailed information about the damage will be published in the final investigation report.

Figure 20: Damage to the hull along the starboard side of HNoMS Helge Ingstad after the collision. Photo: The Norwegian Coastal Administration

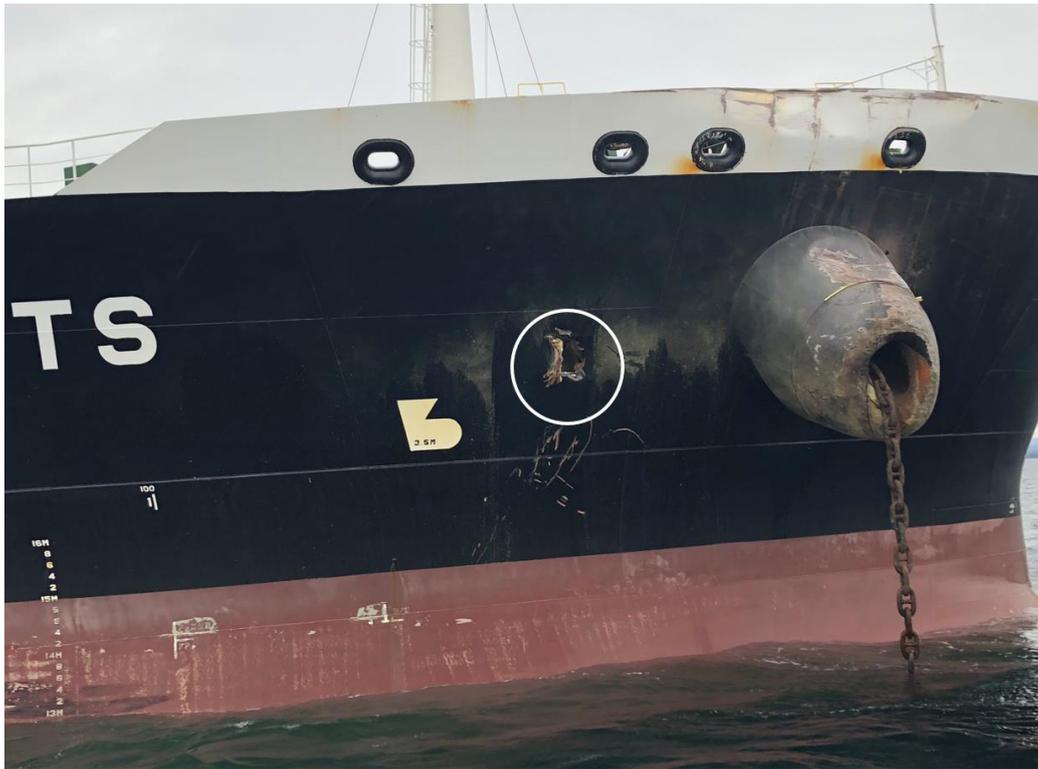
The tanker's starboard anchor was the first point of contact in the collision between HNoMS Helge Ingstad and Sola TS. The anchor and 20 m of the anchor chain were ripped out. The collision also caused damage to the hawsepipe and left a small hole in the hull just aft of the hawsepipe (see Figure 21). Parts of the bulwark above the anchor were indented.

Figure 21: The hawsepipe and the damage sustained by Sola TS in the collision. The hole in the hull is marked with a white circle. Photo: The Norwegian Maritime Authority

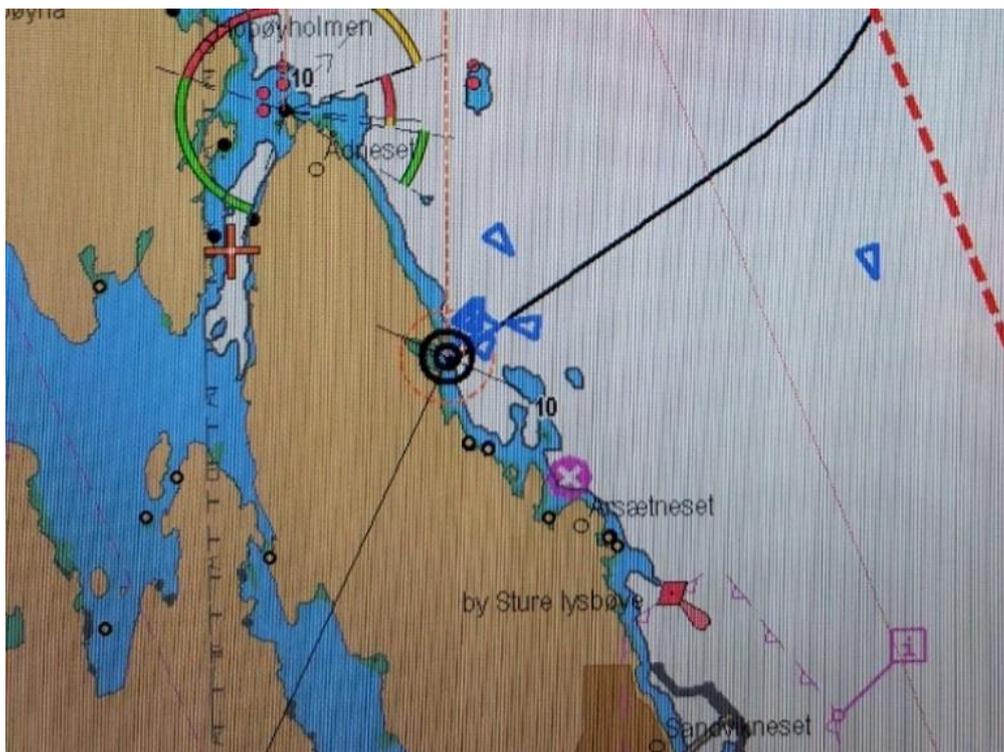
Figure 32: Map section showing the safety zone (marked with a pink broken line in the lower right corner) around the Sture Terminal. Photo of the ECDIS/MFD 3 on HNoMS Helge Ingstad taken after the accident. Photo: Crew member of HNoMS Helge Ingstad

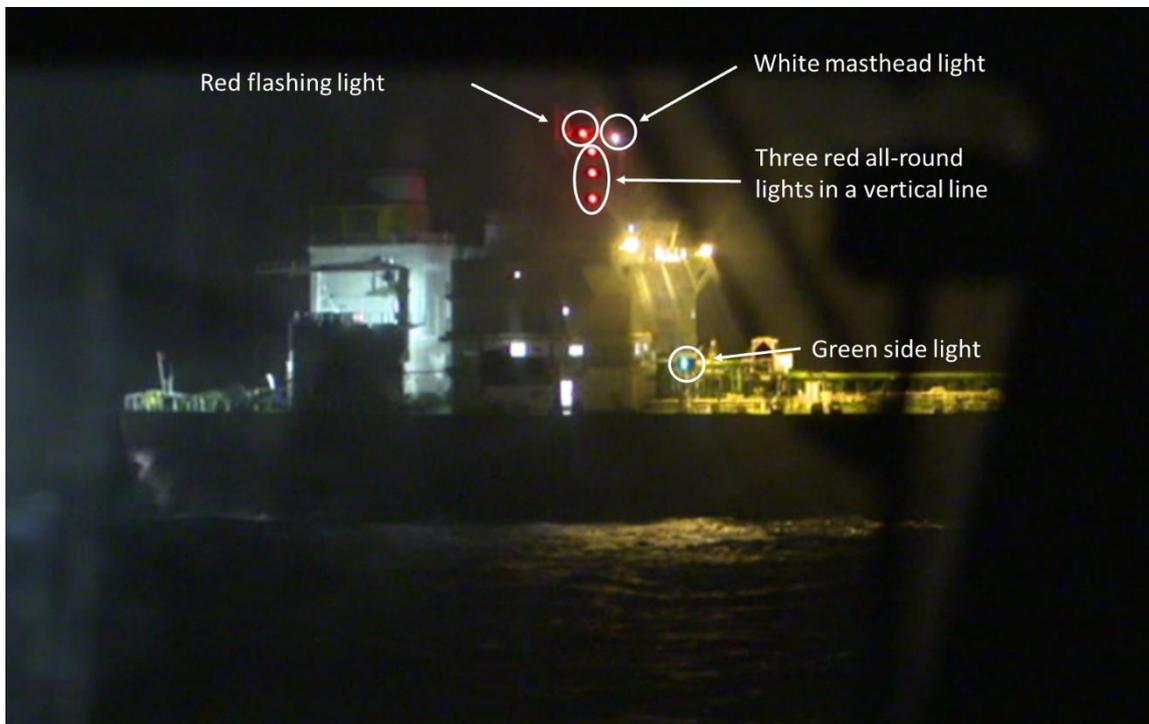
Figure 35: The lights exhibited abaft midship on Sola TS, viewed from the starboard side during the observation voyage. Photo: The police

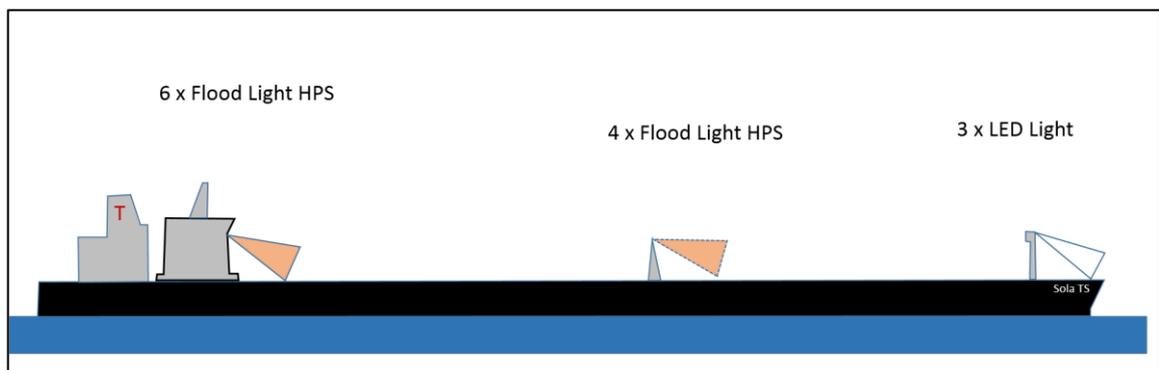
Figure 36: Simplified drawing of the forward-pointing deck lights that were lit on departure. Shortly after departure, the four midship lights were turned off. Illustration: Tsakos Columbia Shipmanagement S.A./AIBN

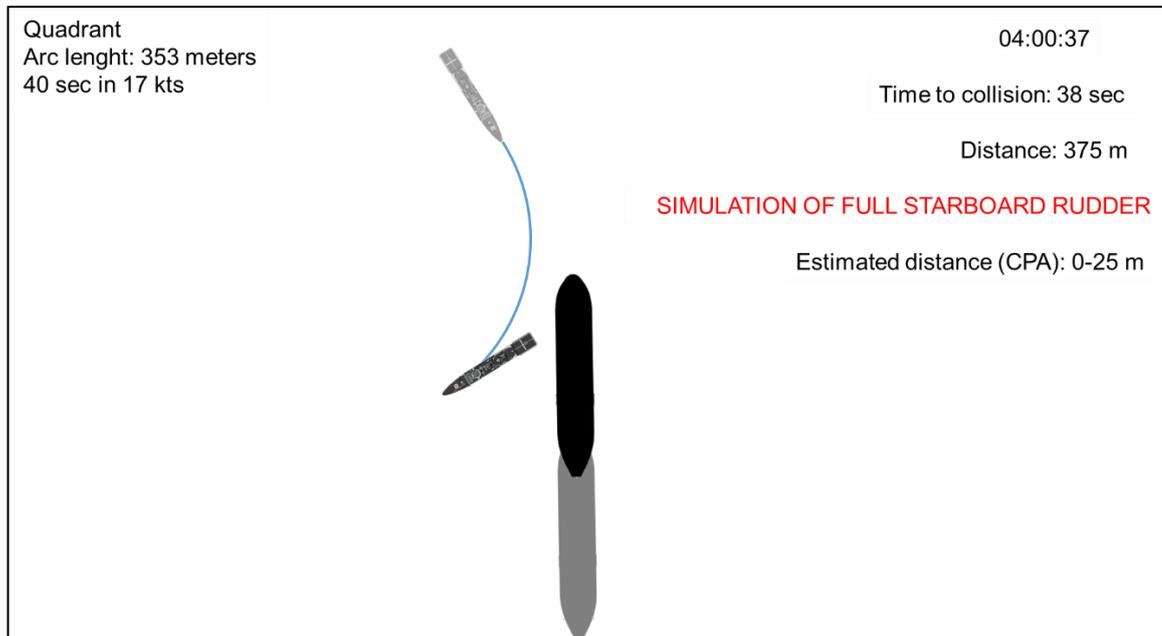
Figure 43: Had HNoMS Helge Ingstad made a manoeuvre to starboard 38 seconds before the collision, the collision would probably have been avoided. The vessels would then have passed each other port to port with a CPA of approximately 0 - 25 m. Illustration: Safetec/AIBN
