# Grounding of the bulk carrier *Orient Centaur*

Weipa, Queensland | 6 November 2017

**ATSB Transport Safety Report**  
Marine Occurrence Investigation  
MO-2017-010  
Final – 14 November 2019

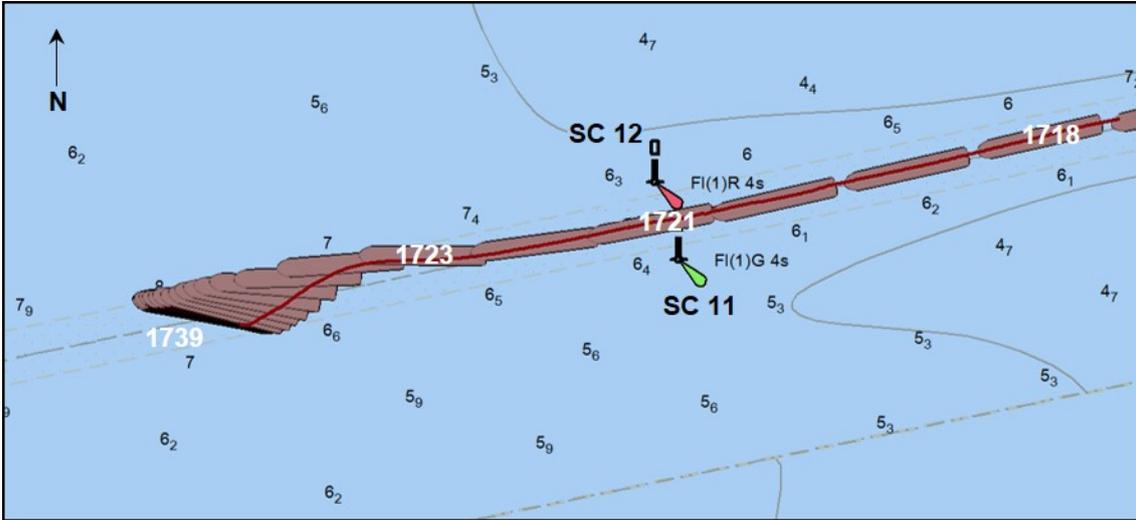
**Figure 3: *Orient Centaur*'s main engine shutdown to the grounding at 1 minute intervals**

At 1718, the main engine shut down, with the ship's speed at 8.6 knots (Figure 3). *Peter Crooke* was the first tug to respond to the call for assistance, and the comms pilot asked the tug master to attend the ship as soon as possible. The comms pilot then made several further radio calls to

Weipa VTS, stating ‘the ship had lost the main engine, taking a sheer, and was about to ground in the vicinity of SC12’.

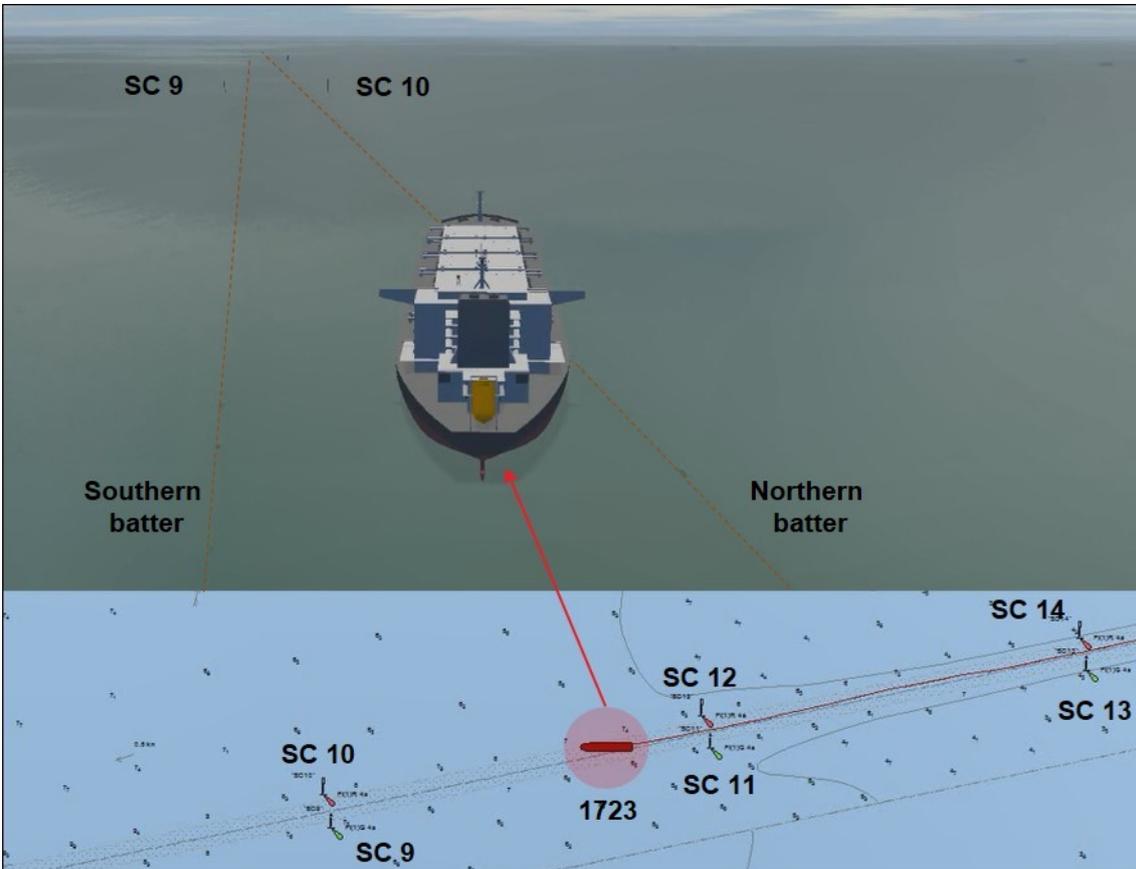
**Figure 4: *Orient Centaur* aground in the South Channel at 1723**

The ship's speed reduced to 8.3 knots as it passed beacons SC11/SC12, and it started to turn to starboard with an increasing rate of turn. The conning pilot ordered hard to port, but this had little effect. The ship continued to turn to starboard and at 1723 (Figure 4), the ship's starboard shoulder grounded on the northern batter (bank of the channel) of the South Channel, at a speed of 6.7 knots, on a heading of 270°, and the rudder positioned amidships.

By 1739, the ship had come to rest with the starboard shoulder aground on the northern batter, on a heading of 279°, south-west of SC 12 with the port quarter across the channel and drifting towards the southern batter.

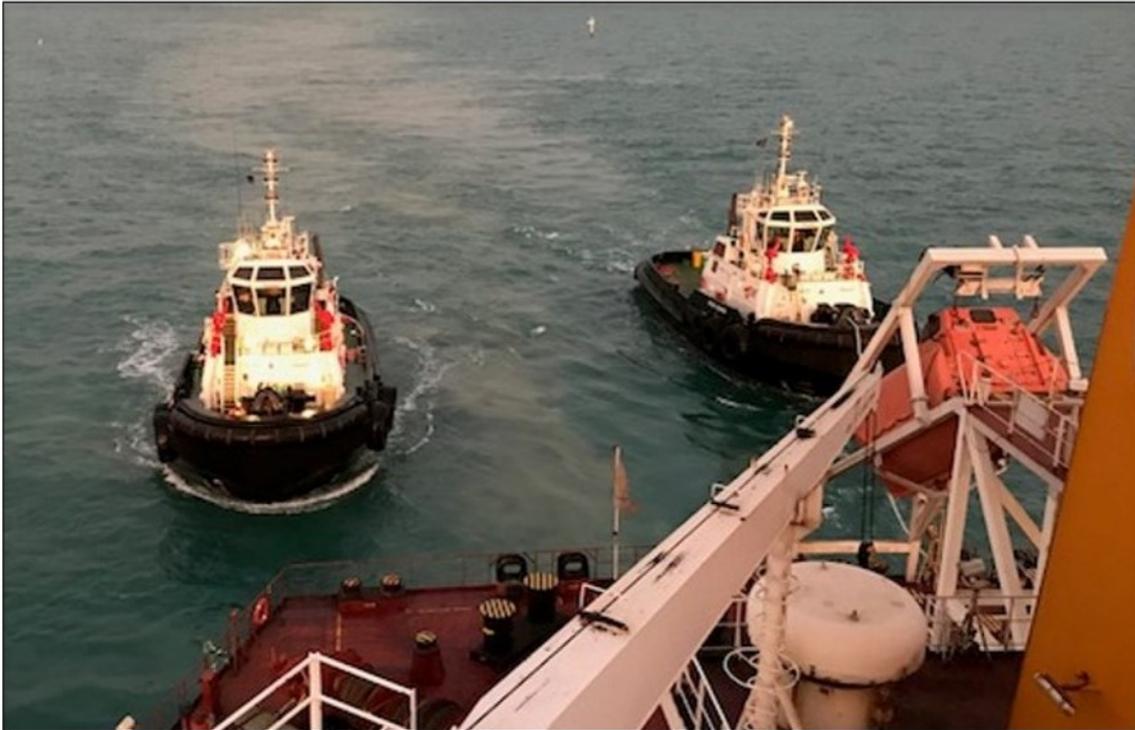
**Figure 5: Tugs *Harry Evans* arriving at *Orient Centaur* and *Peter Crooke* fast on the port quarter**

The pilots and *Orient Centaur's* master checked the proposed route to the emergency anchorage, and determined that the emergency anchorage position would not provide a satisfactory UKC for the ship in the loaded condition. At 2010, the comms pilot informed RHM that the emergency anchorage area did not have sufficient water for the ship's draught and an alternative position was agreed.

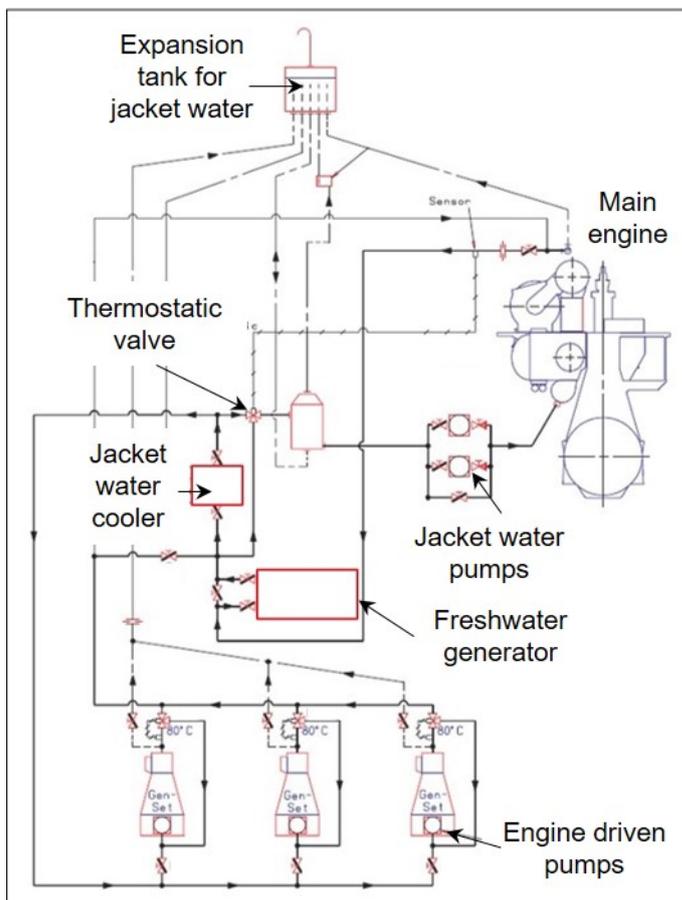
**Figure 6: Jacket water cooling diagram**

Consistent with the detail in the service letter, the engine jacket water needed to be carefully treated, maintained and monitored to avoid corrosion, corrosion fatigue, cavitation, and scale formation.

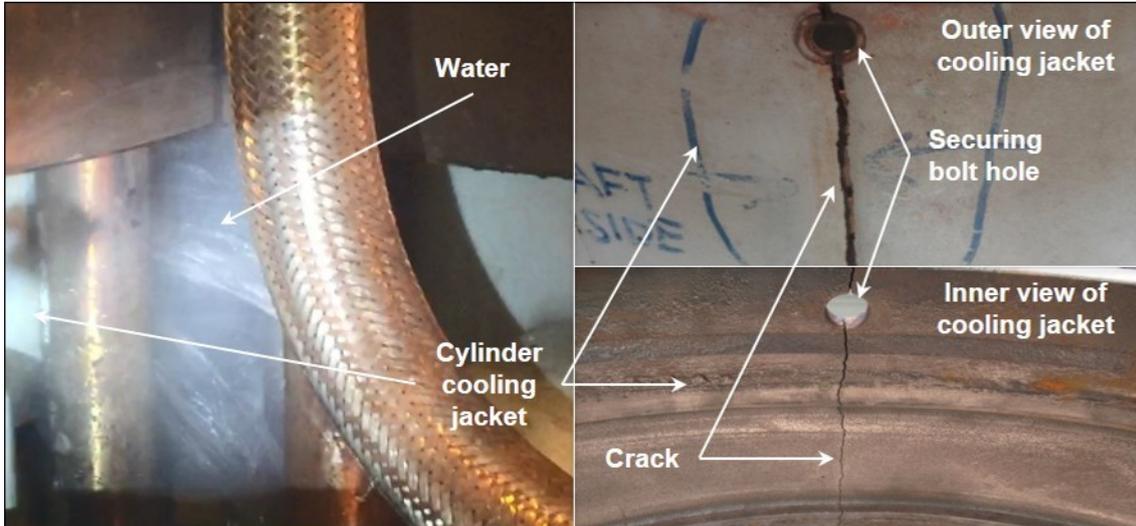
**Figure 7: Cylinder cooling jacket failure and crack (after cleaning)**

The crewmembers who were in the engine room at that time of the occurrence sighted water coming from a crack in the cylinder cooling jacket of the cylinder head of cylinder number 1 (Figure 7). The loss of jacket water triggered the main engine to shut down.

The engine manufacturer subsequently inspected the failed cylinder cooling jacket and identified that:

- the jacket had one vertical crack that passed through a securing bolt hole
- there were four bulges around the crack but no evidence of any impact marks
- the cooling space of the inner cooling jacket had heavy corrosion/rust and metal peeled off.

The loss of cooling water was the result of a crack in a main engine unit's cylinder cooling water jacket through a securing bolt hole, an area of inherent stress concentration. Furthermore, consistent with the engine manufacturer's service letter, it is possible that the effects of corrosion products found in the cooling water space contributed to the cracking due to increased stress in the area of the failure.

- water analysis on board weekly
- water analysis at shore every 6 months
- checking appropriate tightening of Cylinder Head every 8000 hrs
- proper overhaul of cooling jacket (replacement of o rings and cleaning) and use of original spares according to manufactures instructions, service letters and manual every overhaul
- checking securing bolts as per manufactures service letters every overhaul
- proper tracking of running hours monthly
- original spare cooling to be available on board at all times
- all cylinder jackets renewed within 1 year from incident
- maker guidance/recommendations and service letters are followed as per planned maintenance system schedule.
