National Transportation Safety Board

Marine Accident Brief

Collision of Sand Barge *Weeks 207*, Pushed by Tugboat *Seeley*, with Sailboat *Sea Jay*

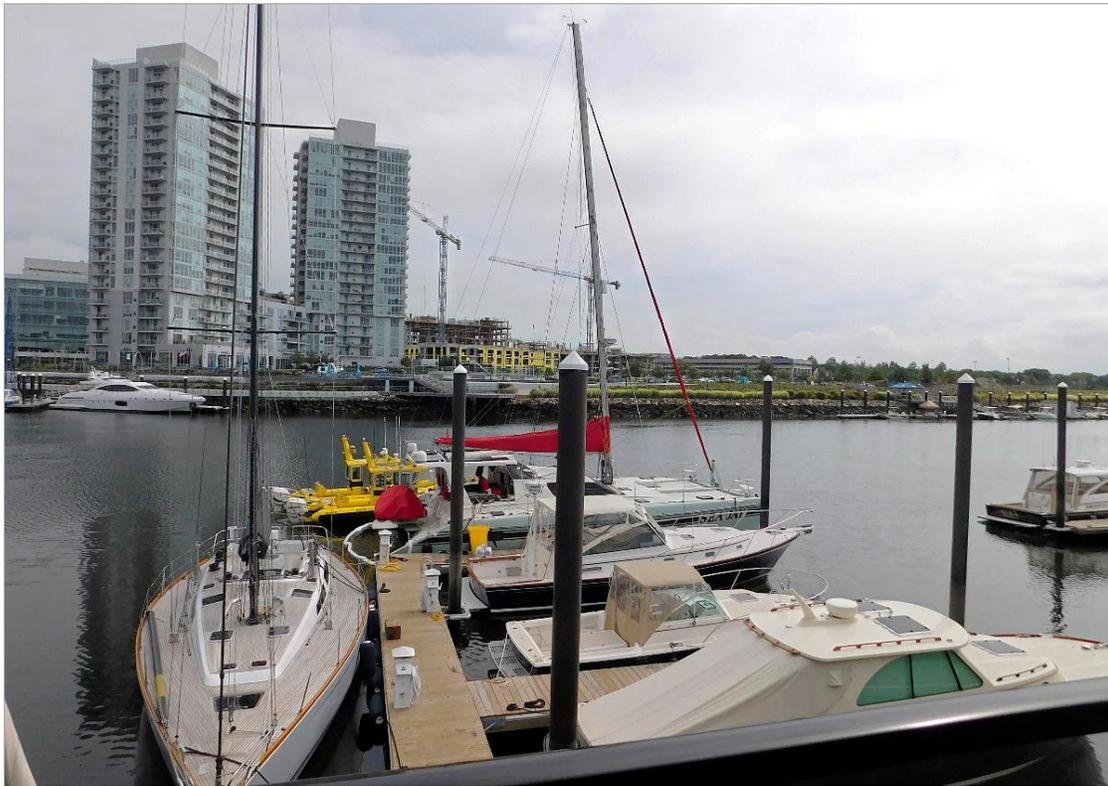
Catamaran *Sea Jay*, the vessel with a red main sail cover, seen docked at the end of Hinckley pier after the accident. (Source: US Coast Guard)

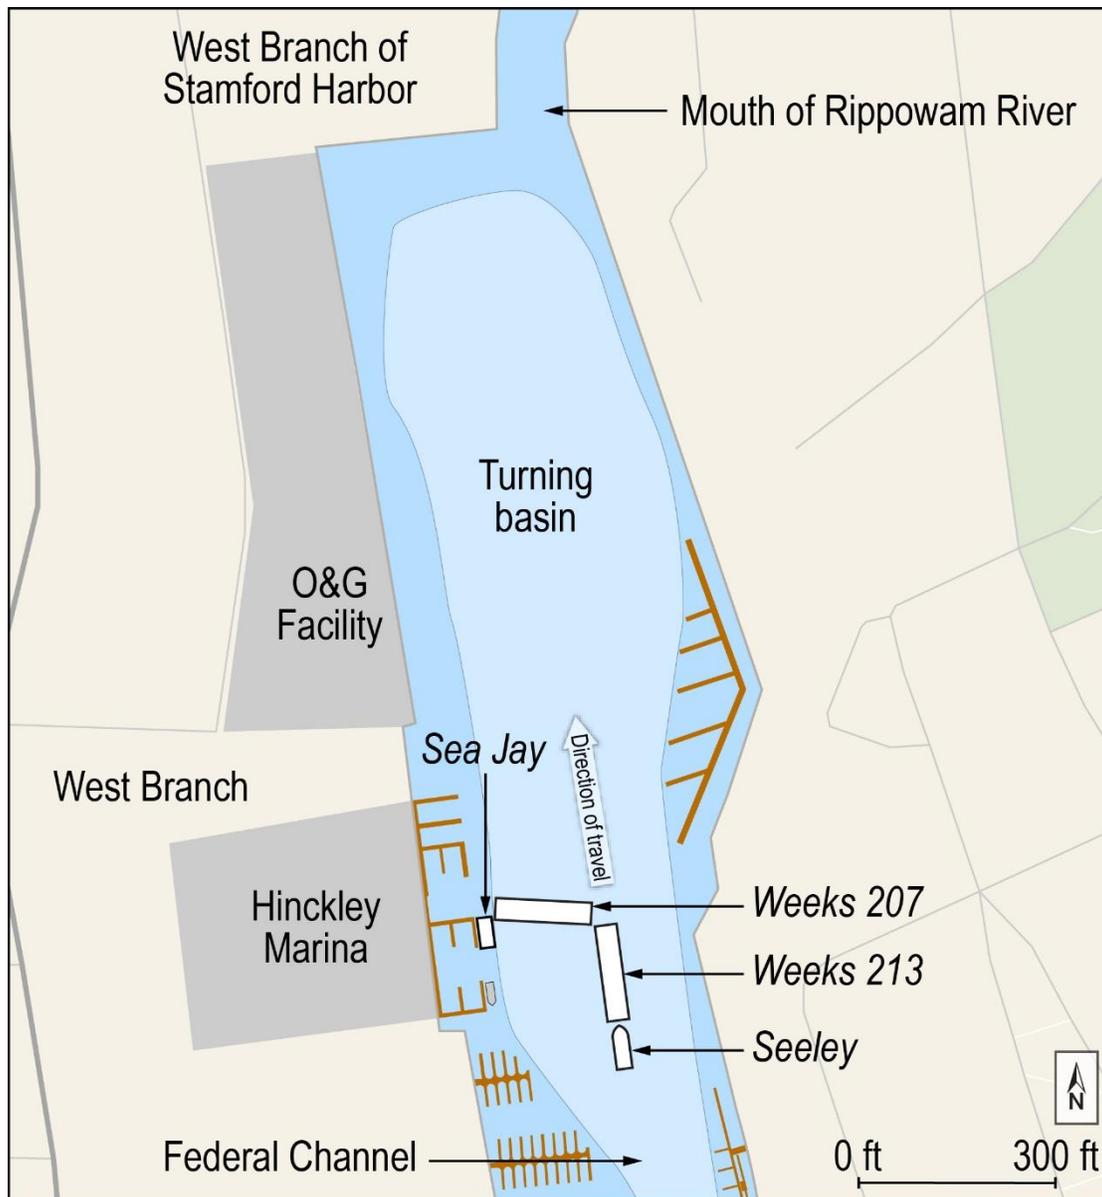
Rendition showing the approximate position of barge *Weeks 207*, pushed by tugboat *Seeley*, striking sailboat *Sea Jay*. (Background by Google Maps)

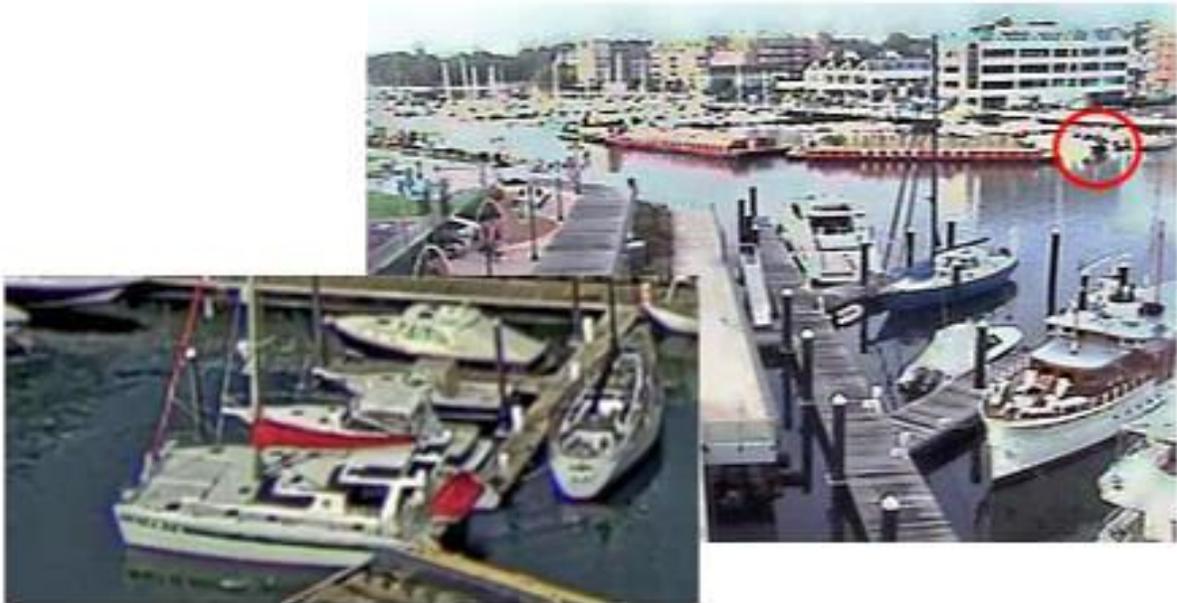
Surveillance footage of (top) *Seeley* with *Weeks 213* and the separated *Weeks 207* angled and moving toward the *Sea Jay* (circled) at 0825:19. Inset: Port forward corner of *Weeks 207* at the moment it falls away from the *Sea Jay*. (Source: US Coast Guard)

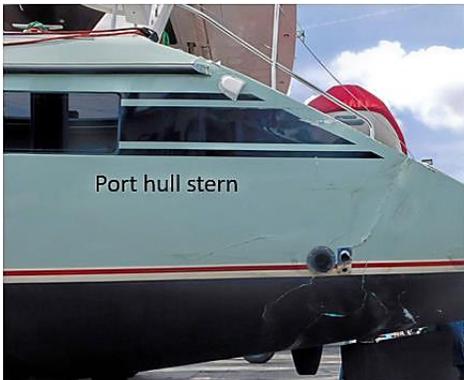
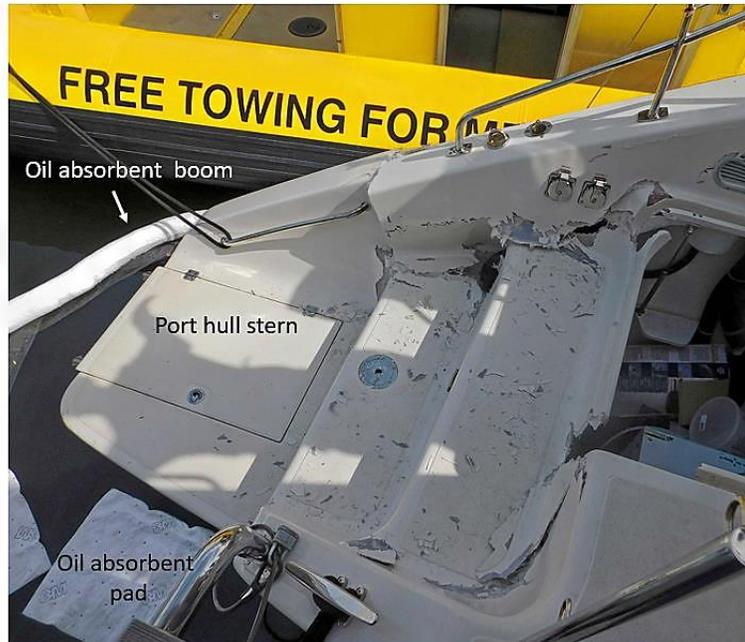
the port side of the *Sea Jay* at its stern and damaging the fiberglass hull. The impact pressed the *Sea Jay* against the dock on the sailboat's starboard side and causing movement of the floating pier, its finger piers, and four vessels moored to the dock. As the *Seeley* continued moving ahead, the barge came away from the *Sea Jay* and continued swinging to port.

After *Weeks 207* struck the *Sea Jay*, the tripping maneuver continued until the barges were brought together. The *Seeley* mate told investigators that because the tow was still in the navigable channel, he did not want to obstruct other vessel traffic and so he continued with both barges to the terminal and moored them. Employees from Hinckley Marina scrambled to the *Sea Jay* to assess the damage. The collision damaged an oil line on the *Sea Jay*, which spilled oil into the bilge. This oil mixed with water and was pumped overboard by one of the *Sea Jay*'s small automatic bilge pumps. Responders noted the sheen and contained the spill with absorbent boom; they subsequently removed the oil using absorbent pads. The *Sea Jay* was towed that same day to a boat yard for repair of its port hull and deck. The dock and *Weeks 207* were undamaged in the accident.

From left: crack in the fiberglass on the port side of the *Sea Jay*'s port catamaran hull; cracks in the fiberglass in way of steps and engine compartment at stern of port hull. (Source: US Coast Guard)
