National Transportation Safety Board

Marine Accident Brief

Overturning of the Liftboat *Ram XVIII*

Vessel name	<i>Ram XVIII</i>	Accident No. DCA19FM007
Accident type	Other	
Location	Gulf of Mexico, West Delta Block 68, about 15 miles south-southeast of Grand Isle, Louisiana 29°00.87' N, 089°50.50' W	
Date	November 18, 2018	
Time	0200 central standard time (coordinated universal time – 6 hours)	
Injuries	Three minor	
Property damage	\$1,140,000 est.	
Environmental damage	1,000 gallons of hydraulic fluid	
Weather	Visibility 10 miles, winds southeast 5 knots, combined seas 3 feet, air temperature 61°F, water temperature 62°F	
Waterway information	The West Delta lease area of the Gulf of Mexico lies immediately west of the Mississippi River entrance and offshore Barataria Bay, Louisiana. West Delta block 68 is midway between Southwest Pass and Grand Isle, Louisiana.

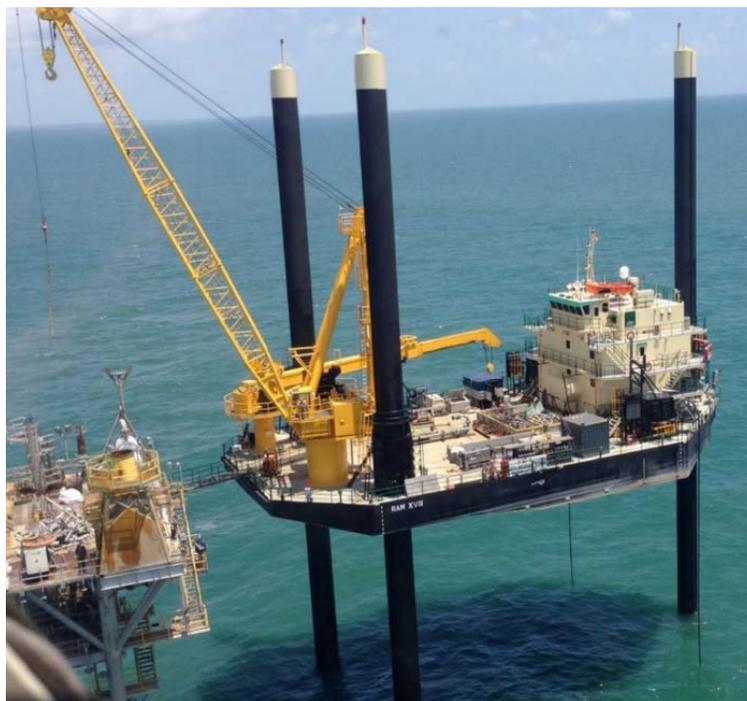
The liftboat *Ram XVIII* elevated at a previous work site. (Source: Aries Marine)

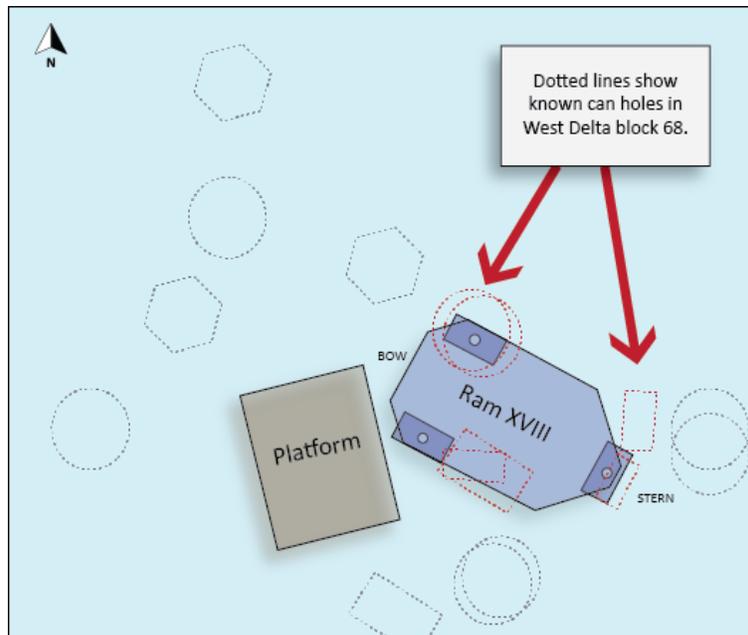
The WD-68-U platform and surrounding seafloor, including outlines of documented can holes. The *Ram XVIII*'s position is shown in relation to the platform, with its starboard leg in a can hole.

Of the 190 tons carried on board, the *Ram XVIII* had an estimated 25 tons sitting on deck on arrival, including a compressor, grocery boxes, and sandblasting equipment. The mate loaded 400 tons of water in the preload tanks, filling them to the top. While jacking up the *Ram XVIII*, the starboard and stern legs penetrated the seabed, indicating they were in the can holes as planned. The master worked for about two hours, keeping the vessel level while slowly elevating it out of the water. As expected, the port leg did not penetrate very far, despite the master's effort to “lean” the vessel in that direction by jacking the starboard side to put more weight on the port leg. The mate relieved the master about 1700 and continued to “tweak” the legs until about 1930. The master then continued until 2230, when he let the ship settle. Satisfied that the legs were no longer moving, the master began dumping preload tank water at 0230 on Saturday morning. He then stripped the tanks to prevent any free surface effect. The mate told investigators there was a 15-foot difference in the height of the port leg and the other two legs after the preload and estimated the port leg had only penetrated 12 to 18 inches. Aries' management stated this 15-foot difference was not unusual.

The mate, master, and Aries’ Operations Manager all described the West Delta area of the Gulf of Mexico as a “bad area” to work due to the soft bottom, and the master stated that can penetration was up to 17 feet. Previously in his career, the master had refused to work at locations due to can holes, losing his job at least once due to this. He told investigators that he had placed legs in a can hole only two other times in his 34-year career. Despite his experience, and although he had never been to this platform before, he “felt good” about the location. He also stated the can hole nearest the port leg was far away, and “...there’s no way that leg slid into the can.” The weather was “slick calm” with no wind, and the elevated vessel was not rocking or swaying before the accident.

Seafloor conditions, including can holes; bottom changes due to storm passages; proximity to major rivers; and soil composition can pose significant hazards to safe liftboat operations. Operators should use all available information in selecting sites to land out legs. Leaseholders should provide and liftboat operators should request all necessary information for safe operations, including, but not limited to, soil analysis, penetration history for the site, and/or core samples, before commencing jack up operations.

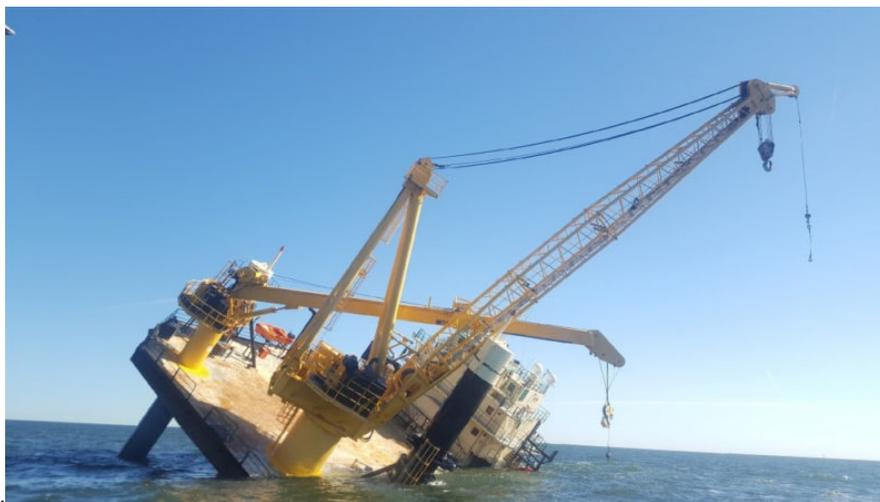
The *Ram XVIII* after the vessel was abandoned, showing a significant angle of inclination to port. (Source: Coast Guard)

The National Transportation Safety Board determines that the probable cause of the overturning of the elevated liftboat *Ram XVIII* was the industry practice of not regularly providing liftboat operators with adequate information about the seafloor composition, which resulted in the instability of the port leg due to unidentified conditions/hazards in seabed composition near the port leg landing site.

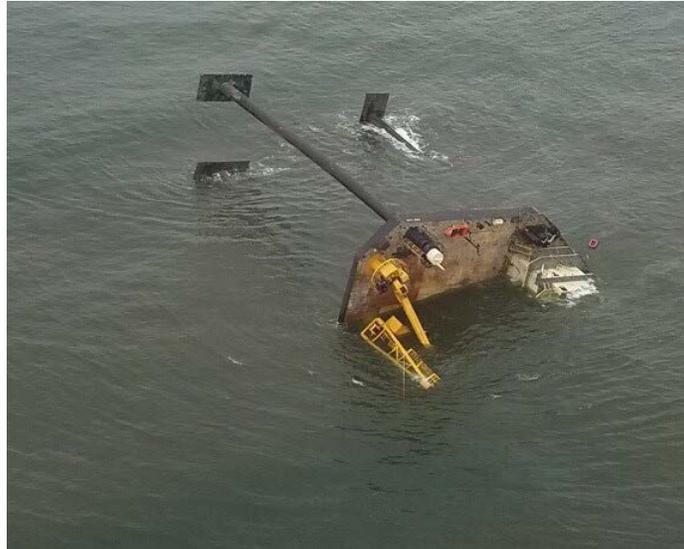
***Ram XVIII* six days after the accident, on November 24. Note the life float adrift astern of the vessel. (Source: Coast Guard)**

Efforts to salvage the vessel began immediately; however, further salvage of the vessel was hampered by winter weather, and the liftboat further inclined on November 24. Salvors completed the recovery of 12,300 gallons of diesel from two integral fuel tanks by December 12. The hull was later towed further offshore and scuttled in West Delta block 96, where it would not damage subsea pipelines or other structures, until a weather window would allow salvage. The *Ram XVIII* has yet to be salvaged as of the publication of this brief.

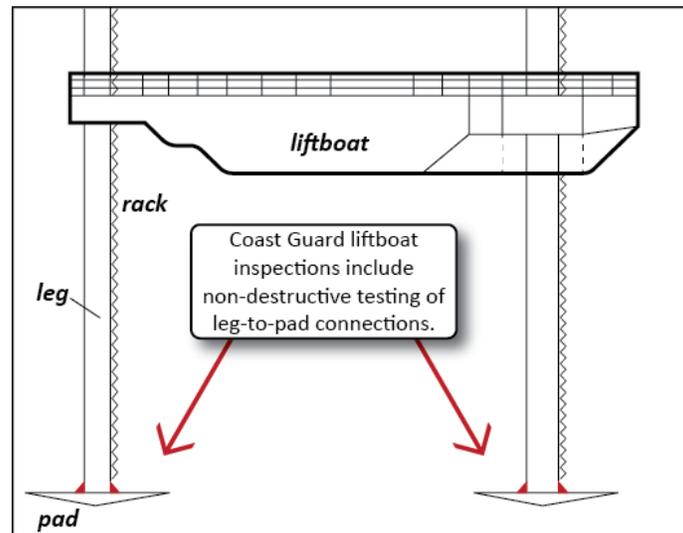
The vessel completed annual Coast Guard inspections in 2016 and 2017 with no deficiencies, and the Coast Guard documented only minor repairs during the first and only drydock exam in 2017. The last documented visit by the Coast Guard was in February 2018 for an annual inspection, during which inspectors witnessed NDT of the can-to-pad welds at Aries' request to ensure repairs had been made. These welds bear the main load of the vessel when elevated, and

they are subject to extreme stress when the legs are raised, since the pads can be embedded in silt and mud for months.

Representation of a liftboat. The leg-to-pad connections, which are critical welds unique to liftboats, are illustrated as red triangles.
