SAFETY INVESTIGATION REPORT

REPORT NO.: 20/2019

November 2019

MV *Khosrov Bey* **Fatal fall down in the engine-room** **in position 41° 35.6' N 028° 44.0' E** **03 November 2018**

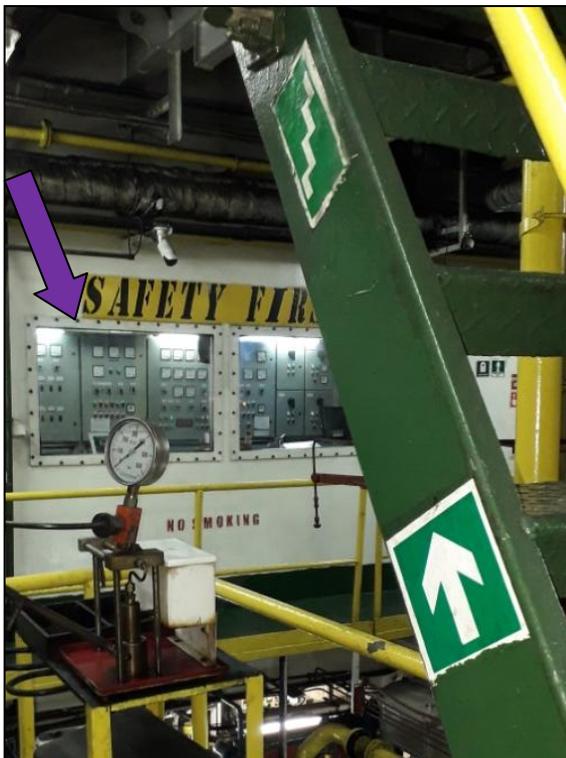
Figure 2: Engine control room window

By around 1200, the chief engineer, the third engineer, the electrical engineer, and one motorman, were all in the engine control room (ECR). In the meantime, the second engineer, who was on duty from 1200 till 1600, was making his way towards the engine-room. The electrical engineer, from the ECR's window (Figure 2), saw the second engineer descend the first few steps of the stairs (Figure 3) that led to the engine-room.

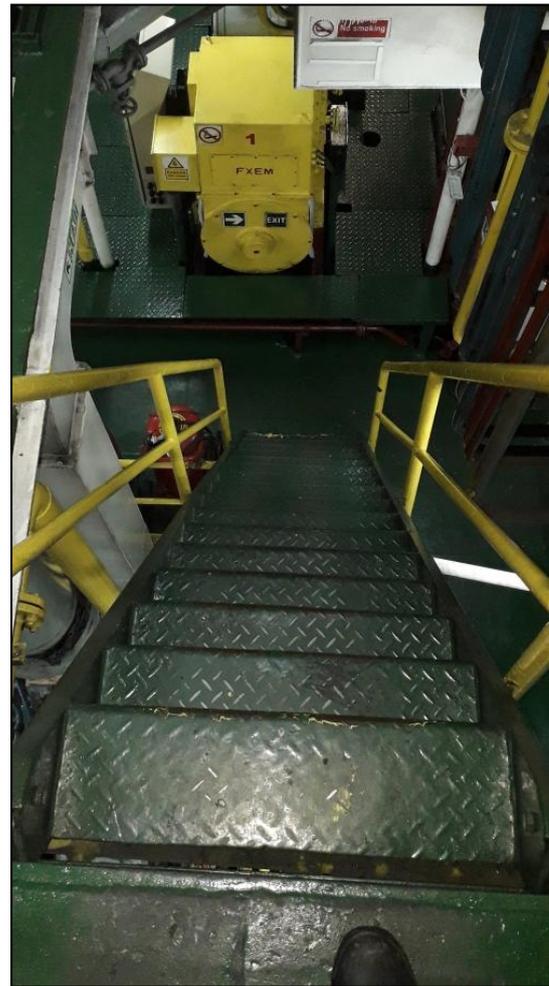
Figure 3: Stairs leading into the engine-room

The access to the first engine-room platform, (which is at level with the ECR), from the upper deck, is via a flight of stairs (Figure 4). These stairs are set at a 60° angle from the horizontal and comprise of sixteen steps, painted in green. Each step was reported to be uniformly placed, with a riser height of 22 cm and a depth tread of 20 cm.

At the time of occurrence, the crew reported that no defects in the structure or fittings were observed.

In addition to the above, the design of the staircase lacked contrasting step edges (nosings), which are highly effective against

missing a step and slipping⁴. It did not transpire to the safety investigation that the fitting of step edges is a mandatory requirement.

20/2019_R1 Mark nosings of stairs with a contrasting colour.

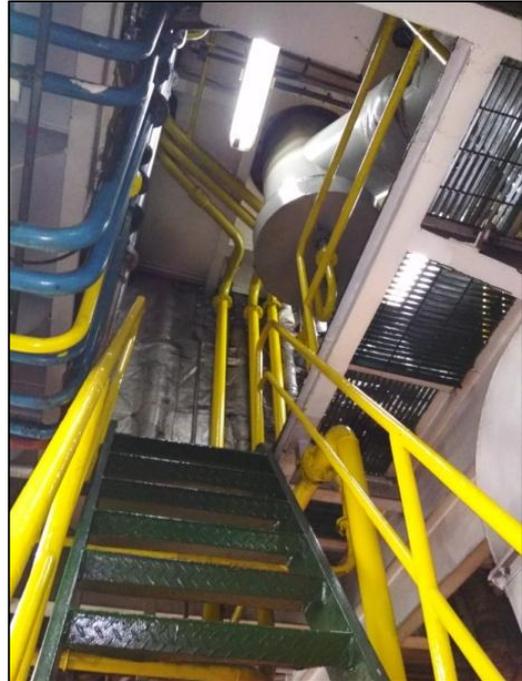
Figure 5: Lighting above the stairs

The stairs included a fixed handrail and a midrail at either side of the stairway, both painted in yellow. At the time of the occurrence, the stairs were reported as being clear of any obstructions and not being slippery. The stairs were adequately lit by artificial lighting throughout its entire length (Figure 5).

10. The stairs were free from any defects or damages which might have contributed to the fall;
11. The stairs were adequately lit by artificial lighting at all stages of descent.

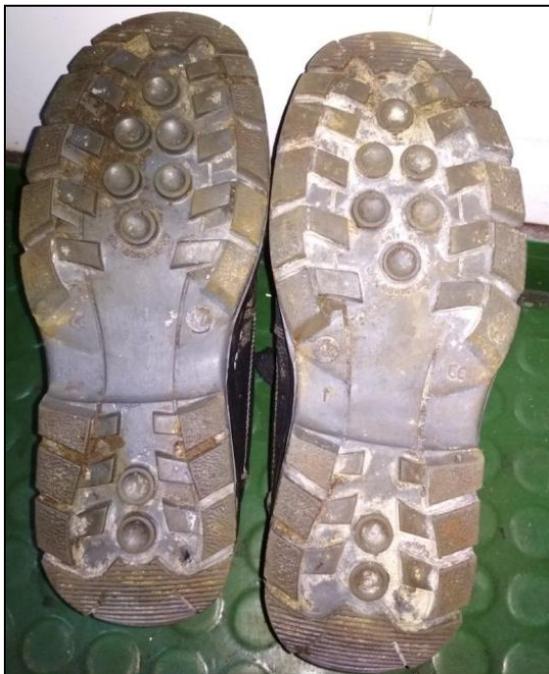
Figure 7: Grooves in the sole of the second engineer's safety boots

Close-up photos of the safety boots indicated that although evidently used, there was still adequate depth to the sole (Figure 7). The safety investigation could not attribute the fall to the condition of the safety boots.
