National Transportation Safety Board

Marine Accident Brief

Capsizing of the Towboat *Miss Roslyn*

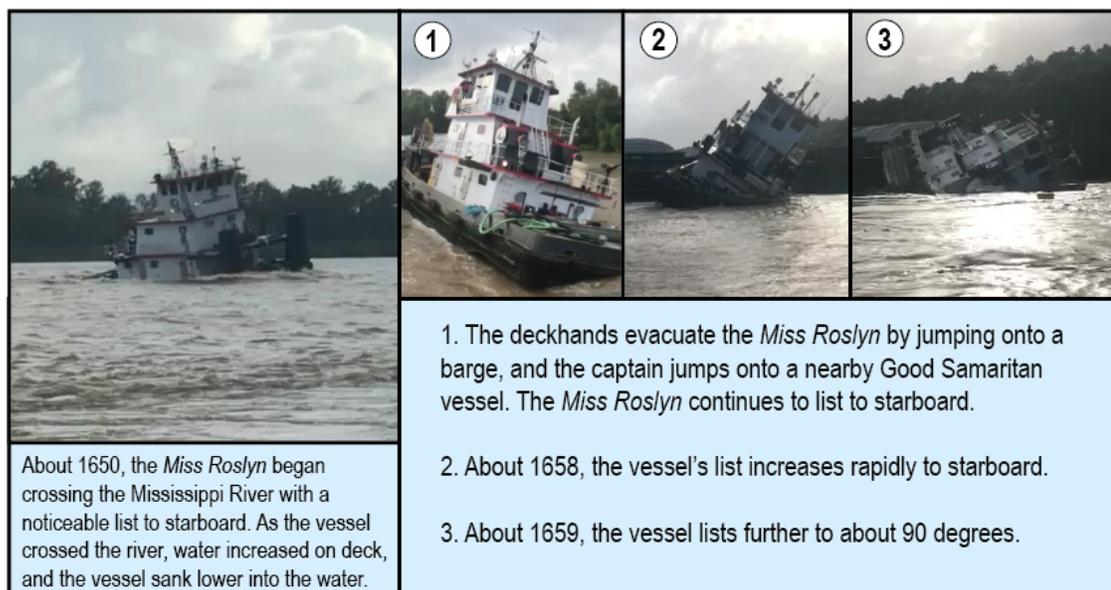
The captain stated that when the *Miss Roslyn* was about 50 feet from an empty moored fleet barge on the left descending bank, the list increased to a slow roll to starboard. As soon as the *Miss Roslyn* touched the barge, the two deckhands jumped to the barge from the towboat's push knees. The captain then disembarked the *Miss Roslyn* by jumping from the stern onto the *Kristy Dutsch*. At 16:59:11, the *Miss Roslyn* continued to roll over until the vessel came to rest on the river bottom with about 5 feet of the port bow above the surface and the stern fully submerged. The final capsizing of the *Miss Roslyn* was caught on video by a crewmember of the *Kristy Dutsch*.⁶

Sequence of events as the *Miss Roslyn* headed toward moored barges with a heavy list to starboard and eventually capsized. (Source: Clay Hebert, ITV *Kristy Dutsch*)

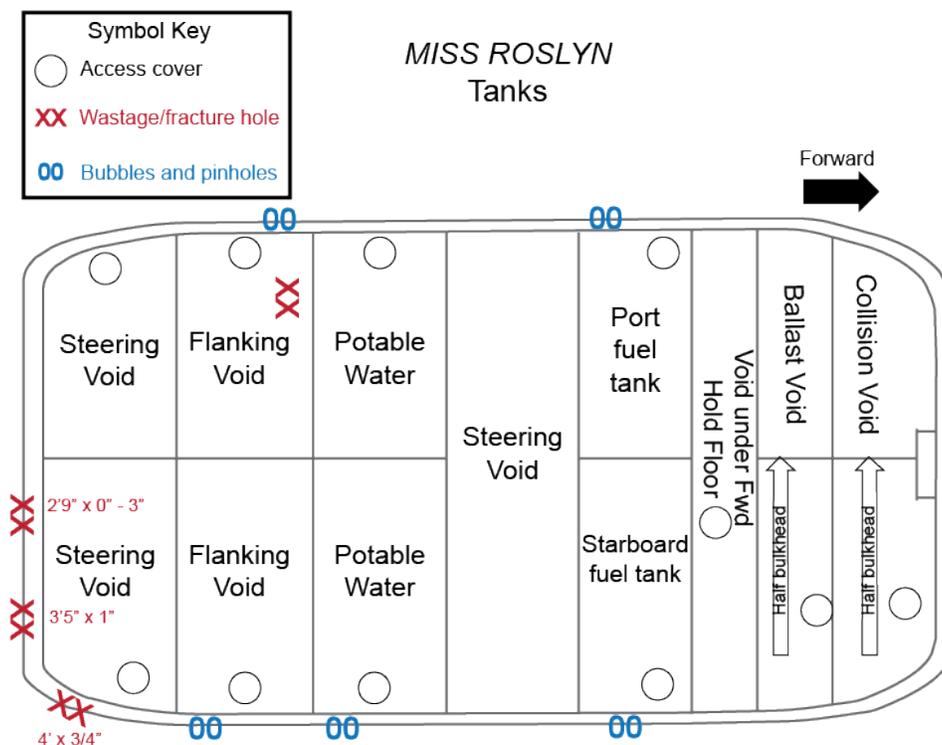
On November 16, a marine surveyor conducted a tank compartment air test while the salvaged vessel was in drydock.⁷ The surveyor noted severe wastage, including a hole and a fractured seam in the hull to the starboard steering void and a fractured deck plate on the stern deck above the port flanking void, and bubbles were observed on the hull, indicating corrosion holes to the following: both port and starboard flanking voids, starboard potable water tank, and both port and starboard fuel tanks. Investigators noted the manhole covers to the starboard steering void had severe wastage. The marine surveyor estimated damages at \$1,130,000 and considered the vessel a constructive total loss.

Estimated position of holes in the hull and deck found during the *Miss Roslyn* tank compartment air test. (Background source: Marquette Transportation)

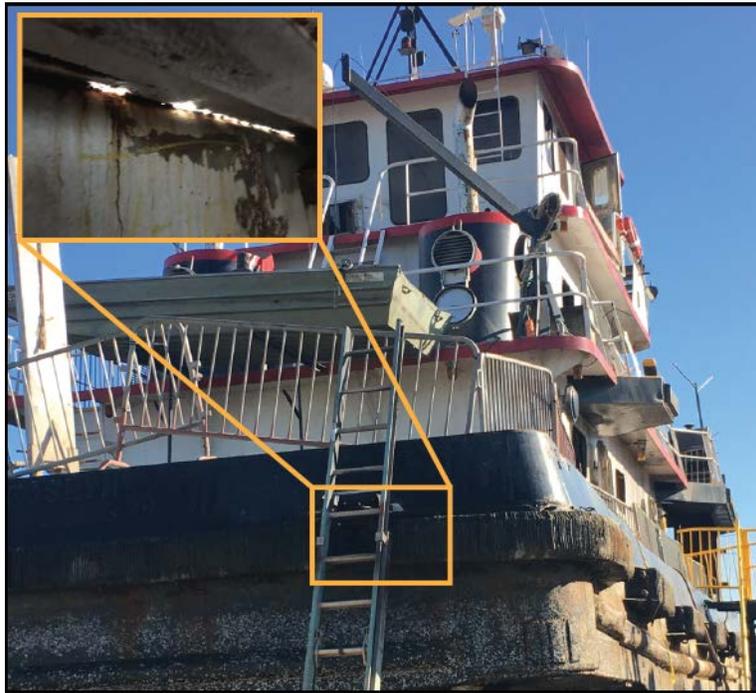
The *Miss Roslyn* was in drydock in June 2017 for maintenance and repairs to the hull. However, after the accident, the marine surveyor found two wastage holes and a fractured weld seam at the main deck to the starboard steering void, which therefore was not watertight. The captain stated that he was assisting in making up a tow, which required him to push against the tow at a 90° angle to the bank for 2.5 to 3 hours. This action, in combination with the current, likely would have lowered and intermittently submerged the wastage and fracture holes on the starboard stern quarter (which were normally just above the waterline) and allowed continuous water ingress to the starboard steering void for about 3 hours. As the *Miss Roslyn* got underway to head back for crew change, the aft steering void would have been partially flooded, which likely caused the observed starboard list. Once the hull flooded, the vessel sank lower, increasing the rate of flooding through the holes to the starboard steering void (which were only intermittently submerged at first), thus increasing the starboard heel and submerging the starboard bulwark and

then the stern deck. Eventually, the port flanking void flooded, resulting in the vessel's loss of stability and capsizing.

A ladder on the stern shows the approximate location of a large hole along the seam between the *Miss Roslyn*'s starboard steering void and aft main deck; the hole is shown in the inset image.

The severe wastage found throughout the vessel in the post-accident survey indicates that the *Miss Roslyn* was poorly maintained. The company did not have an effective maintenance program on board the vessel, so holes in and fractures to the hull and deck went undetected and ultimately led to flooding while the vessel was conducting normal operations. An effective maintenance program would have prevented the holes from forming and made identification of hull fractures easier to see and flag for repair, or helped to determine when the vessel had outlived its useful service life.

The National Transportation Safety Board determines that the probable cause of the capsizing of the *Miss Roslyn* was the company's lack of effective hull inspection and maintenance program, which resulted in flooding into a steering void through multiple wastage holes in the hull.

To protect vessels and the environment, it is good marine practice for owners to conduct regular oversight and maintenance of hulls, including between drydock periods. Regardless of inspection requirements, owners are obligated to ensure vessels are properly maintained, equipped, and operated in a safe condition. Issues with watertight integrity and wastage need to be addressed by permanent means.
