National Transportation Safety Board

Marine Accident Brief

Grounding of Fishing Vessel *Imperial*

Accident type	Grounding/Stranding	No. DCA19FM008
Vessel name	<i>Imperial</i>	
Location	Gulf of the Farallones, near Point Reyes, California 37°59.03' N, 123°01.66' W	
Date	November 19, 2018	
Time	0445 Pacific standard time (coordinated universal time – 8 hours)	
Injuries	0	
Property damage	\$950,000 est.	
Environmental damage	None observed	
Weather	Visibility 10 miles, passing clouds, winds south 2 knots, seas west-northwest 4.6 feet, air temperature 48°F, water temperature 58°F, morning twilight 0629, sunrise 0651	
Waterway information	The Gulf of Farallones is in the Pacific Ocean and borders California north and south of San Francisco. The Gulf includes traffic separation lanes for the port of San Francisco. The accident occurred inside the Gulf of the Farallones National Marine Sanctuary.

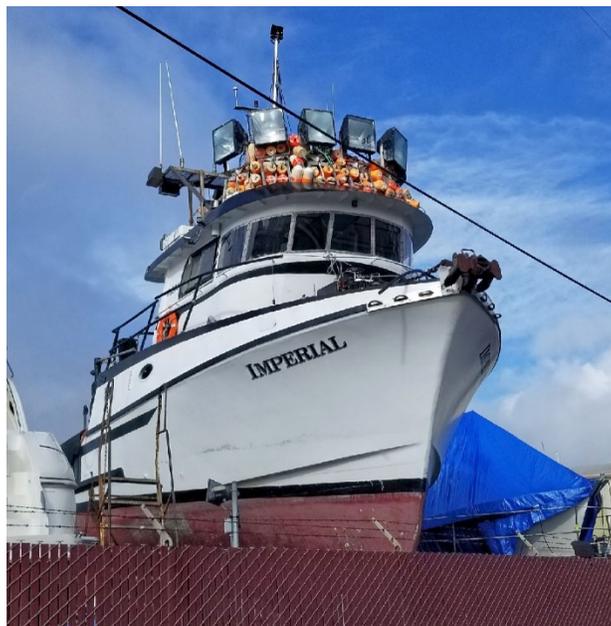
Imperial on blocks after the accident. (Source: US Coast Guard)

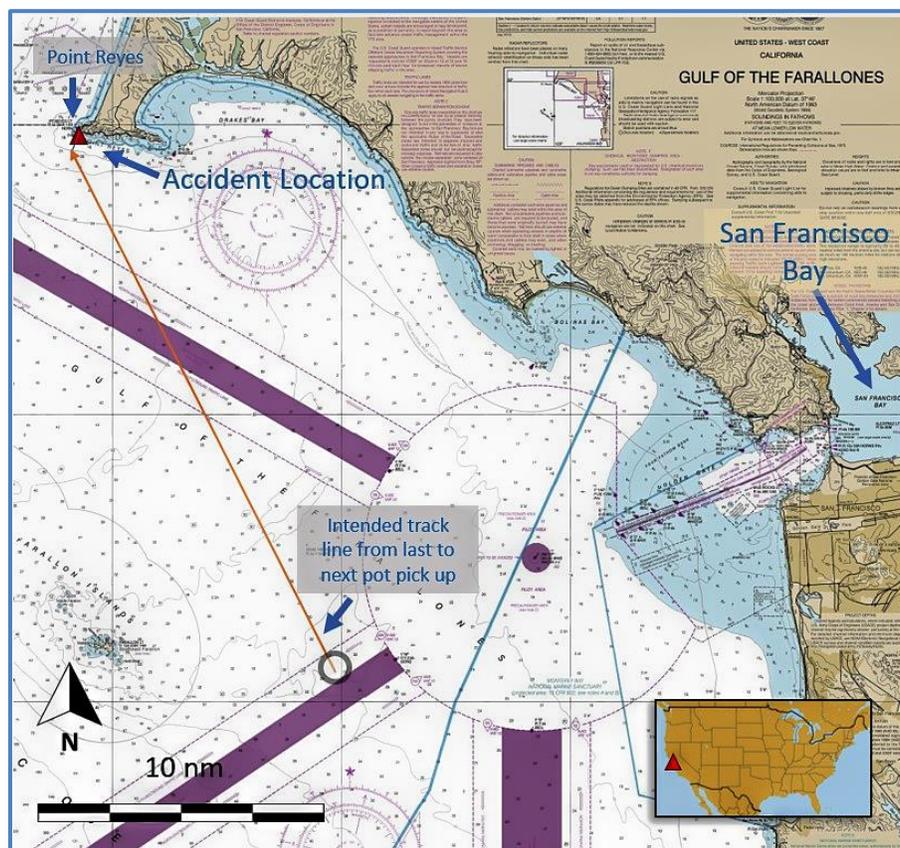
Intended trackline (marked in orange) for the *Imperial* from the last pot pick-up to the next pot pick-up; the orange arrowhead indicates the approximate location of the last pot pick-up. The accident location where the vessel grounded is indicated by a red triangle. Traffic separation schemes are shown on the chart [which shows the separation zone (purple shading) between the inbound and outbound lanes]. (Background Source: NOAA Chart 18645)

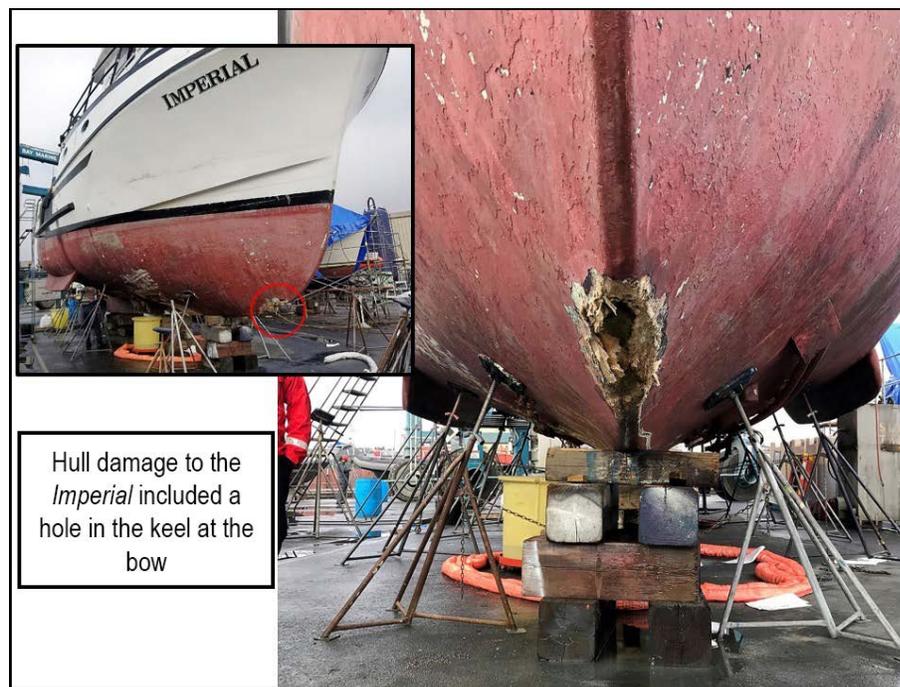
***Imperial* bow damage. The damage is indicated with a red circle in the inset image. (Source: Coast Guard)**

The vessel was placed back in service after hull repairs, the installation of a new propulsion engine and two generators that had been submerged, and the rewiring of the entire vessel. The damage that allowed water to flood the vessel included a hole in the keel at the bow; damage to the through-hull fittings for the keel cooler on the starboard side; damage to one through-hull fitting for the keel cooler on the port side; and a ruptured soft patch on a pipe in the engine room from the sea chest.
