MOUNT OLYMPUS CASUALTY INVESTIGATION REPORT

Local Pilot's Fatality

Tuapse, Russia | 30 December 2018

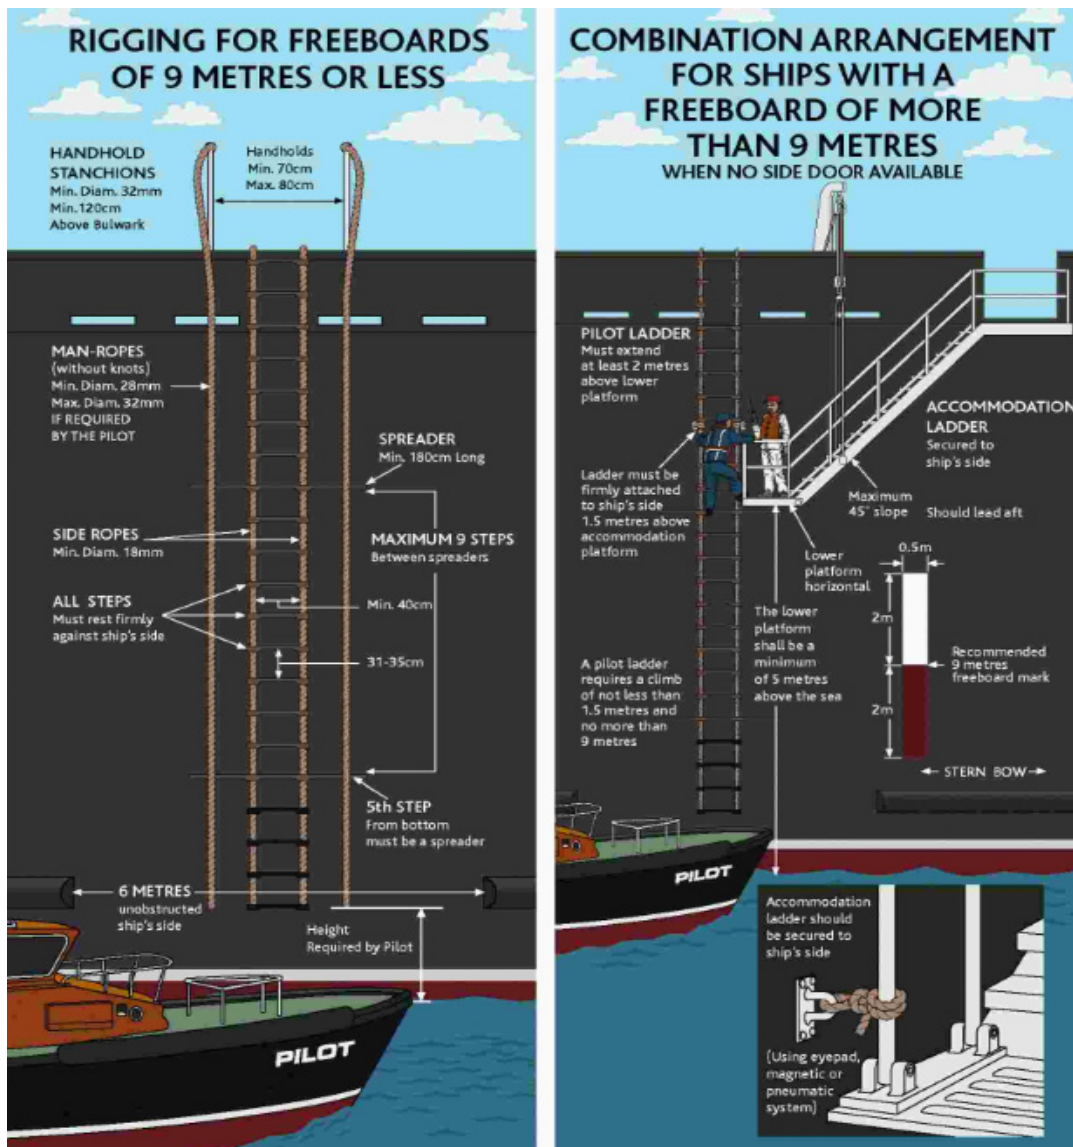
9. The pilot ladder was rigged on the port side ready for the Pilot's departure after the short transit out of the port. According to the available statements, the ladder rigging followed the International Convention for the Safety of Life at Sea (SOLAS) regulations, and the International Maritime Organization's (IMO's) required boarding arrangements for Pilots for freeboards of 9 m or less (see Figure 1).

Figure 1: Boarding arrangements for Pilots.

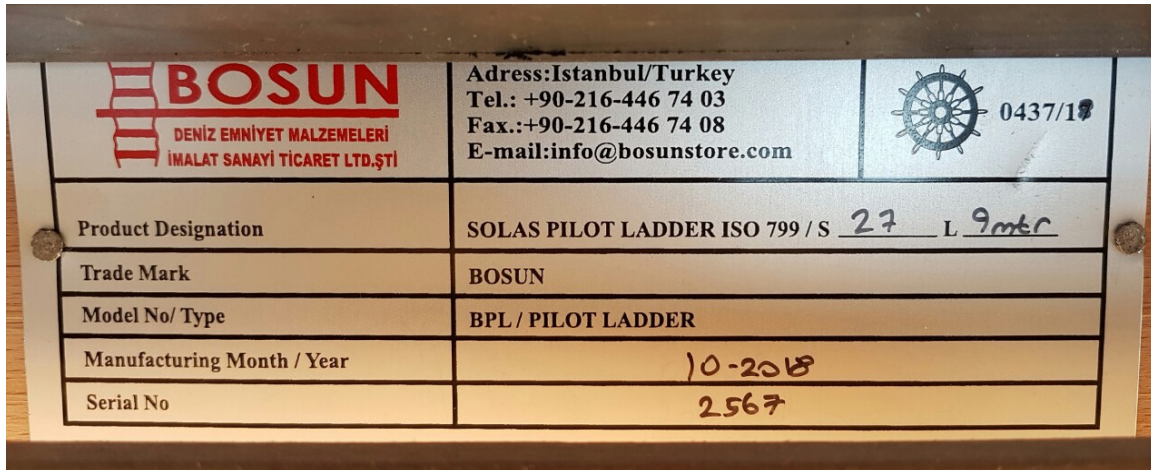
12. The pilot ladder in use was new and had a manufacturing date of October 2018 (see Figure 2). It was supplied to MOUNT OLYMPUS during the recent Special Survey and drydocking period in Turkey from 20 November 2018 to 5 December 2018. MOUNT OLYMPUS completed the third Special Survey and was issued with new Classification certificates on 5 December 2018. The Company's "Monthly Inspection of Pilot Ladders" report form completed by the Chief Officer (C/O) on 25 December 2018 noted no defects.

Figure 2: Pilot ladder manufacturer's information plate.

The crew had prepared the pilot ladder following all statutory regulations. At the Pilot's request, it was positioned at the 4.5 m height from the waterline. The Pilot fully agreed with the arrangement and signed the Company checklist accordingly. The pilot ladder was new and in good condition and is discounted as having any bearing on the incident.

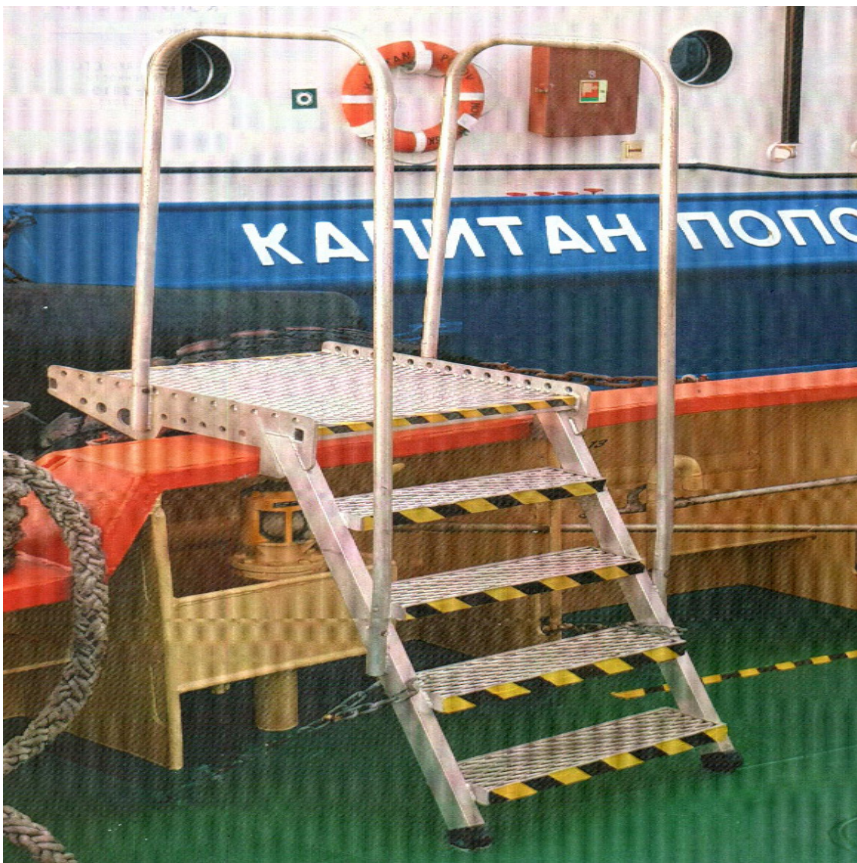
16. The Pilot was escorted to the embarkation area by the 4/O and they were met by the 2/O, an Able Seafarer Deck (ASD), and two Ordinary Seafarers (OSs). The 4/O and Pilot both checked again to ensure that the pilot ladder was properly rigged. The tugboat KAPITAN AVDYUKOV approached the ship, and the Pilot began descending the ladder. According to the local authority's investigation report, the pilot ladder was well lit by searchlights from both the ship and the tugboat.
17. The KAPITAN AVDYUKOV is a harbor tugboat of 441 gross tons (GT) with a length of 26.17 m, breadth of 12.6 m, and moulded depth of 5.3 m. The tugboat had a crew of five, and the pilot boarding arrangement consisted of a portable platform with handrails and four steps secured to the deck of the tugboat (see Figure 3).³

Figure 3: Pilot embarkation platform on KAPITAN AVDYUKOV.

MOUNT OLYMPUS' side. The Pilot lost his balance and fell into the water. However, the local investigation report states that the Pilot did not step on to the tugboat platform, but was hanging from the pilot ladder by his left arm and fell directly into the water between the tugboat and the ship.

1. ensuring that pilot boarding arrangements onto pilot boats and tugboats are fully compliant with SOLAS Chapter V, Regulation 23.4.2, and paragraph 5.2 of IMO Resolution A.1045(27);
2. not permitting Pilots to use inflatable life jackets without annual inspection and maintenance being carried out at certified service stations;
3. checking the status of inflatable life jackets being used by Pilots;
4. conducting unscheduled training for Pilots of the Pilot Service on observing safety requirements; and
5. circulating to other Pilots the circumstances surrounding this incident.
