## SAFETY INVESTIGATION REPORT

REPORT NO.: 21/2019

### **MV *NEW ISLAND*** **Fatal fall in cargo hold** **in position 36° 01.2' N 027° 58.0' E** **28 December 2018**

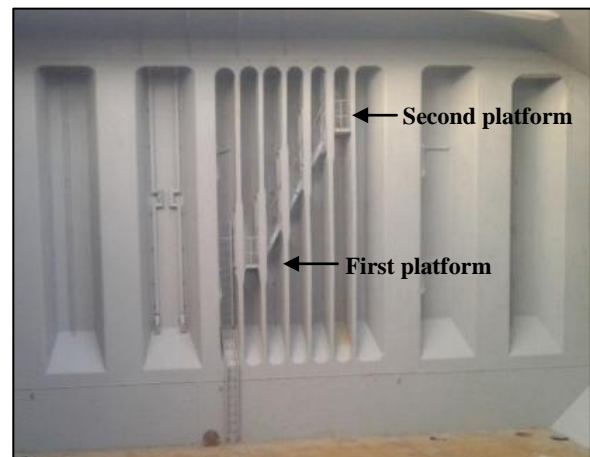
To access the cargo hold, *New Island* had two points of entry. One entry was located in the aft part of the cargo hold (Figure 1); which was a combination of vertical ladders and an inclined ladder. The first platform was located at 6.0 m above the tank top, while the second platform was located at 10.5 m above the tank top.

**Figure 1: The aft access ladder to cargo hold no. 3, at the aft bulkhead**

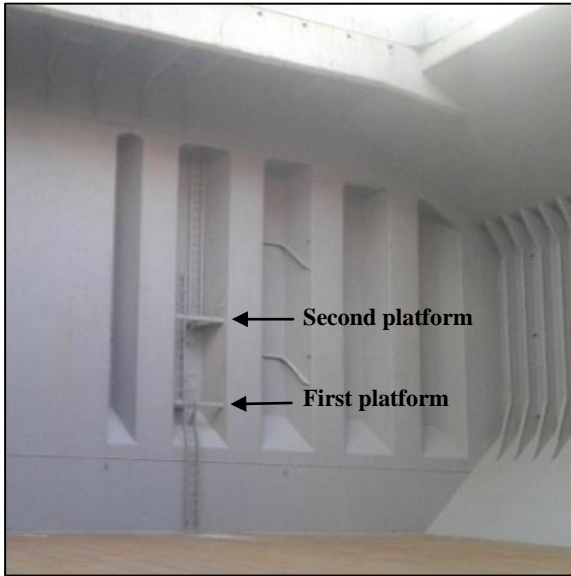
The other cargo hold access was located at the forward end of the cargo hold, and consisted of three sections of vertical ladders with two platforms at each interval (Figure 2). The first platform was approximately 3.96 m above the tank top, and the second one was situated at a height of approximately 6.85 m from the tank top.

**Figure 2: The forward access ladder to cargo hold no. 3, at the forward bulkhead**

The latter access was the one that the fatally injured AB was using at the time of occurrence.

Inspections of the ladder carried out by the vessel's crew, after the accident, did not reveal any deformations or other defects in this ladder.

The fittings and structure of the forward access ladder, as inspected by the ship's crew after the accident were found to be free from any defects or deformities. The condition of the forward access ladder was therefore not considered to be contributory to this accident.

During the course of the safety investigation the Company had identified the need to clearly mark both ends of the vertical ladder, with signs that such ladder is to be used as an emergency exit only and to be used with a safety harness.

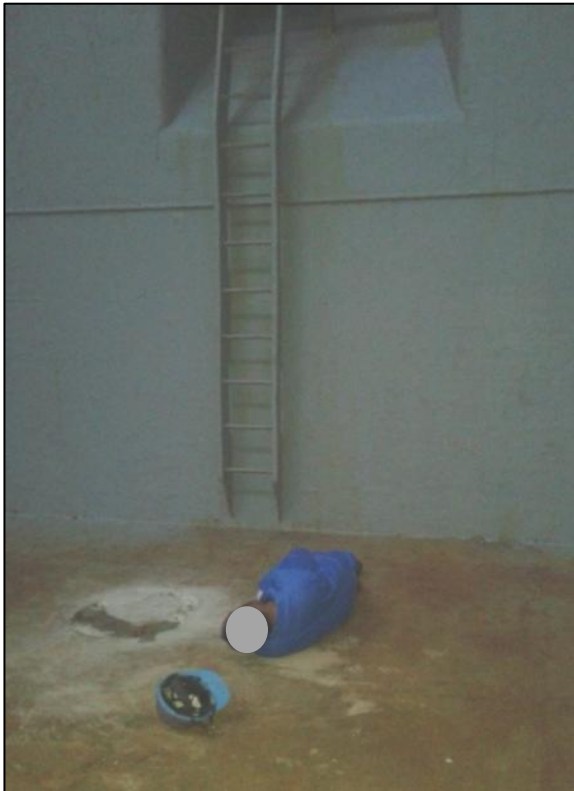
At about 1500, the bosun stopped the work in the cargo hold, for a coffee break. All crew proceeded towards the aft ladder, with the exception of AB 1, who was noticed making his way quickly to the forward access ladder. No items were reported to be seen in his hands, while climbing the forward access ladder. AB 2 and AB 3 were out of the cargo hold, before anyone else. While the bosun and AB 4 were still climbing up the aft access ladder, they heard a loud noise coming from the forward area of the cargo hold. When they looked back, they both saw AB 1, lying on the tank top close to the ladder (Figure 3).

AB 1 had been previously noticed to have passed the first platform on his way up. Although no one saw him fall, it was estimated that he had fallen from a height of about six to seven metres.

**Figure 3: Simulation of the injured AB, as he was found lying on the tank top**

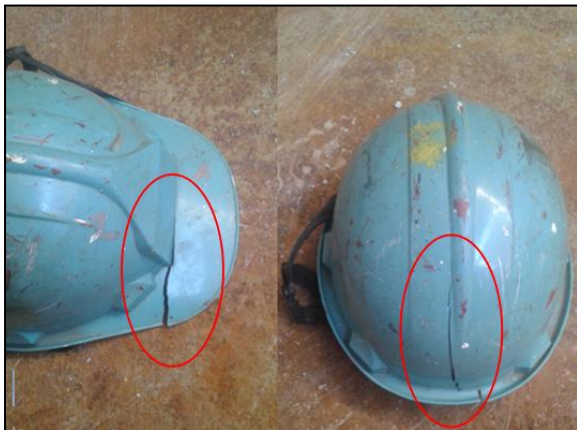
Evidence showed that the safety helmet (Figure 4) was found some distance away from the AB's fallen position; which suggests that the chin strap had not been fastened.

Figure 4: Safety helmet worn by the AB, showing visible cracks front and back

It cannot be excluded that the helmet had come off and thus, provided little to no protection to the AB's head. However, it has to be highlighted that the death certificate indicated serious injuries to the chest area as the cause of death.

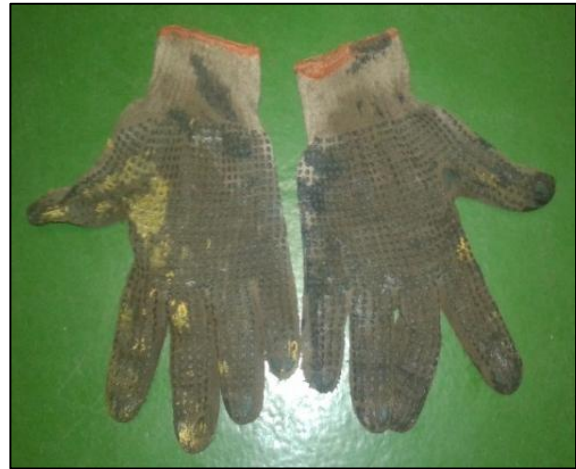
The gloves worn by the AB (Figure 5) were dirty and stained with paint. Both dirt and paint may have considerably reduced the friction provided by the gloves, contributing

to the AB losing his grip on the ladder while climbing up.

Figure 5: Working gloves worn by the fatally injured AB

any worn or damaged PPE found is to be replaced accordingly.

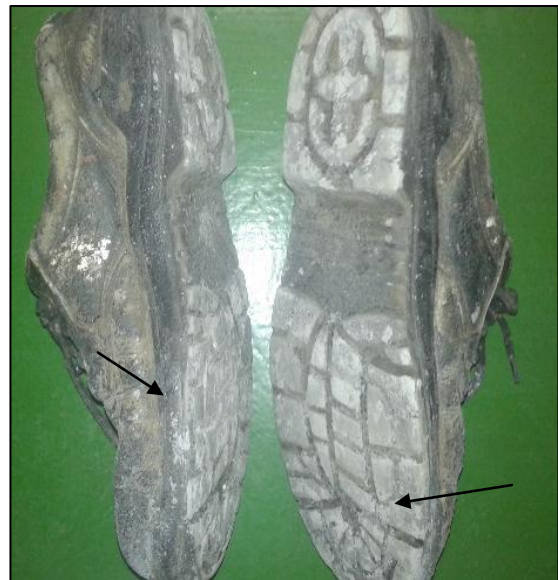
The safety shoes used by the AB were worn out, especially the soles (Figure 6). The MSIU, however, could not determine the effects which this may have had on the dynamics of the accident.

Figure 6: Safety shoes worn by the fatally injured AB. Arrows showing signs of thinning soles

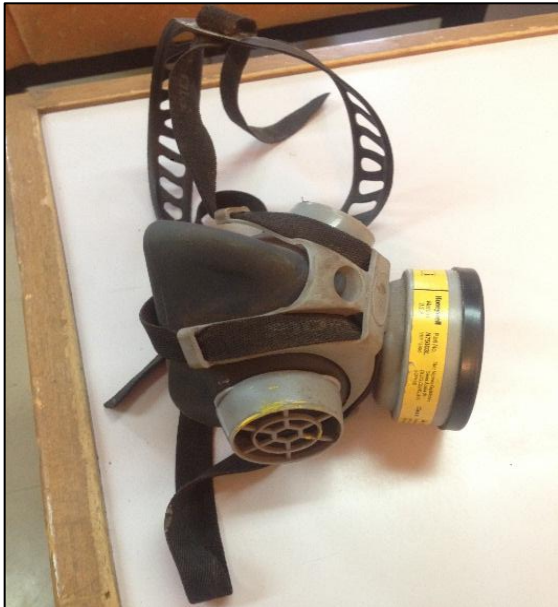
While working with the paint spray machine, the AB was reported to be wearing safety goggles and a gas mask (Figure 7). He was not wearing these PPE while climbing up the ladder and therefore, these were not

considered to have hindered the AB's ascent to the main deck.

Figure 7: Cartridge type gas mask used by the AB

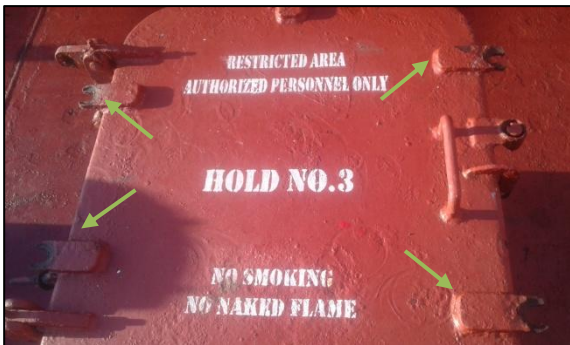
For the vertical access ladder to be used as an emergency exit, the access hatch on deck would have to be kept open while personnel are in the cargo hold – as its means of securing were butterfly nuts (Figure 9) which could be only operated from the main deck. Thus, the MSIU believes that the access hatch for the forward vertical access ladder was open at the time of the accident and was readily available for AB 1 to use.

**Figure 9: Access hatch to cargo hold no. 3. Butterfly nuts securing points (green arrows)**
