Fatal accident on board fishing vessel *Artemis* (FR 809) Kilkeel, Northern Ireland 29 April 2019

SUMMARY

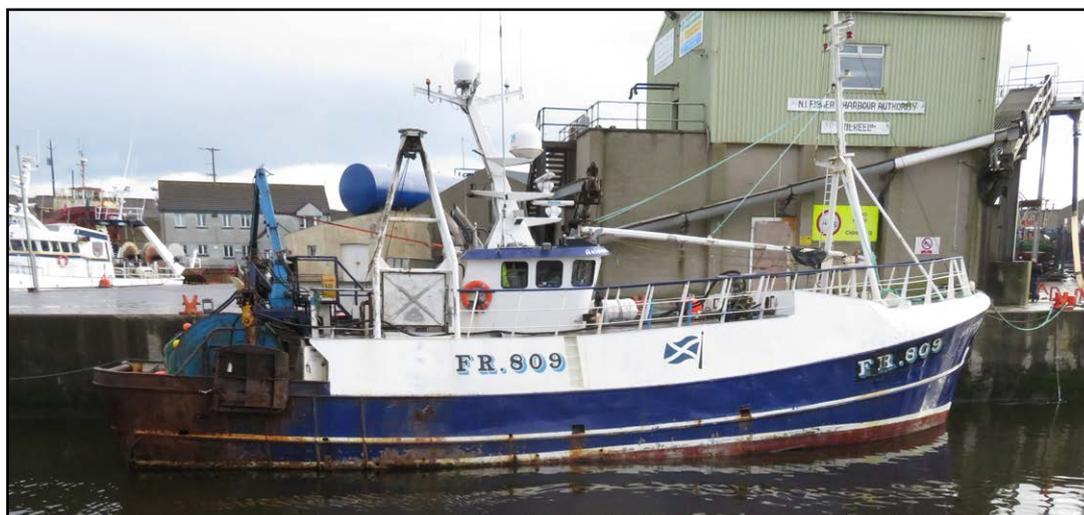
Figure 1: *Artemis* alongside Kilkeel, Northern Ireland

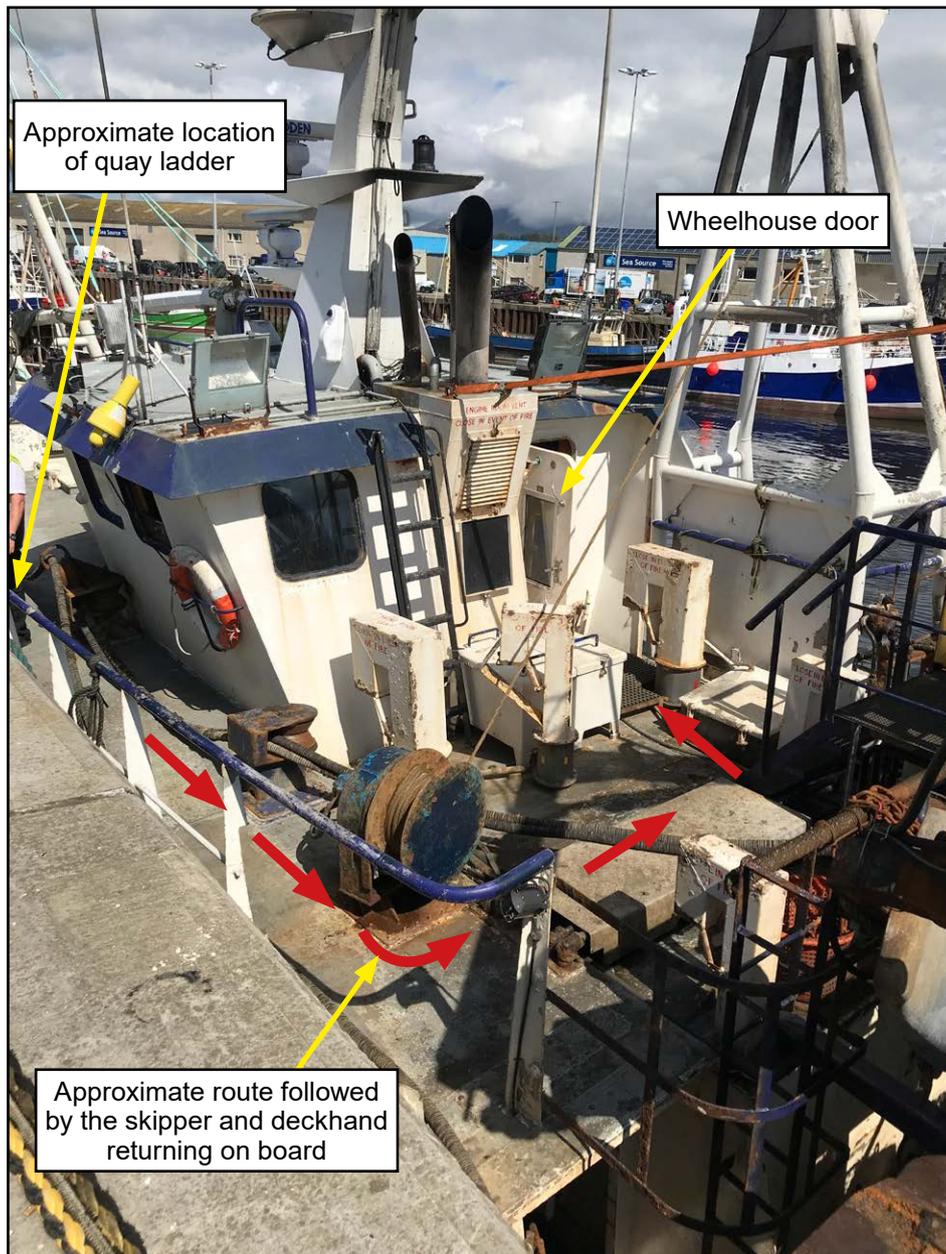
At 1247, the skipper and one of his deckhands went ashore for a drink in a local public house. At 1623, having spent about 3 hours drinking whiskey and beer, they left the public house and returned to harbour. When they arrived at the ice berth they climbed down the quayside ladder to the fishing vessel's foredeck. They then proceeded aft, to the wheelhouse (**Figure 2**).

Figure 2: Access from the upper deck to the wheelhouse door

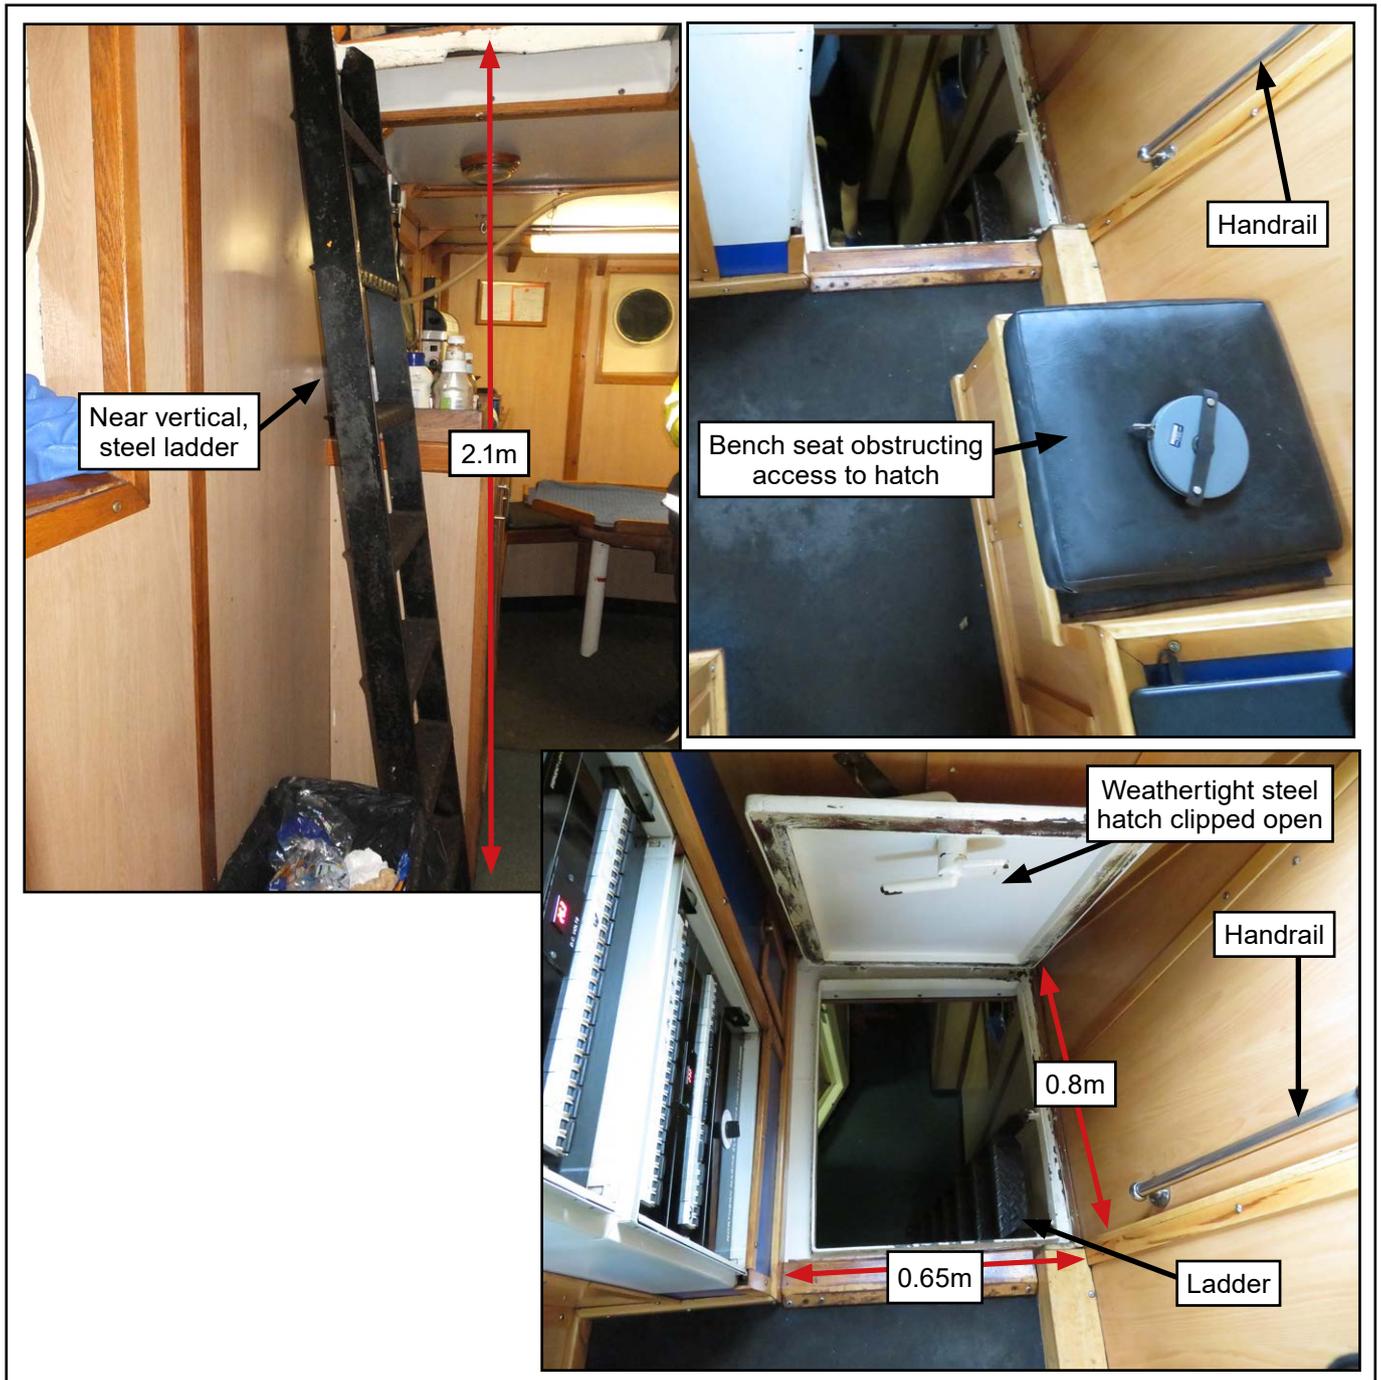
Access to the mess deck from the wheelhouse was via a weathertight hatch (0.65m wide by 0.8m in length) and a near vertical steel ladder. The hatch was located on the port aft side of the wheelhouse and was 2.1m above the mess deck. The hatch cover was secured in the open position to the aft bulkhead with a tie back. The ladder was fixed to the mess room's port bulkhead and a vertical steel handrail was fixed to the wheelhouse bulkhead directly above (Figure 3). There were no handrails on the ladder itself.

Figure 3: Access from wheelhouse door to hatch and ladder to crew accommodation

To step onto the ladder from the wheelhouse, the crew had to grab hold of the bulkhead handrail with their right hand, and probably would reach across the open hatch and grab hold of the hatch cover for support with their left hand. Access to the hatch was constrained by a small bench seat. The wheelhouse deck was carpeted throughout. The carpet tiles were dirty but dry; two additional loose tiles had been used to protect the carpet on the starboard side close to the working deck access door.

It is unlikely that a slip caused the fall because the carpet in the vicinity of the hatch was dry, the skipper's footwear was in good condition and the loose floor tiles were on the starboard side of the wheelhouse. It is more likely that he either stumbled on his approach to the open hatch or he tripped over the bench seat next to it. However, given that he fell head-first through the hatch without striking its coaming or sides, the most likely scenario is that he lost his grip on the vertical handrail or open hatch cover as he leaned across to steady himself (**Figure 3**).

- The removal of the wheelhouse door created an unguarded edge whenever the hatch cover was open.
- The reorientation of the access ladder/steps meant that the crew had to step across the open hatch to get onto the vertical ladder.
- The ladder was not fitted with handrails; and,
- The installation of the bench seat introduced a trip hazard.

- Review the design and layout of the wheelhouse to mess deck hatch and ladder, to reduce the risk of crew falling through to the deck below.
- Update its drug and alcohol policy to ensure its crew are: aware of the legal limits stipulated in the Railways and Transport Safety Act 2003; provided with clear definitions of when they are on or off duty; and ensure that they are aware of the circumstances under which they may be required to undergo drug and alcohol testing.
- Ensure that it complies with the requirements of the International Labour Organisation 188 and owner's responsibilities under the Fishing Vessel (Health and safety at work) Regulations and that all crew have fishermen's work agreements.

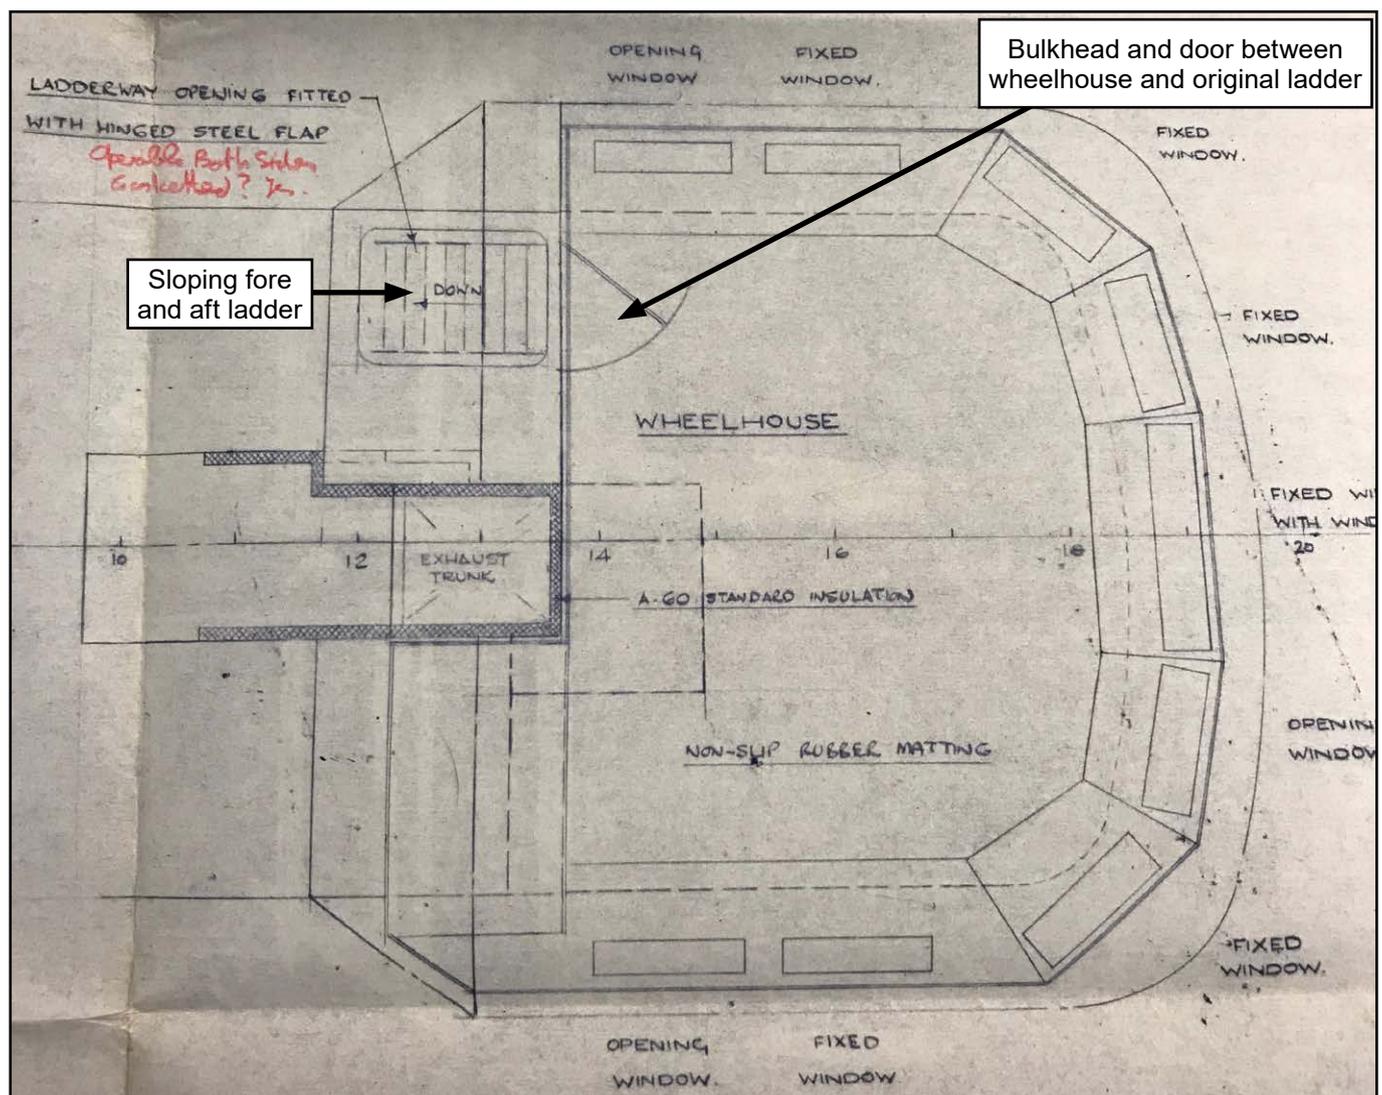
Over its 40-year life, *Artemis* had been refitted many times and modified on several occasions. One of the modifications included changes to the access route between the wheelhouse and the mess deck. According to the vessel's drawings (**Figure 4**) the hatch was originally separated from the wheelhouse by a bulkhead door and the ladder was fixed to the forward edge of the hatch and sloped aft. The original drawings did not include a bench seat on the port side of the wheelhouse.

Figure 4: Original vessel drawing showing bulkhead and door separating wheelhouse and hatch and sloping ladder to crew accommodation

If the original, sloping, fore and aft ladder, which effectively would have filled the hatch opening, had been in place, it would have been impossible for the skipper to directly fall 2.1m onto the deck below. Therefore, the resultant injuries would likely have been less severe and might not have been fatal.
