National Transportation Safety Board

Marine Accident Brief

Collision of Heavy Lift Vessel *Hawk* with Unnamed Barge and Destroyer *Delbert D Black*

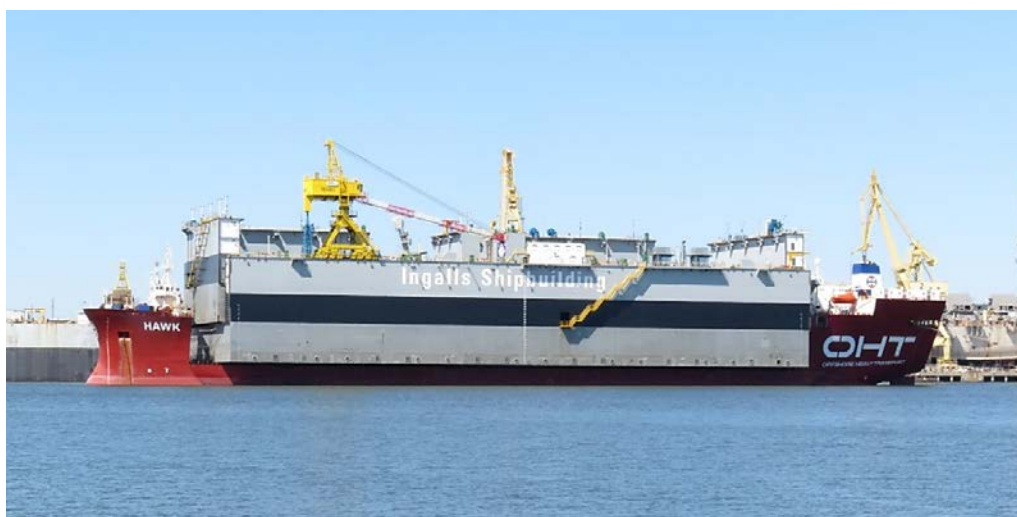
Hawk with floating drydock cargo postaccident.

At 1012, the starboard side of the drydock on the *Hawk* struck the electrical testing barge, puncturing the side of the drydock. At the time of the impact, the heavy lift ship was making 3.3 knots. An electrical fire broke out on the barge and was extinguished by shipyard workers using portable CO₂ extinguishers. The force of the impact drove a 3-foot-high steel beam on the barge into the *Delbert D Black*, causing damage to the destroyer's weather decks, boat davit, and a bulkhead on the aft superstructure. The barge was driven into the side of the destroyer's hull, creating a breach at the waterline that resulted in flooding in berthing and equipment spaces on the ship.

After the initial collision, the stern of the *Hawk* continued to swing, pivoting on the barge toward the destroyer's bow. Concerned with the stern's movement, pilot 3 took control of the aft tugboats and ordered the *Signet Valiant* to pull the port stern at a 90-degree angle to the side of the ship at full astern power. However, before the tugboat came up to full speed, the line to the *Hawk* parted. The *Hawk* then began moving astern until the aft starboard corner of the drydock struck the starboard bow of the *Delbert D Black*, causing indentations in the hull and deck plating along the deck edge.
