National Transportation Safety Board

Marine Accident Brief

Contact of *Bettye M. Jenkins* Tow with Bunge Grain Facility

Accident type	Contact	No. DCA19FM018
Vessel names	<i>Bettye M. Jenkins</i> and barge <i>T9353</i>	
Location	Lower Mississippi River, mile 361, near Vidalia, Louisiana 31°32.95' N, 091°26.43' W	
Date	February 15, 2019	
Time	0130 central standard time (coordinated universal time – 6 hours)	
Injuries	None	
Property damage	\$3.3 million est.	
Environmental damage	None	
Weather	Visibility 10 miles, partly cloudy, winds south 4 knots, air temperature 60°F	
Waterway information	The Lower Mississippi River near mile marker 361 is 0.6 mile wide with a maintained channel depth of 9 feet. At the time of the accident, the river near mile marker 361 was at flood stage, and a high-water safety advisory was in effect. The river stage near Vidalia, at Natchez, Mississippi, was 49.1 feet.

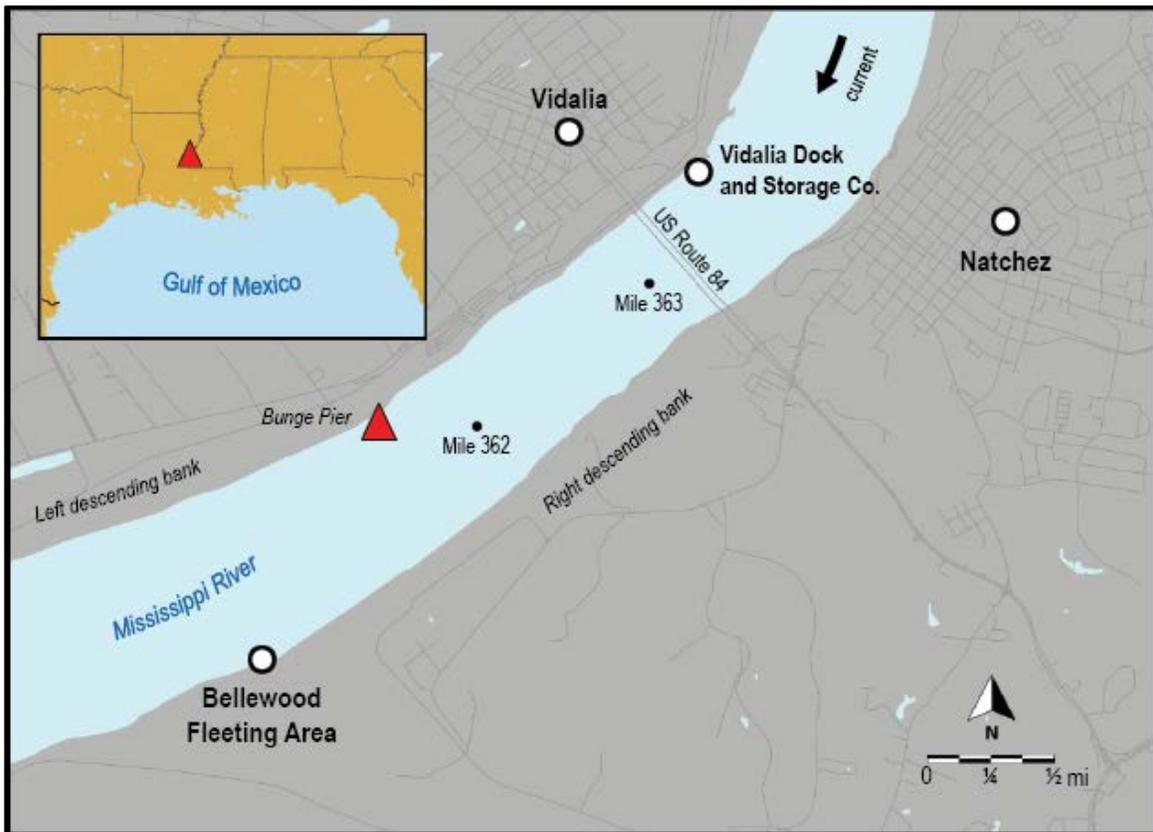
Area where the *Bettye M. Jenkins* tow contacted the Bunge pier and pilings as indicated by the red triangle. (Background Source: Google Maps)

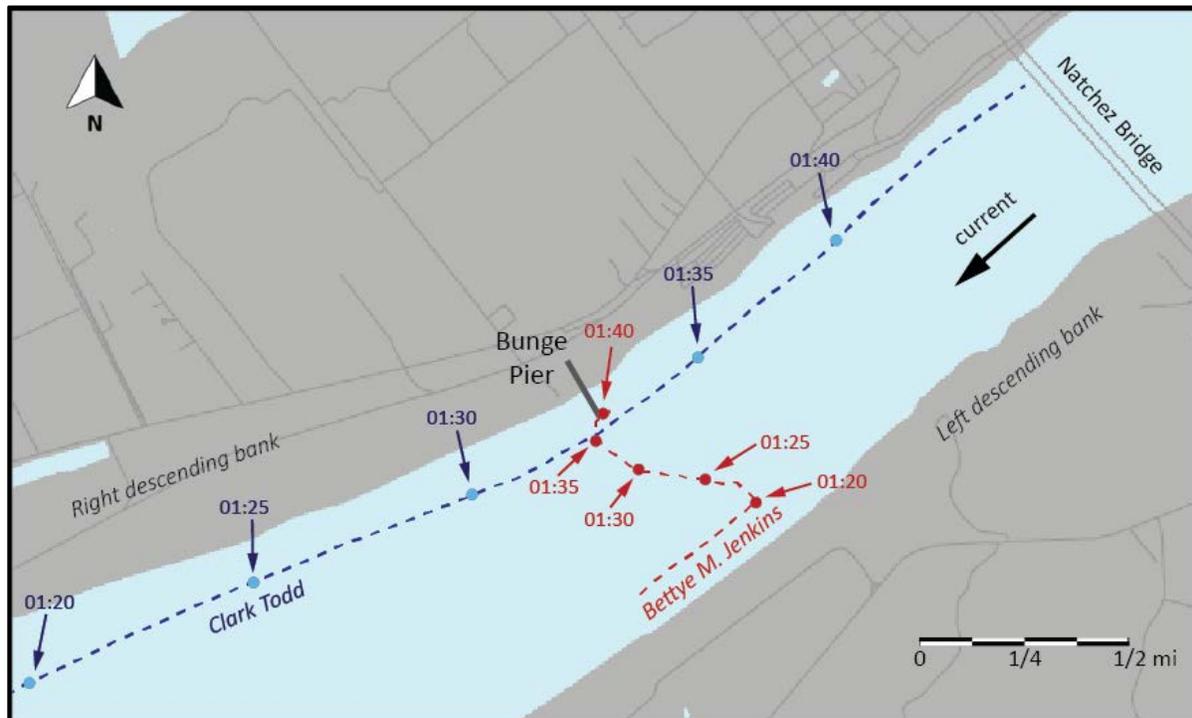
Select positions of the *Clark Todd* and the *Bettye M. Jenkins*. (Data source: US Coast Guard Navigation Center; background source: Google Maps)

While moving upriver, the *Clark Todd* hugged the right descending bank. The initial plan agreed upon by both vessels was for the *Bettye M. Jenkins* to pass ahead of the *Clark Todd*. However, the *Bettye M. Jenkins* took longer than expected to cross the river since the high current caused the tow to be set further downstream. The *Bettye M. Jenkins* attempted to turn upriver after the *Clark Todd* passed ahead of it, but because they had to wait for the *Clark Todd* to clear ahead of them, they turned later than originally planned. The captain of the *Bettye M. Jenkins* stated that along with the difficulty of turning the tow into the high current, his turn was slowed by the *Clark Todd*'s wheelwash. The late turn left the tow too close to the Bunge facility, which the lead barge contacted, parting the tow's lines.

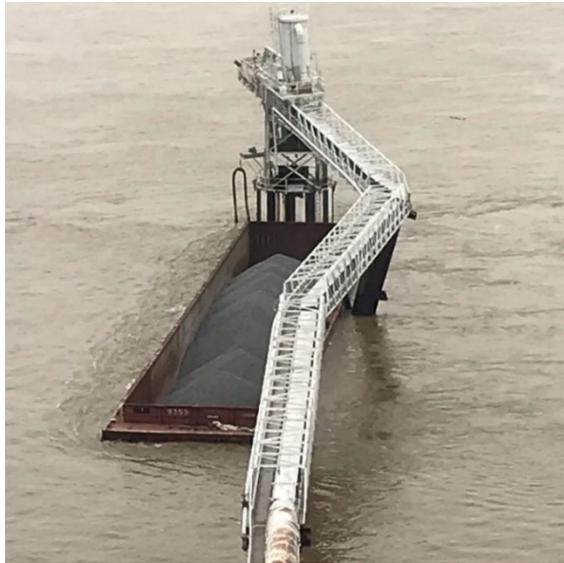
As a result of the contact, the two dolphins farthest from shore that supported the conveyor and trusses were deflected up to 15 feet. Three conveyor trusses were forced out of alignment as much as 3 feet. Bunge employees cut the conveyor belt to prevent the entire structure from being damaged. Due to the damage, Bunge had to transport cargo 7.4 miles across the river to the Adams County Port for loading on barges until repairs were completed on August 20, 2019.

The damaged Bunge grain conveyor and barge T9353, four days after contact. (Source: Bunge Grain Facility)
