SAFETY INVESTIGATION REPORT

REPORT NO.: 01/2020

MV Guro*n*i
Main engine failure
in position 57° 44.4' N 010° 08.0' E
08 January 2019

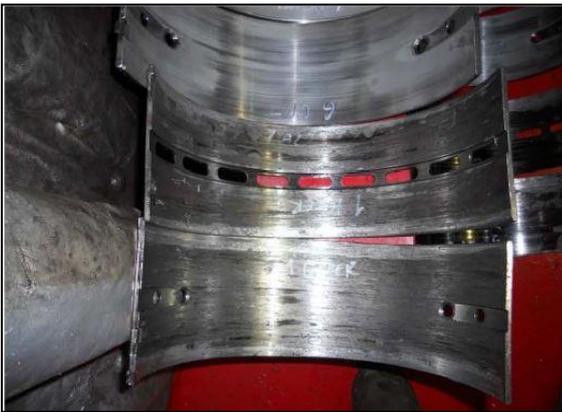
- the big end bearing shells of cylinder nos. 1, 2 and 3 were severely damaged (Figures 1, 2 and 3), and the bearing shells of three other cylinders had sustained minor damages;
- the crankshaft pins of cylinder nos. 1, 2 and 3 were damaged, while the pins of the other cylinders had sustained minor damages;

Figure 1: Big end bearing of cylinder no. 1 (scouring)

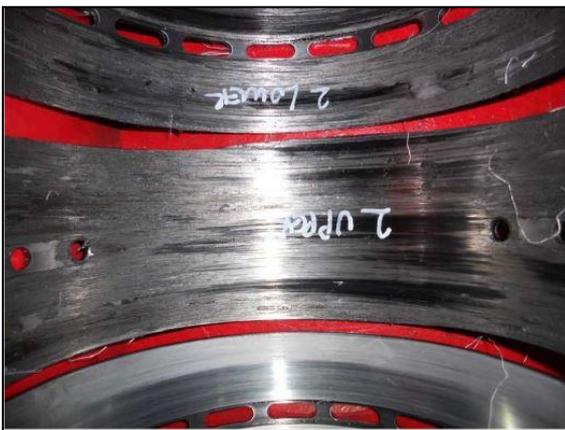
Figure 2: Big end bearing of cylinder no. 2 (scouring)

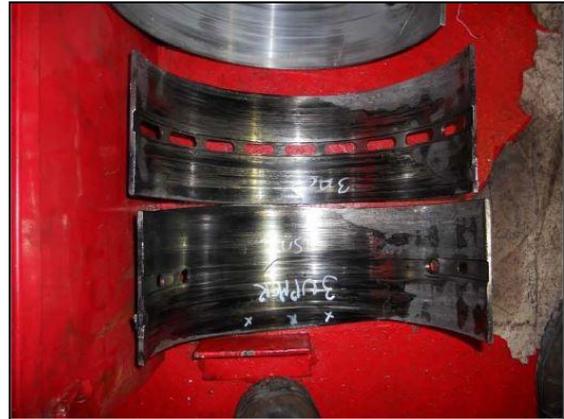
Figure 3: Big end bearing of cylinder no. 3 (scouring)

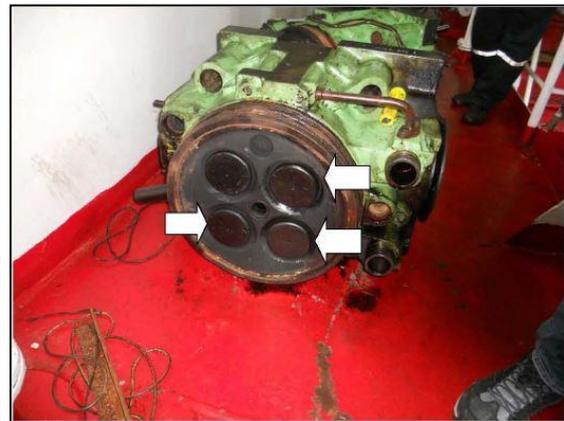
- all cylinder heads had sustained severe damages (Figures 4, 5 and 6);
- the piston crown of cylinder no. 3 was damaged;
- the connecting rods of cylinder nos. 1, 2 and 3 were damaged; and
- the lower portion of the liner of cylinder no. 2 was broken.

Figure 4: Cylinder head no. 1 (bent valves)

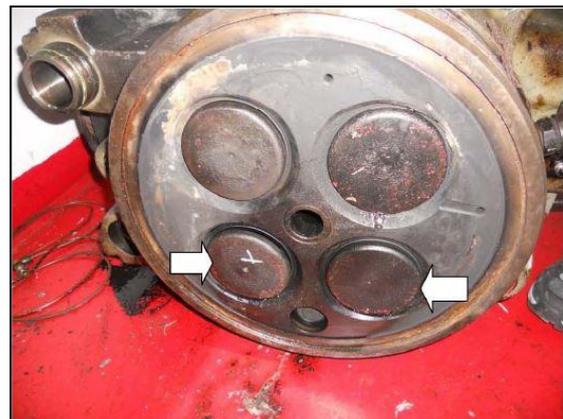
Figure 5: Cylinder head no. 3 (bent valves)

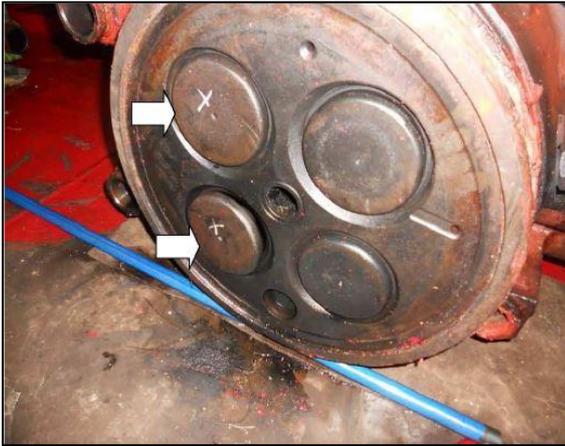
Figure 6: Cylinder head no. 6 (bent valves)

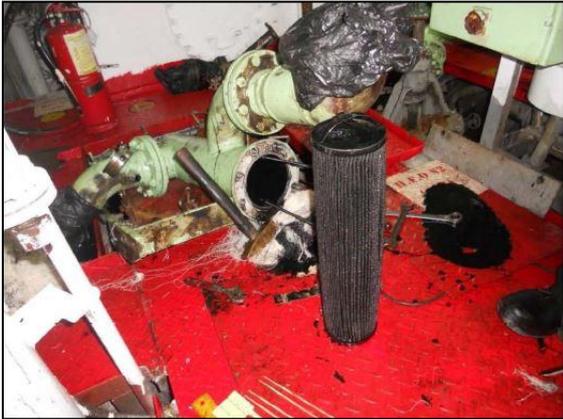
Figure 11: Lubricating oil filter cartridge

14. This would have restricted the flow of lubricating oil to the main engine.

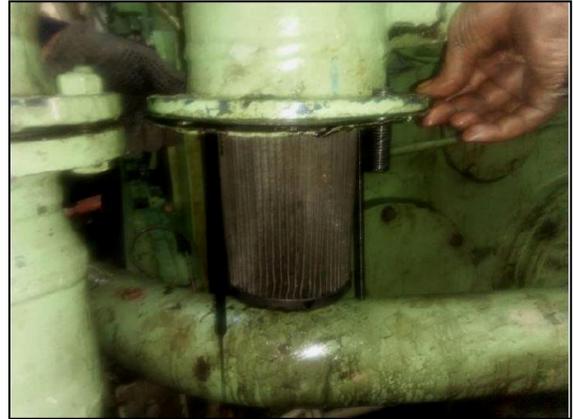
Figure 12: Extraction of the filter cartridge

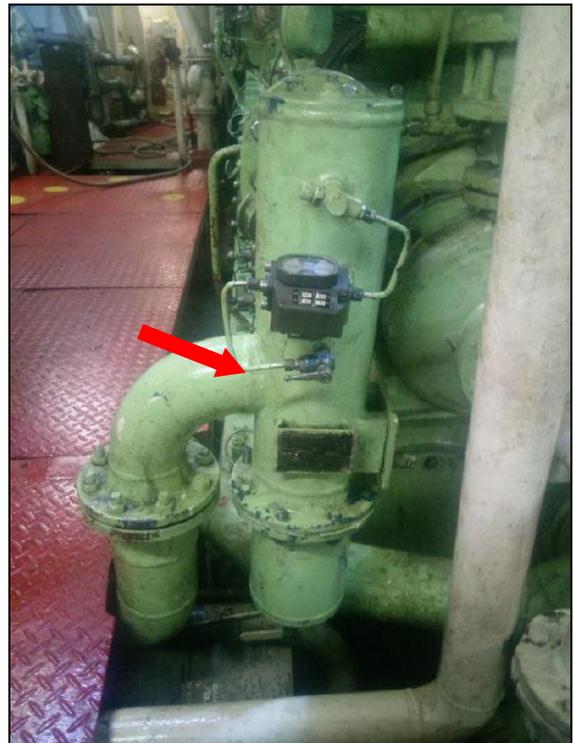
On dismantling the lubricating oil filter at the repair facility, it was reported that the upper end of the filter cartridge was damaged, as it was pressed up against the opening of the inlet pipe of the filter (Figure 13). This indicated that the cartridge had slipped to an angle before the filter cap was tightened in position when the filter was being re-assembled, as simulated in Figure

Figure 13: Position where the upper end of the filter cartridge was pressed

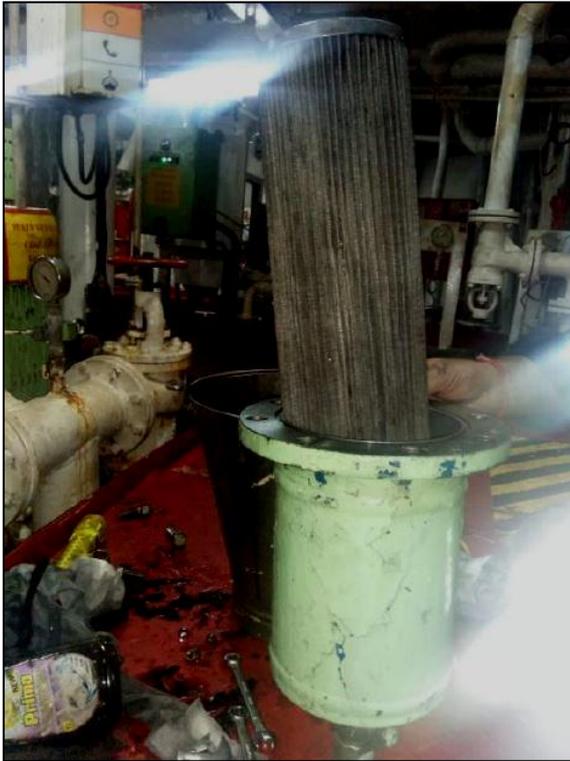
Figure 14: Simulation showing the angle at which the filter cartridge was found mounted

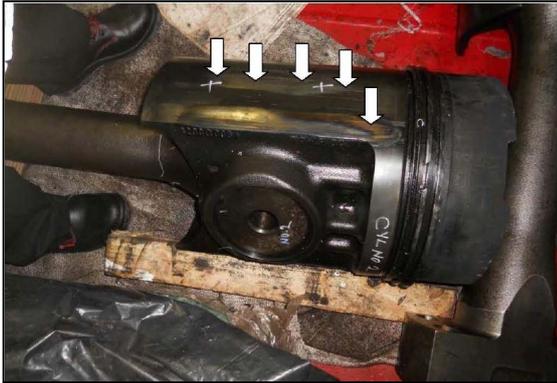
The damages sustained by the main engine's running gear seem to indicate that these components were subjected to extensive friction. The cylinder pistons, liners and crank pin bearing journals of the crankshaft showed similar signs of friction (Figures 13 to 18).

Figure 13: Piston of cylinder no. 2

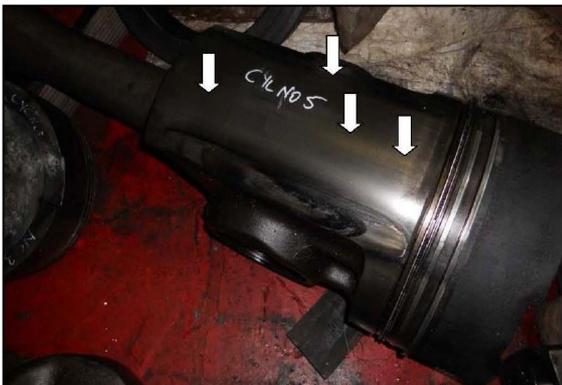
Figure 14: Piston of cylinder no. 5

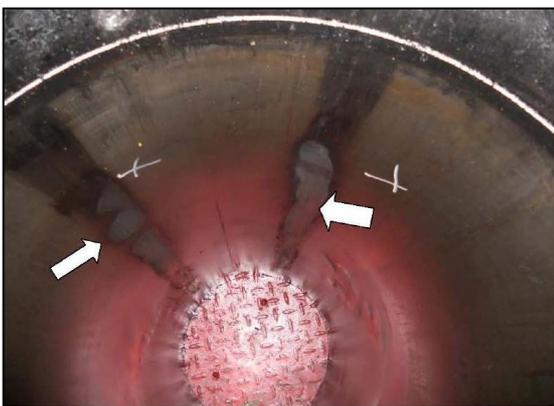
Figure 15: Liner of cylinder no. 6

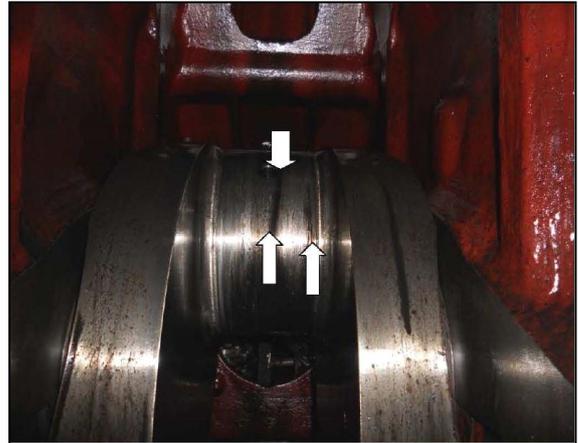
Figure 16: Crankpin journal no. 1

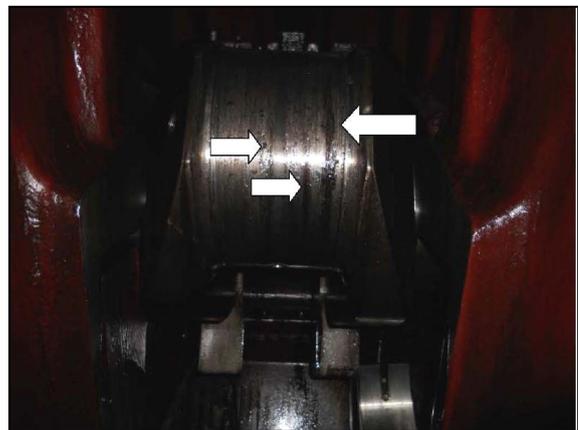
Figure 17: Crankpin journal no. 2

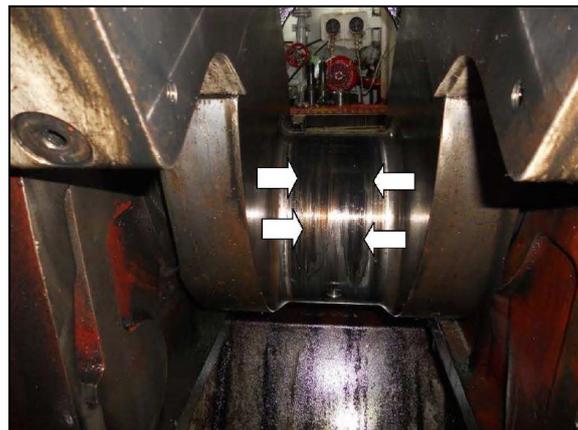
Figure 18: Crankpin journal no. 2
