## Collision between the bulk carrier *Gülnak* and the moored bulk carrier *Cape Mathilde* River Tees, England on 18 April 2019

### SUMMARY

On 18 April 2019, the Turkey registered bulk carrier *Gülnak* collided with the Panama registered bulk carrier *Cape Mathilde*, which was moored alongside the Redcar bulk terminal, Teesport, England. Both vessels were damaged but there were no injuries and there was no pollution.

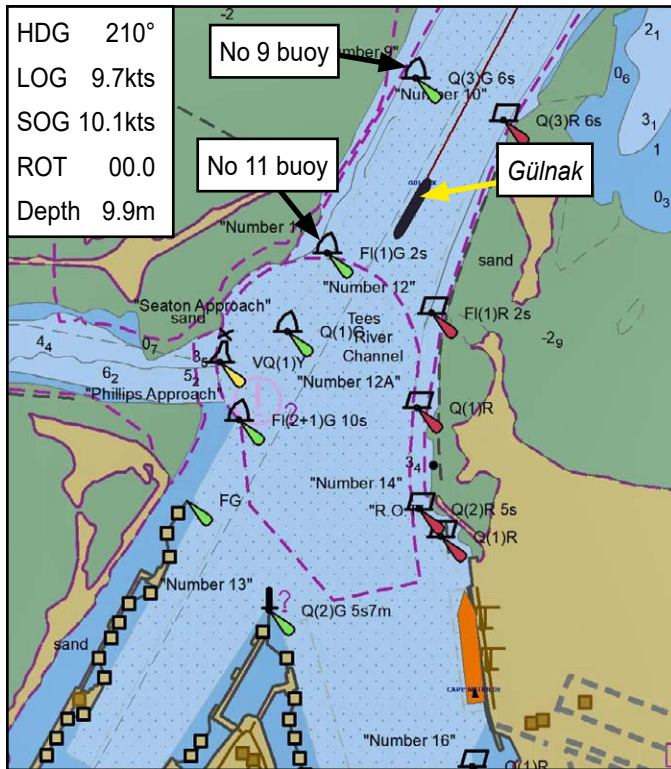
As *Gülnak* approached No 11 buoy (**Figure 3a**), the pilot ordered 'port 10', to start to turn the vessel towards a heading of about 170°, keeping towards the centre of the main channel. Within 1 minute, *Gülnak* was turning towards the south at a rate of 23°/minute (min) (**Figure 3b**) and the pilot ordered 'slow ahead' (64rpm – 7kts). The order of 'midships' soon followed in order to reduce the rate of turn. At 0321:17, *Gülnak*'s heading was passing through 190° at about 28°/min (**Figure 3c**), which was quicker than the pilot expected. The pilot ordered 'starboard 20°' quickly followed by 'hard-a-starboard'.

**Figure 3a:** Position at 0320:10 when rudder put to port 10°

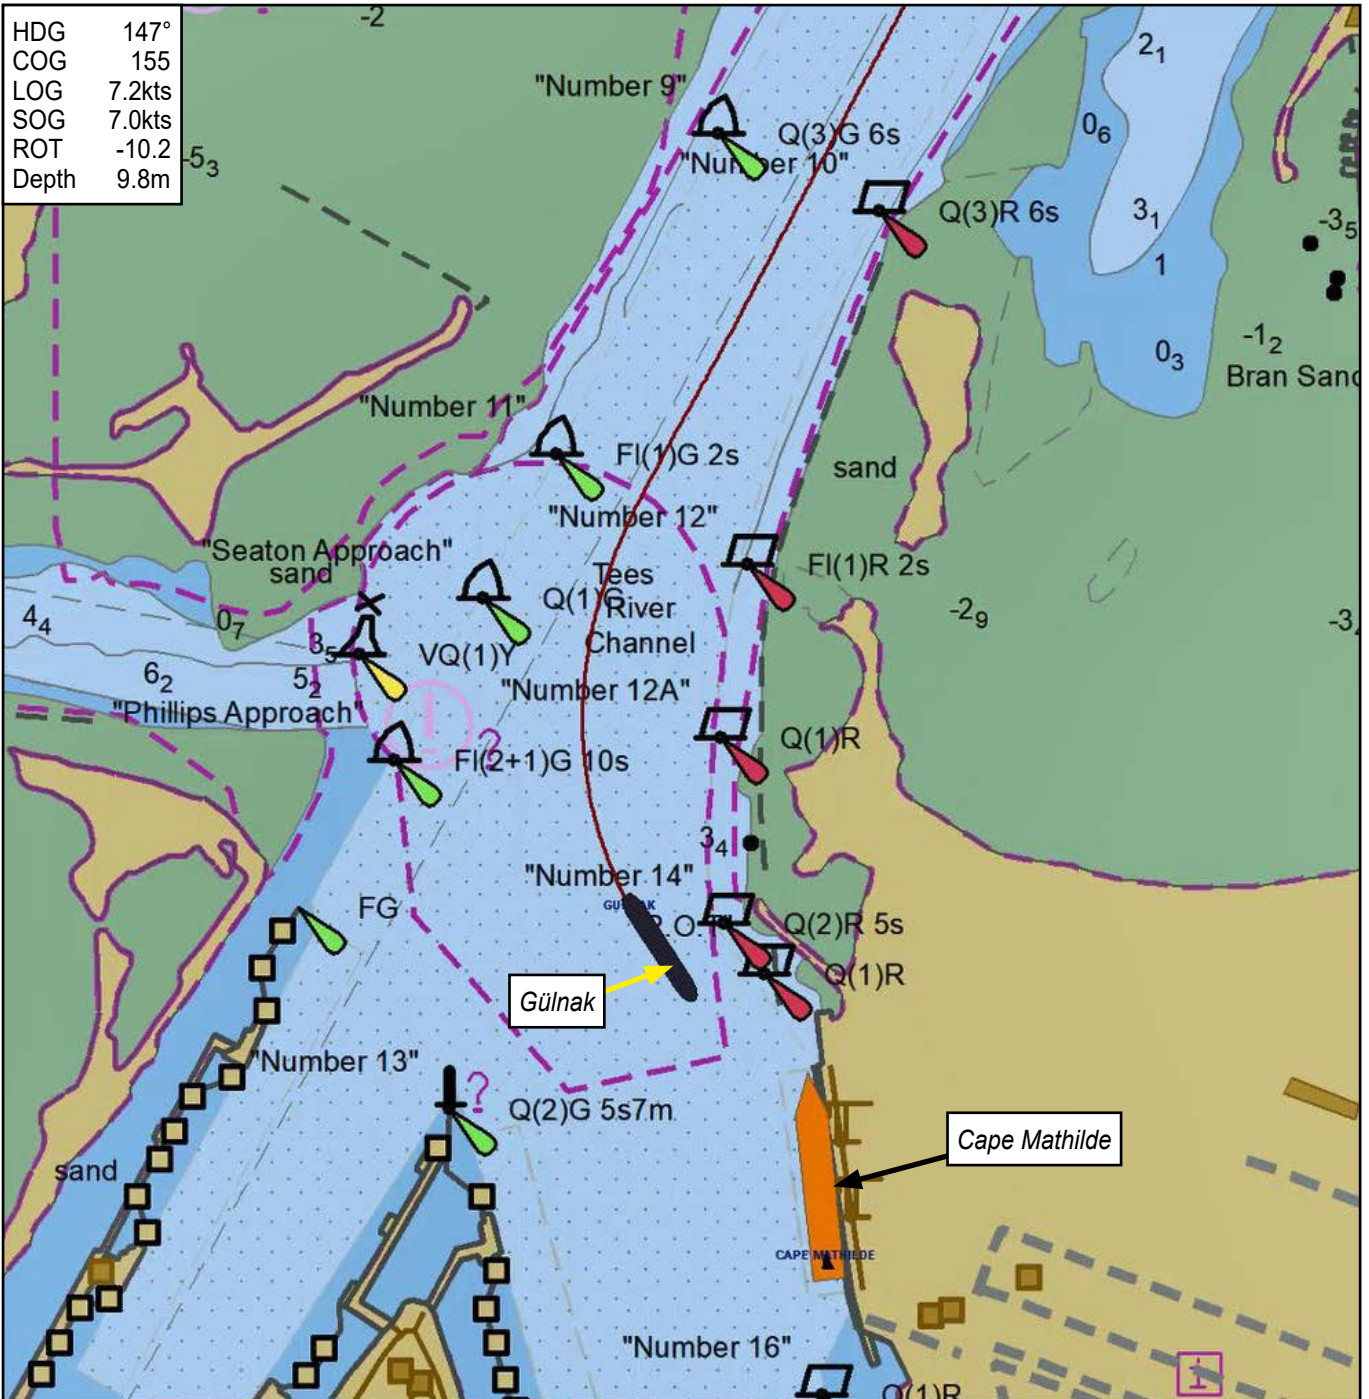
By 0323:23, *Gülnak*'s speed was 7kts, the rate of turn had reduced to about 10°/min to port and the vessel's heading was passing 147°. The bulk carrier *Cape Mathilde* was moored 220m ahead (**Figure 4**) and the master ordered the forward mooring party to be ready to let go the anchors. The skippers of the two tugs that were waiting to assist off the bulk terminal saw the potential hazard and manoeuvred towards *Gülnak*. Although *Gülnak*'s rate of turn continued to decrease, the pilot and master realised that a collision was inevitable. The pilot moved to the port bridge wing and ordered 'full astern'.

Figure 4: Position at 0323:23 when engine put to 'full astern'

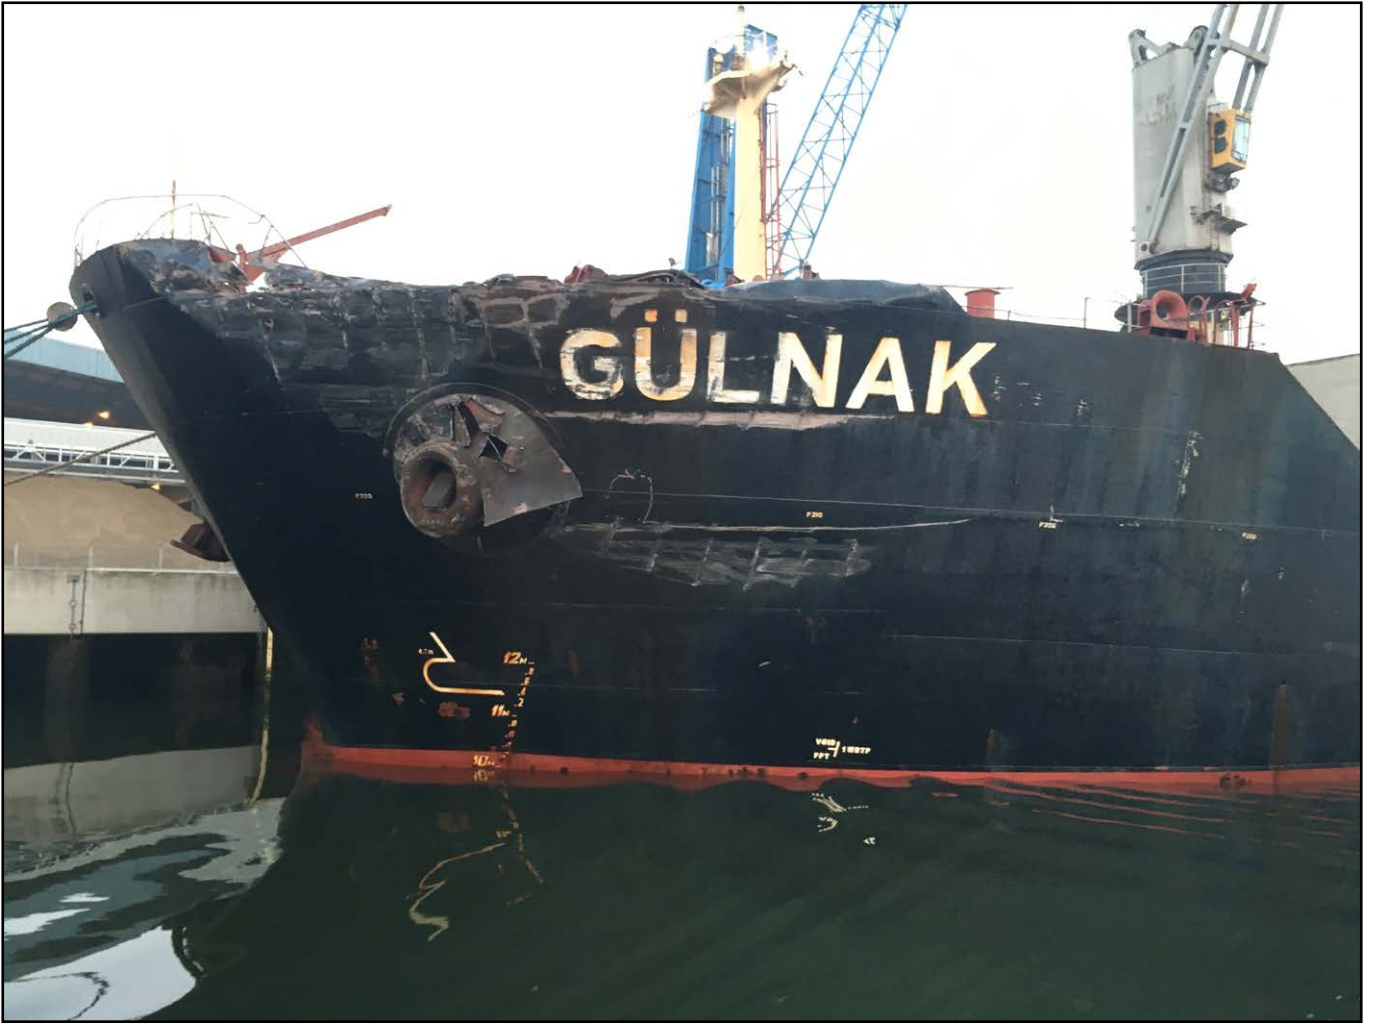
The collision resulted in significant indentation and steelwork damage to *Gülnak*'s port bow (Figure 5) and the shearing of the port anchor at the stock. *Cape Mathilde*'s port side was damaged above the waterline in way of the No 1 and No 2 wing ballast tanks (Figure 6), with the lower section of *Gülnak*'s port anchor embedded in the forward part of No 1 ballast tank. The vessel's mooring lines remained intact.

**Figure 5:** Damage to port bow of *Gülnek*

Temporary repairs to both *Gülnak* and *Cape Mathilde* were completed in Teesport. The vessels were then authorised by the Maritime and Coastguard Agency and their respective classification societies to sail for permanent repairs. *Cape Mathilde* arrived in Dunkerque, France on 10 May 2019 and *Gülnak* arrived in Turkey on 12 May 2019. During *Gülnak*'s departure from Teesport, the embarked pilot noted that the master seemed uncertain about whether the main engine speed indicator on the centre console gauge was operating correctly.

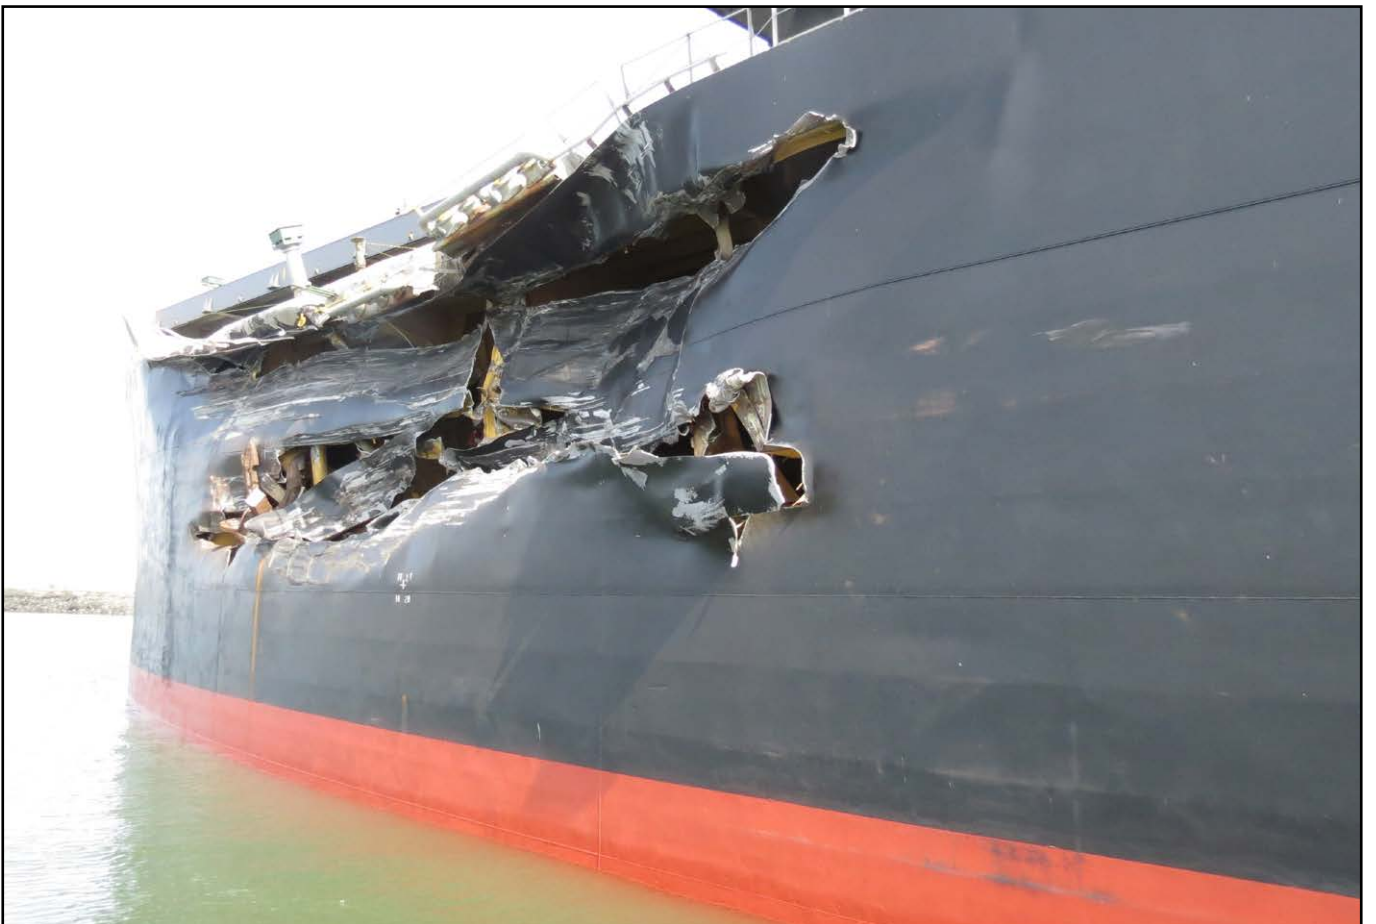
**Figure 6:** Damage to port side of *Cape Mathilde*

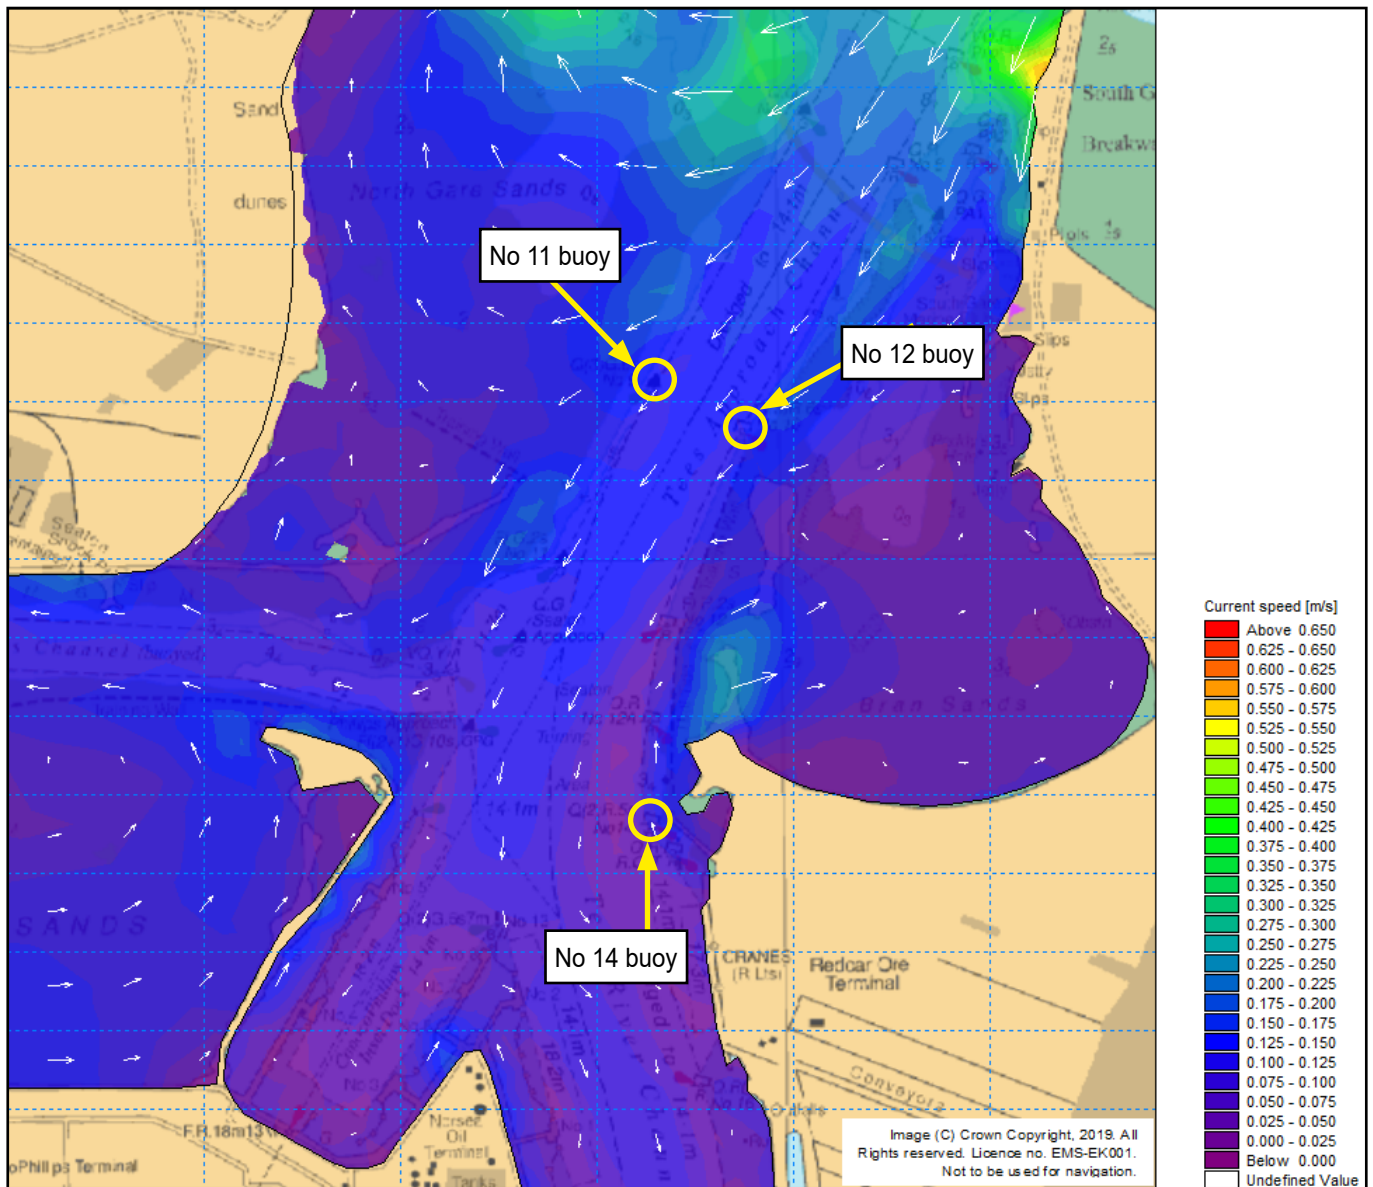
**Figure 7:** Tidal stream at 1 hour before high water (spring tides)

**Figure 7** shows that the predicted tidal stream in the main channel between No 12 buoy and No 14 buoy, where control of *Gülnak*'s direction was lost, was still flooding. However, it was negligible and would not have been sufficient to significantly impact on *Gülnak*'s movement and manoeuvrability. Although a counter-current was evident outside the main channel's eastern side, this was also less than 0.2kt. There is no evidence to indicate that the tidal flows experienced differed from the predictions, with the slippage of the bank into the main channel between No 11 and No 13 buoys being unlikely to have significantly affected the water flow further to the south.

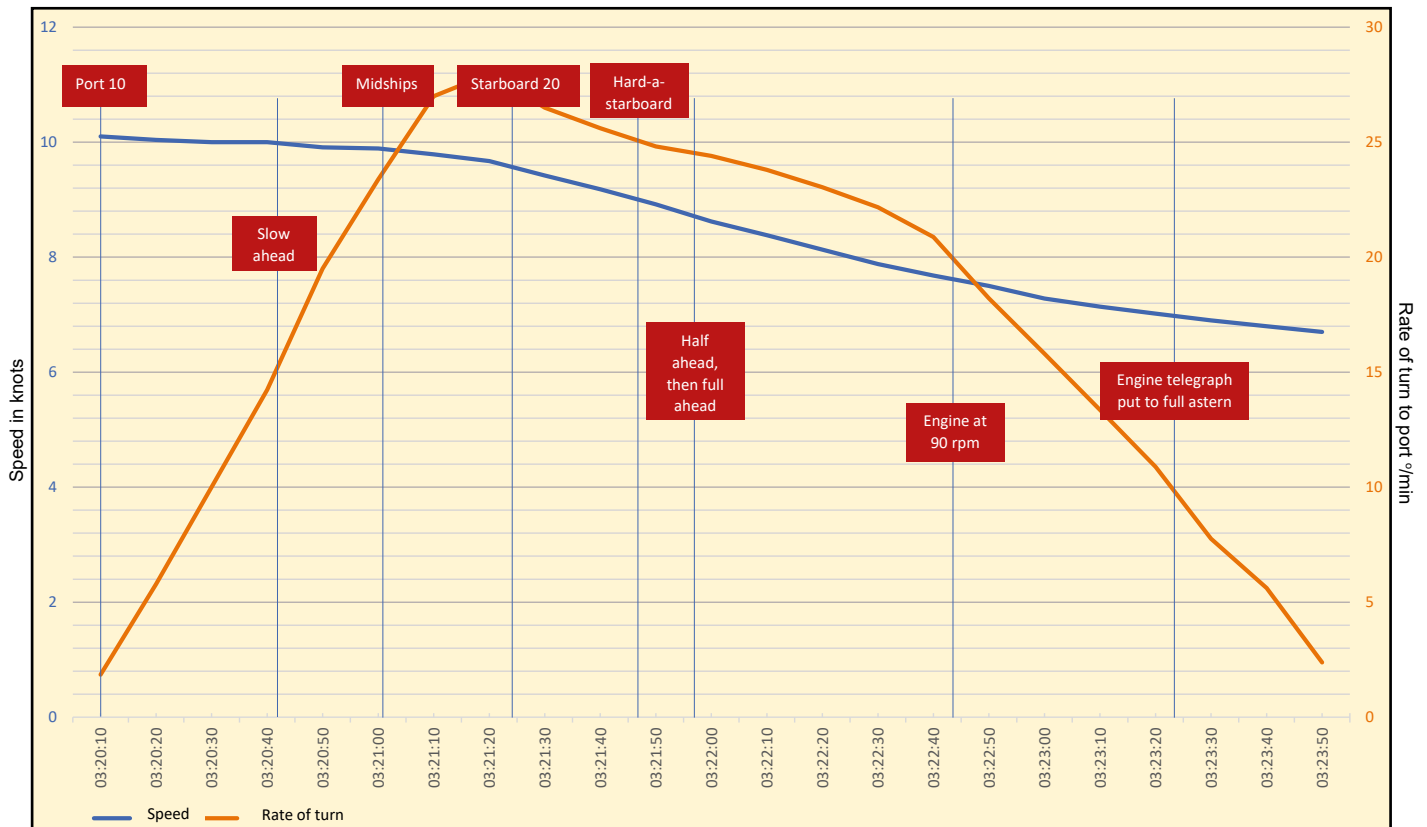
**Figure 8** shows that the helm movement to 'midships', 'starboard 20°' and 'hard to starboard' within a 50 second period decreased the rate of port swing to some extent, but it was not until the engine telegraph

**Figure 8:** *Gülnek's* speed and rate of turn to port

had been set to 'full ahead' and engine speed was reported to have reached 90rpm that the rate of turn to port started to decrease significantly. Despite the subsequent use of 'full astern' power, the decrease in the rate of turn was too late for the collision with the moored *Cape Mathilde* to be avoided.

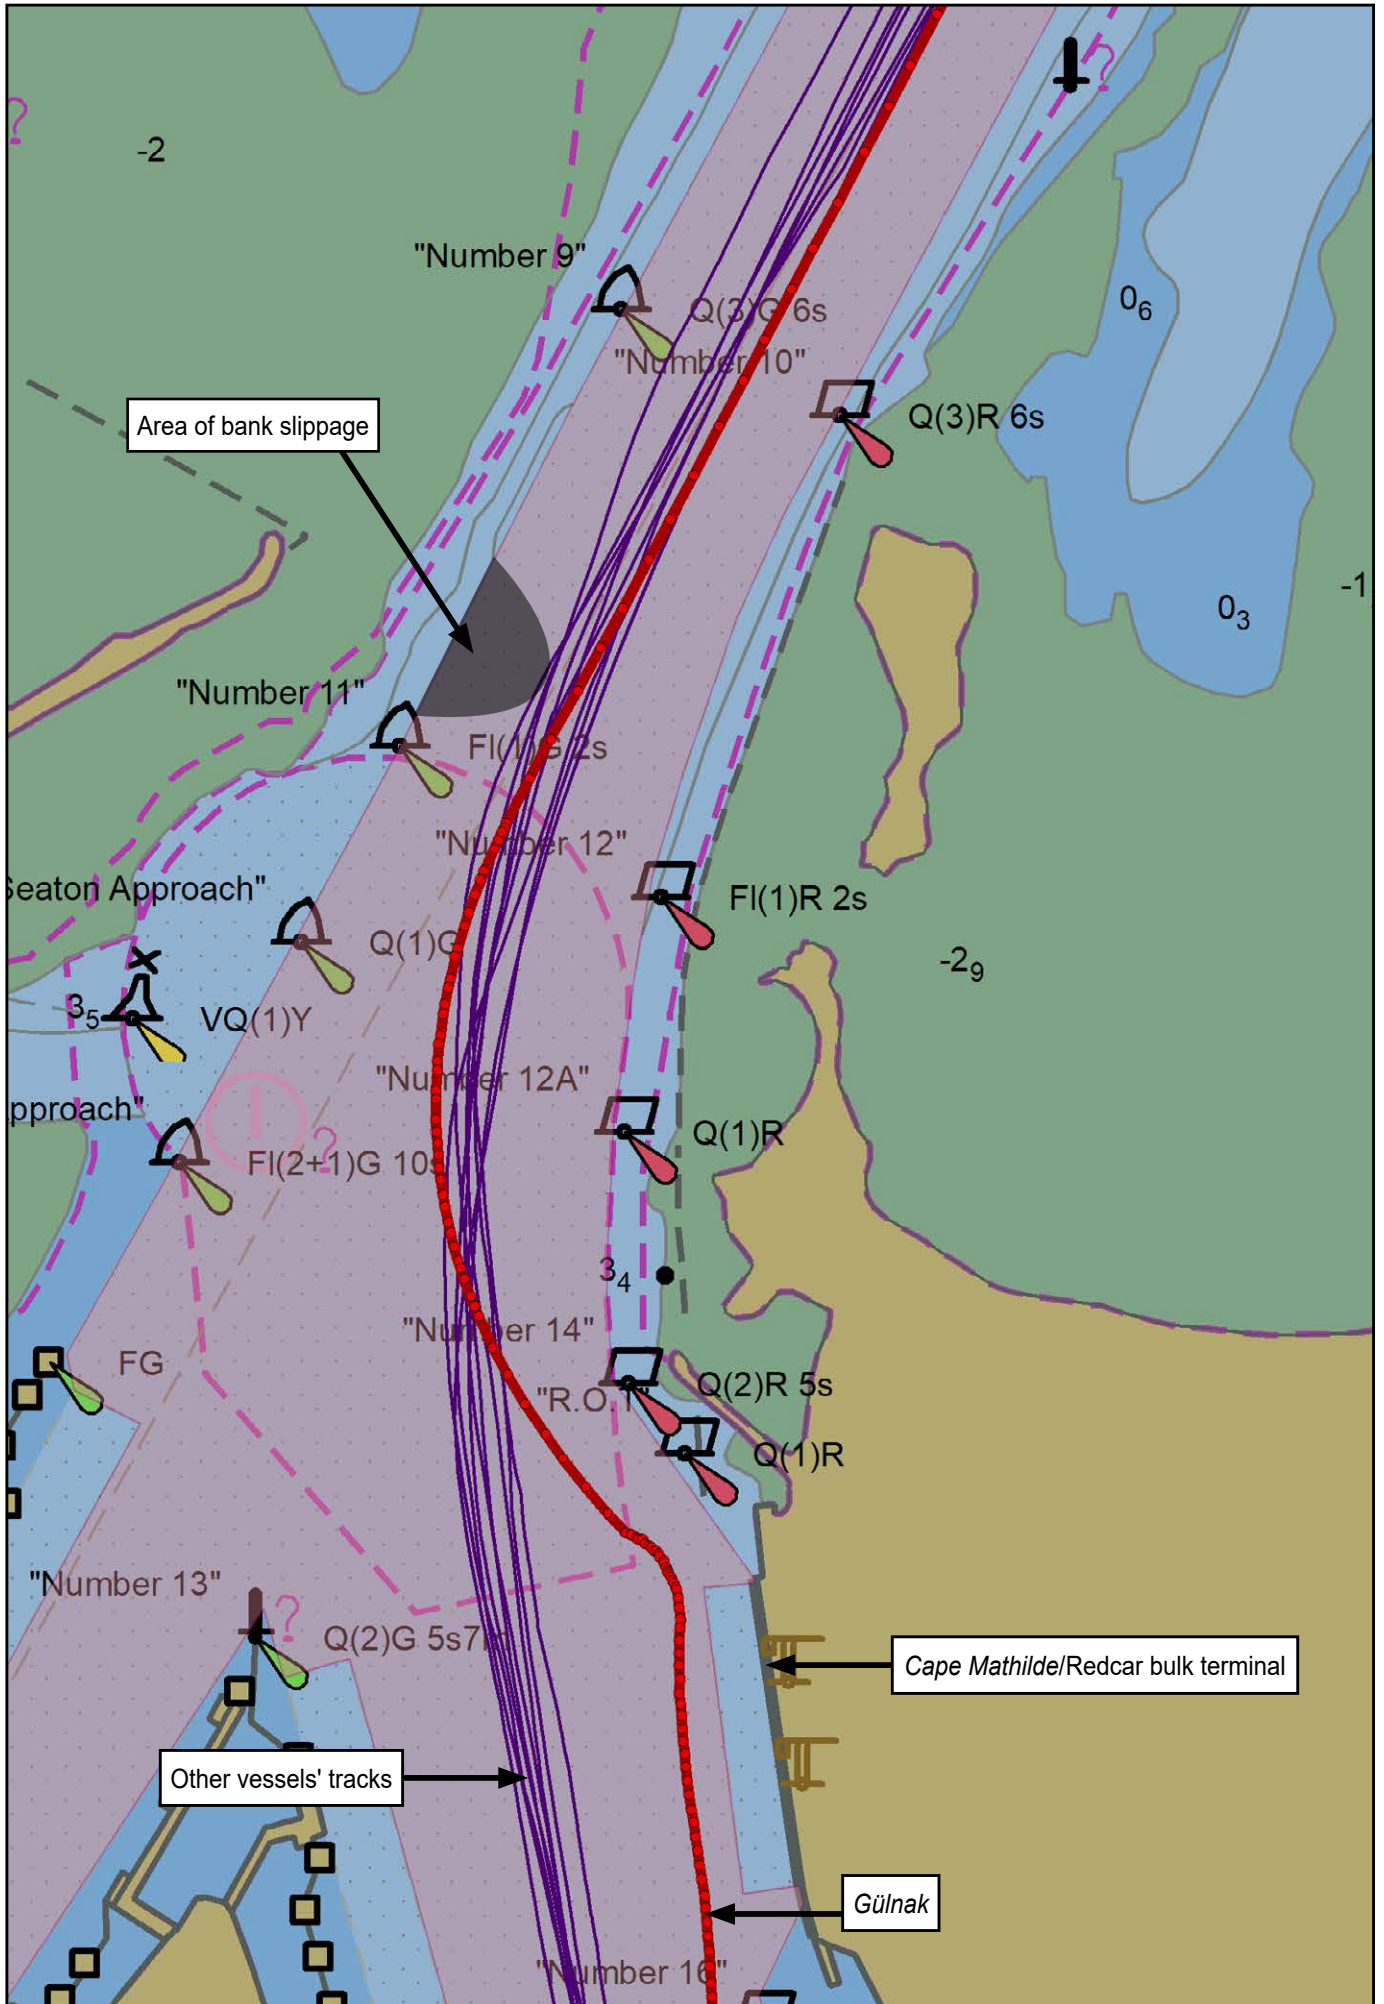
When plotted alongside the inbound routes taken by eight other handysize bulk carriers that had visited Tessport before the accident (**Figure 9**)<sup>8</sup>, it is evident that *Gülnek's* route, although about 30m further to the west during the turn, was generally similar to that of other vessels. However, whereas the speed of the other vessels at the start of the turn to 170° was around 8kts, which accorded with the preferences of some Tees Bay pilots, *Gülnek's* speed was 10kts. Although a faster speed would have reduced the time and safe water available to react to the loss of control, it should not have adversely affected the vessel's steering.

Figure 9: Tracks of Gülnak and other handysize bulk carriers
