## Grounding of the ro-ro freight ferry *Seatruck Performance* in Carlingford Lough, Northern Ireland 8 May 2019

### SUMMARY

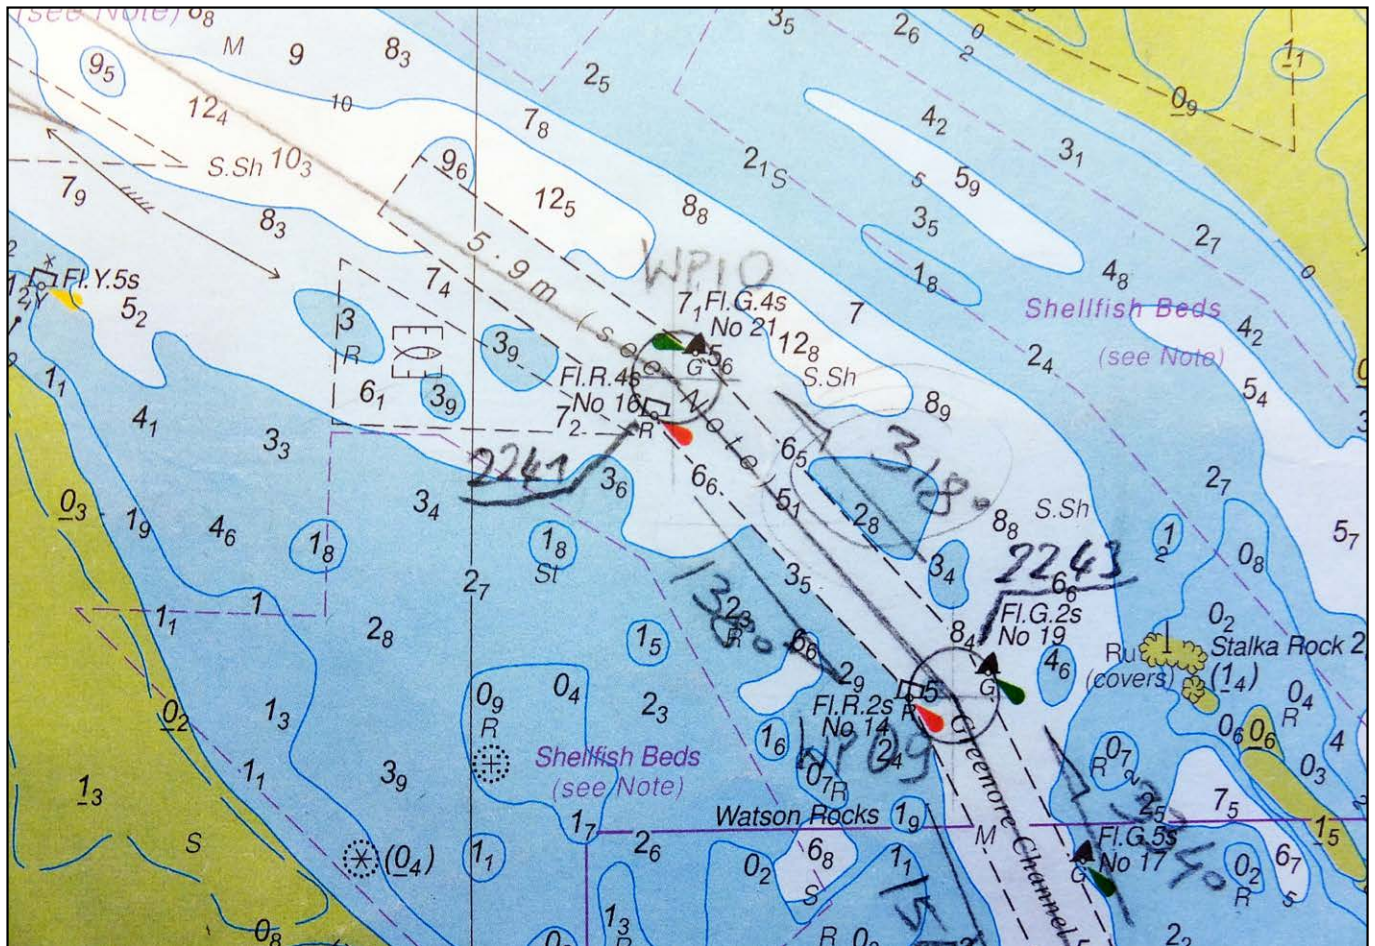
**Figure 3:** Planned track through the Greenore Channel

The Greenore Channel (**Figure 3**) was dredged to a depth of 5.9m and varied in width from 80m to 120m. It was marked by lateral buoys, which were lit, and no reports had been received to indicate they were out of their charted positions. The distance between No 16 and No 21 buoys was 120m. Passing in the channel was not permitted and there were no speed restrictions.

The reduced depths were located in the section of the channel between No 16 and No 14 buoys.

The passage plan required *Seatruck Performance* to alter from 121° to 138° when passing between No 16 and No 21 lateral buoys (**Figure 3**). The plan kept the ferry in the centre of the dredged channel as it headed to the next pair of lateral buoys. Although the planned alteration was only 17°, the width of the dredged channel between submerged granite banks to the east of No 16 and No 21 lateral buoys was only 120m, which afforded little margin for error.

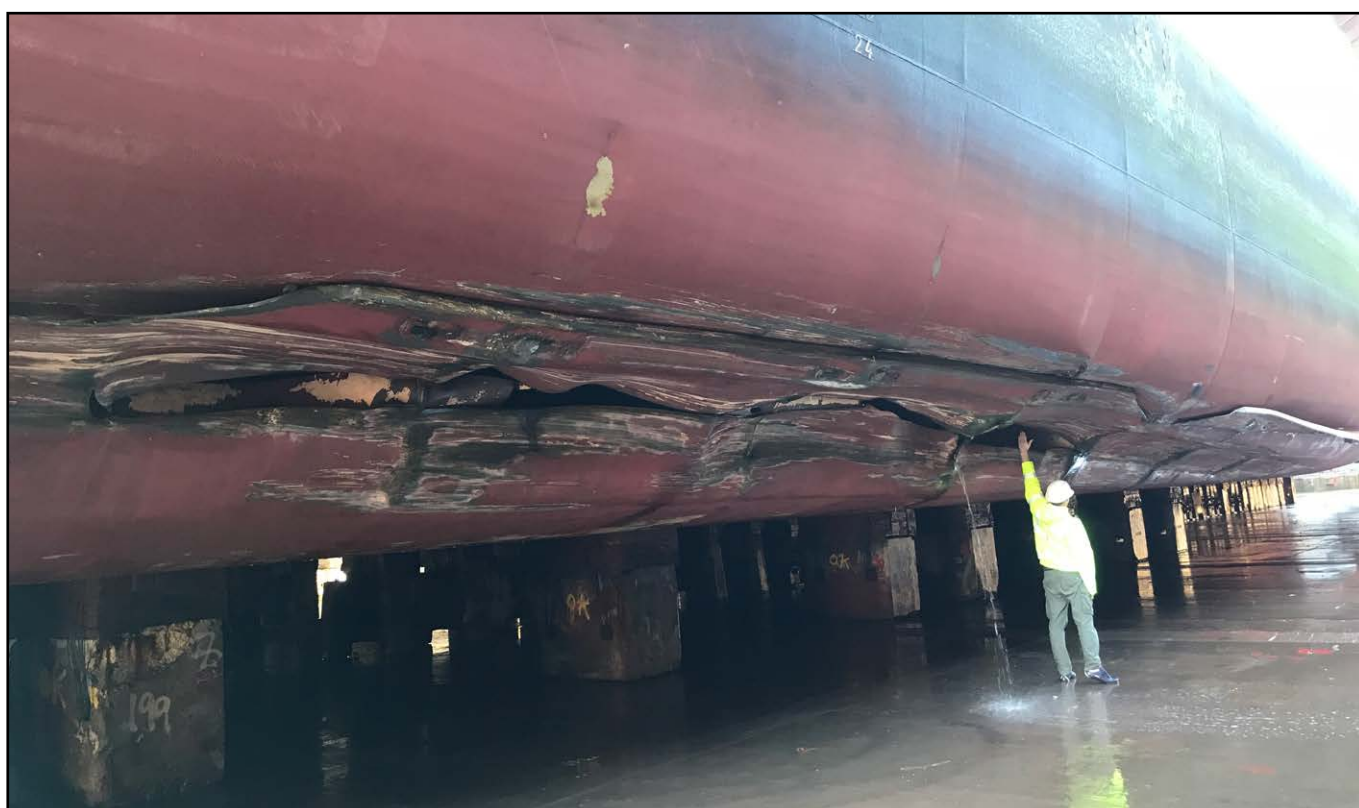
**Figure 4:** Damage to *Seatruck Performance* port side

An underwater inspection of *Seatruck Performance* on 9 May identified significant damage to the ferry's port side, including a 10m tear in way of No 4 void space and No 8 heeling tank, on the turn of the bilge (**Figure 4**). Both spaces were flooded to the waterline.

Following a single voyage dispensation by *Seatruck Performance*'s classification society, the ferry proceeded to a dry dock in Belfast, where it arrived on 11 May. Broken pieces of granite were found in the damaged tanks. *Seatruck Performance* was repaired and returned to service 3 weeks later.

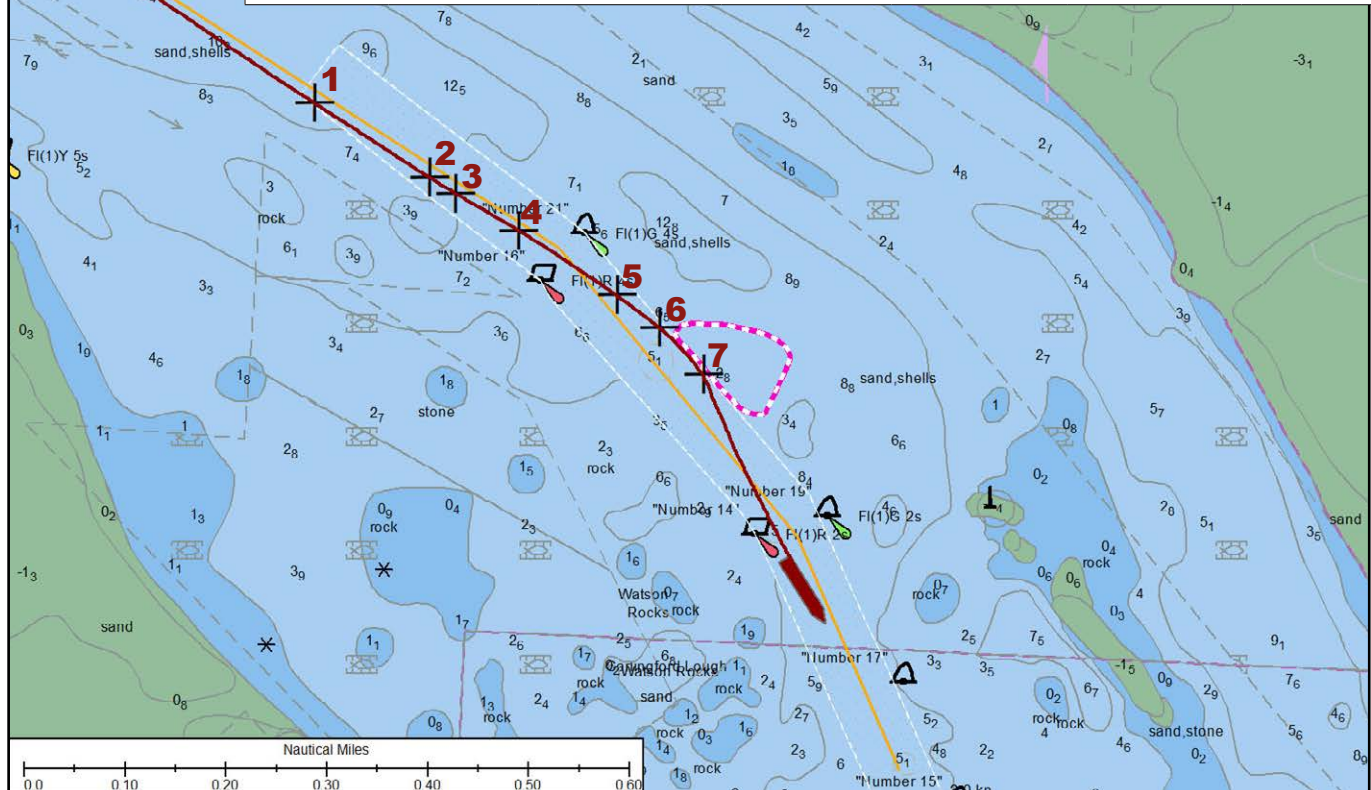
**Figure 5:** Reconstruction of *Seatruck Performance's* planned and actual track

Reconstruction of *Seatruck Performance's* track (**Figure 5**), which is based on voyage data recorder information, showed that when hand-steering was selected at 2241:22, the ferry was 20m to the south of the planned 121° track and was heading 119° at 14.1 knots. Over the next 30 seconds, the ferry's heading turned very slowly to port to a heading of 117°, until checked by the master's use of starboard helm. That *Seatruck Performance's* speed also decreased to 12.8 knots over the same period and the depth of water under the keel reduced from 7.6m to 4.7m, indicates that the ferry experienced 'bow-cushion'<sup>3</sup> and other shallow water effects<sup>4</sup> as it approached and passed the 3.9m shoal patch on the southern edge of the dredged channel.

Having arrested *Seatruck Performance's* slow turn to port with starboard helm, the master maintained the ferry's heading at about 121° between 2241:51 and 2242:23 by using between 5° of port and 5° starboard helm. During this period, the ferry passed between the No 16 and No 21 lateral buoys, beyond the intended course alteration, and was heading towards the north side of the dredged channel. Although the master then used increasing amounts of starboard helm to head between No 14 and No 19 lateral buoys, the turn was started too late. Consequently, *Seatruck Performance's* port side struck the submerged granite bank on the northern side of the dredged channel, which was indicated by a 2.8m spot depth.

Key	Time	Heading	Speed (kts)	Rudder (S+P-)	RoT (°/min) (S+P-)	Depth (m)
1	2240:48	120°	14.5	+ 2°	-2°	7.6
2	2241:22	119°	14.1	0°	-2°	5.1
3	2241:31	118°	13.6	+10°	-8°	4.0
4	2241:51	117°	12.8	+15°	-1°	4.7
From 2241:51 and 2242:23 the rudder movements varied between +5° and -5° the ship's heading remained at 121°						
5	2242:23	122°	13.1	+12°	+6°	4.9
6	2242:37	126°	12.6	+20°	+17°	3.9
7	2242:58	141°	11.3	0°	+51°	2.6
