National Transportation Safety Board

Marine Accident Brief

Grounding of Fishing Vessel *Freyja*

Accident type	Grounding/Stranding	No. DCA19FM024
Vessel name	<i>Freyja</i>	
Location	Bering Sea, near Point Tebenkof, Unalaska Island, Alaska 53° 59.4' N, 166° 53.4' W	
Date	March 9, 2019	
Time	About 0155 Alaska standard time (coordinated universal time – 9 hours)	
Injuries	None	
Damage	\$550,000 est.	
Environmental damage	None	
Weather	Overcast with rain showers and south winds from 20–25 knots; breaking waves estimated at 10 feet; air temperature 36°F; water temperature 40°F	
Waterway information	Fishing grounds in the Bering Sea north of Point Tebenkof, Unalaska Island, Alaska. The island of Unalaska is part of the Aleutian Chain.

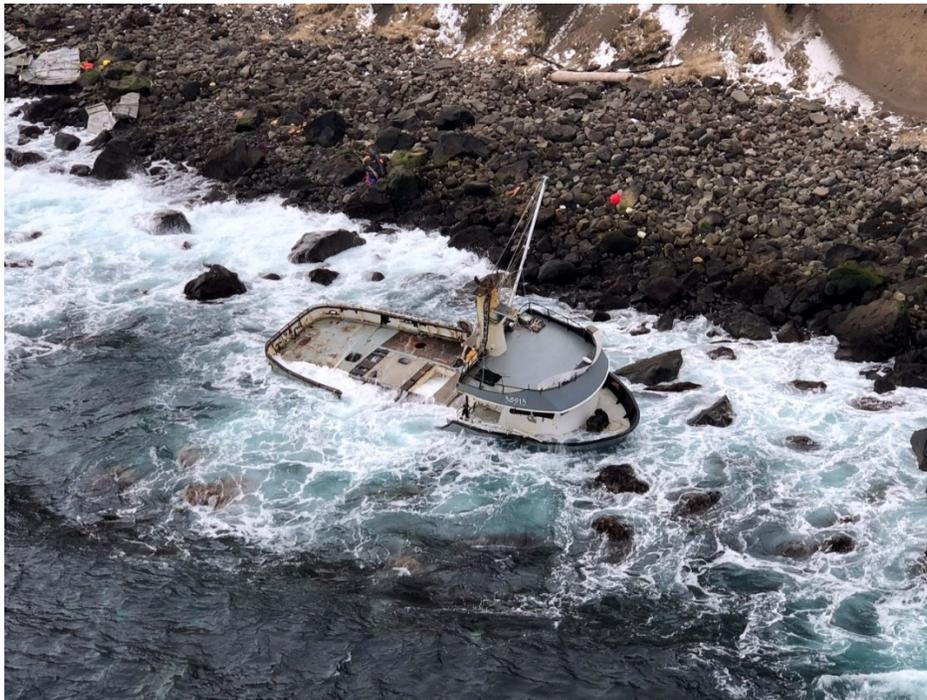
Postaccident photo of the *Freyja*, taken March 18, 2019, along the shore of Point Tebenkof. (Source: US Coast Guard)

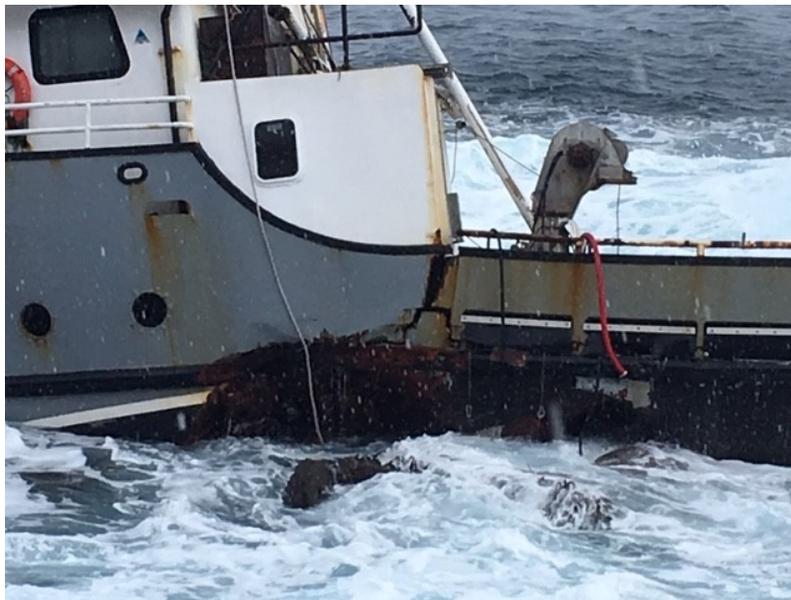
Photo of the *Freyja*'s starboard side, showing structural damage due to grounding. (Source: Resolve Magone Marine)
