SAFETY INVESTIGATION REPORT

REPORT NO.: 04/2020

MV BOSTON TRADER **Serious injury while lashing containers on deck, in the port of Oran, Algeria 14 March 2019**

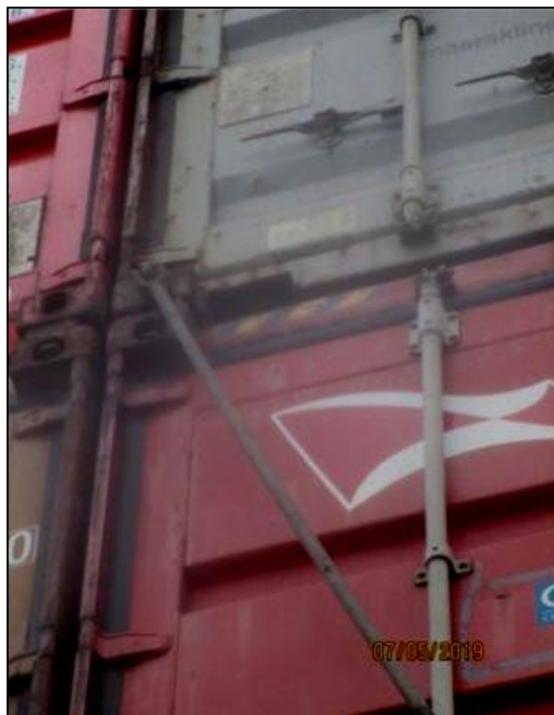
Figure 4: A lashing bar hooked into a corner fitting

The sockets of corner fittings into which lashing bars are hooked, are oval in shape (Figure 4). A lashing bar, such as the one being used by the injured AB, was designed to slip in with ease into the socket of the container and to lock into the socket, once the bar is rotated diagonally across and connected to the turnbuckle. In view of this design, if the lashing bar is left suspended vertically, it may slip out from the socket of the corner fitting. The danger is higher if the lashing bar is not hooked correctly. The upper end of the lashing bar is shown in Figure 10.

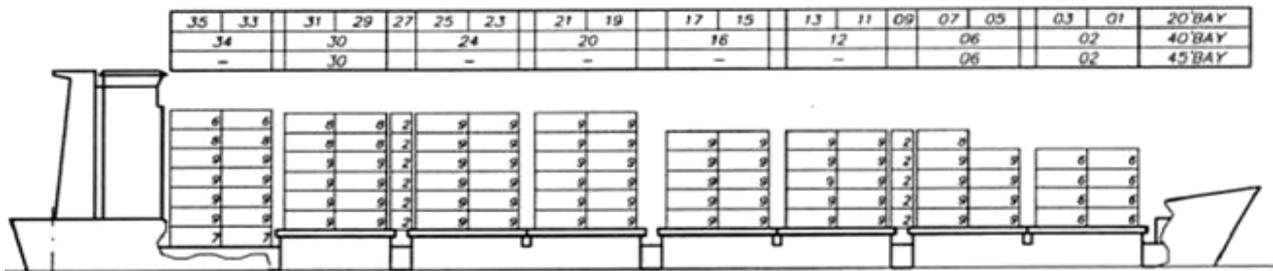
Figure 7: Location of the accident

Cross deck between Bay 06 and Bay 12

While containers were being loaded onto the hatch cover of no. 2 cargo hold (Bay 06), AB 1 was positioned in the cross-deck between Bay 06 and Bay 12 (Figure 7).

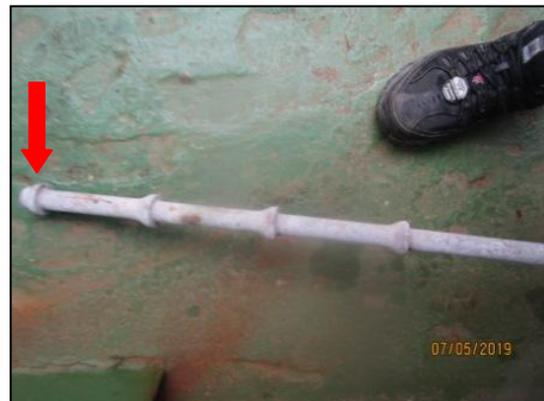
Figure 8: The bottom end of the lashing bar

At this point, the lashing bar slipped out from the container socket and fell vertically down onto his right foot. The bottom end of the lashing bar (Figure 8) cut through the safety footwear (Figure 9) and injured his foot.

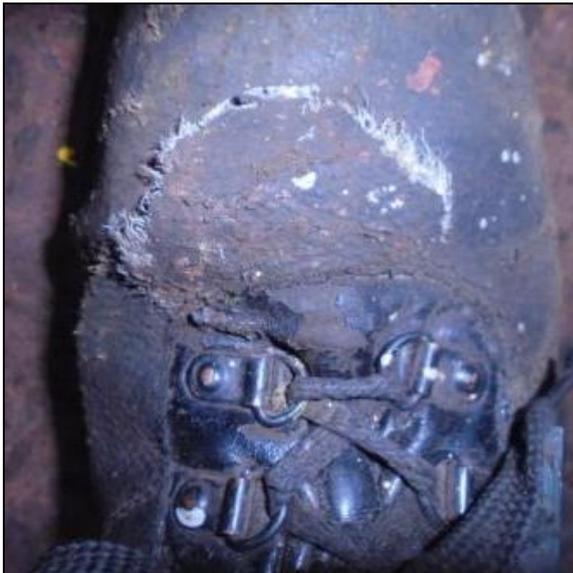
Figure 9: The safety shoe of the injured seafarer, after the accident

⁶ Figure 9 indicated that the damage to the safety boot was in way of the metatarsals whereas he injured part was one of the proximal phalanges, which is normally well protected by the steel toecap.

struck by the lashing bar (Figure 9) did not coincide with the position of the sustained injury.

Although the injury resulted in one of his toes being amputated, there were no signs of other injuries on the seafarer's foot. This suggested that the seafarer's foot might not have been inserted fully into his shoe when the lashing bar fell, either because the shoe was not properly worn or because his foot slipped out.
