SAFETY INVESTIGATION REPORT

REPORT NO.: 06/2020

MV VERMONT TRADER **Serious injury to crew member** **in position 22° 09.63' N 114° 09.44' E** **21 March 2019**

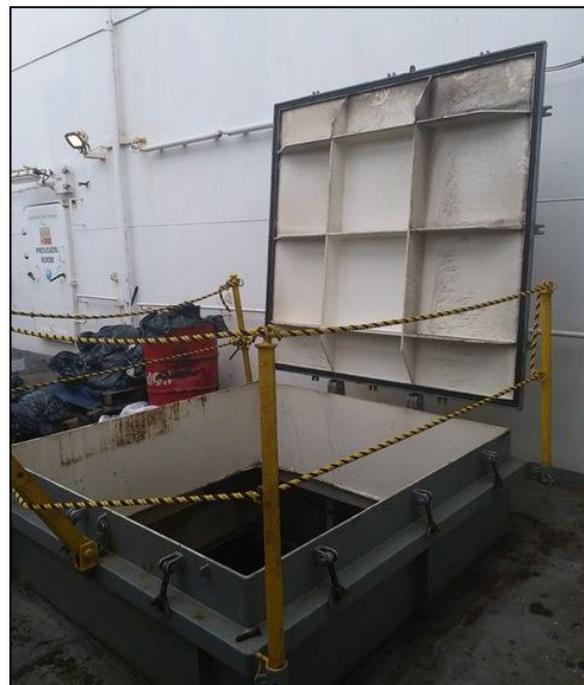
Figure 1: The engine-room hatchway in the open position

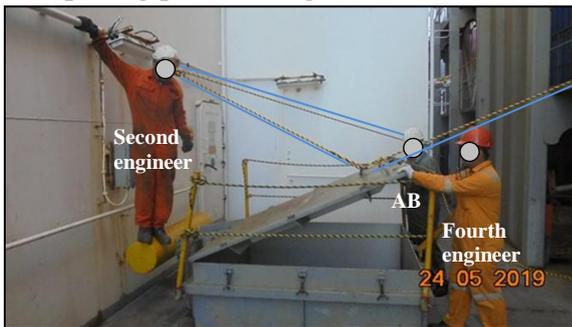
The fourth engineer and the AB lifted the hatchway cover from the front access of the opening, while the second engineer put his weight on the counterweight to assist with the opening process (Figure 2).

Figure 2: Simulation of the accident (the line traced in blue was used as a safety measure during the crew's simulation of the accident)

When the hatchway cover reached in level with the height of the stanchions (Figure 2), the downward force of the counterweight still

did not start acting. The second engineer opted to stand up on the counterweight to continue assisting during the opening. As the counterweight began to act, it caused the cover to swing open, probably during which time, the second engineer fell.

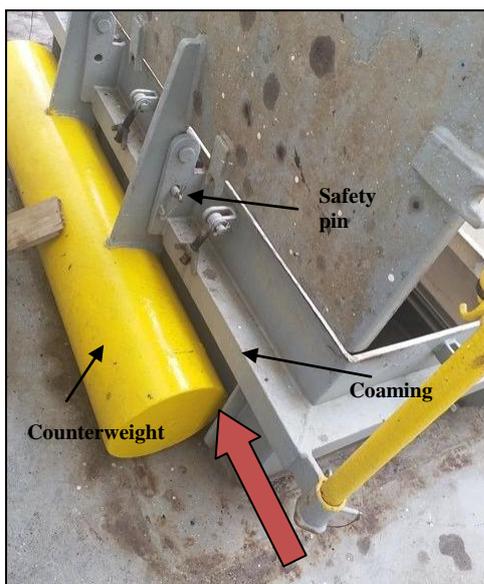
The second engineer intended to secure the hatchway cover in the open position by inserting a safety pin, at the hinge of the hatchway. However, the second engineer fell during the opening and his left leg was caught in between the counterweight and the hatchway coaming (Figure 3).

Figure 3: Red arrow showing the location where the lower leg of the second engineer was stuck

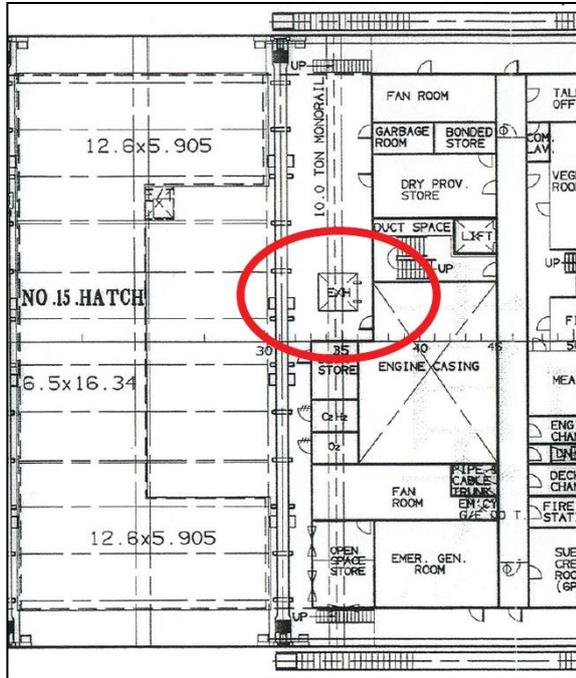
The engine-room hatchway was located on the freeboard deck, in between the aft part of the accommodation and cargo hatch no. 15 (Figure 4).

Figure 4: Extract from the GA plan showing the location of the engine-room hatchway

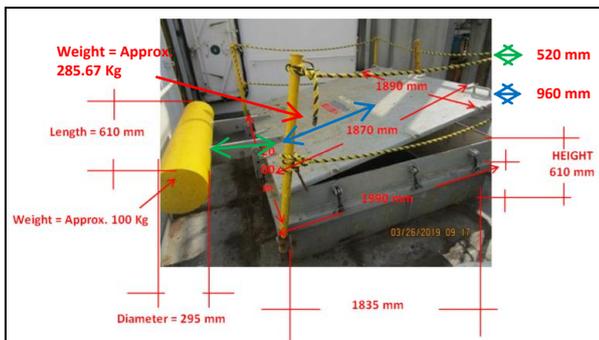
Figure 5: Dimensions of the engine-room hatchway

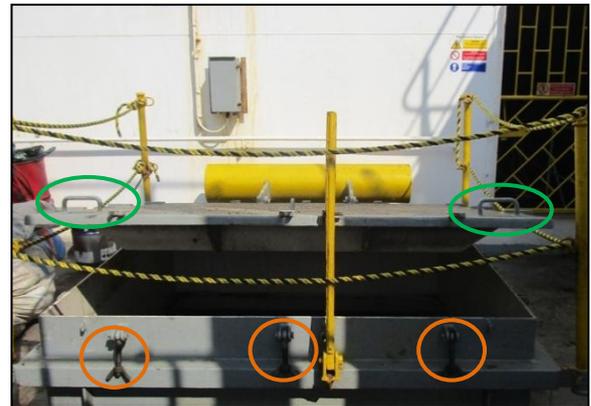
c) Lift the hatch manually by pulling it upwards from the handgrips (Figure 6) (can be done by a single person as the weight of the hatch is countered by the counterweight);

Figure 6: Handgrips on either side of the opening, circled in green, butterfly nuts circled in orange

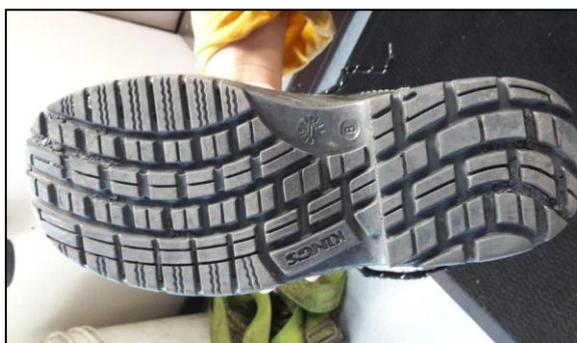
Photographic evidence of the second engineer's safety shoes indicated that there was adequate depth to the shoe's sole (Figure 6).

Figure 6: Shoe's sole in good condition

The second engineer was standing on a cylindrically shaped counterweight. It cannot be excluded that the safety shoes could not be placed flat on the counterweight, thus reducing the surface area whereby friction could have been provided.

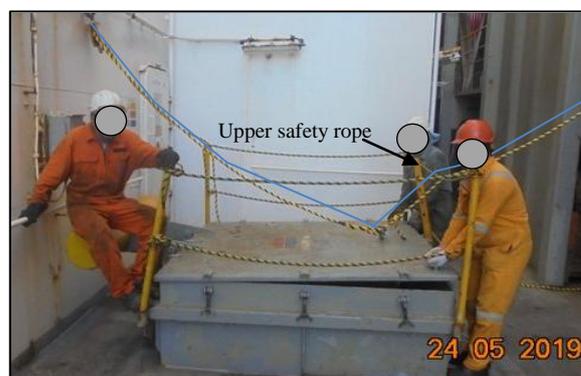
The AB and the fourth engineer were positioned directly in front of its opening. While passing their hands in between the stanchions and safety ropes, they cracked open the hatchway cover by the use of the handgrips, (Figure 7).

Figure 7: Simulated opening – crew lifting the hatchway cover; with their hands passing in between the stanchions and rope (the line traced in blue was used as a safety measure during the crew's simulation of the accident)

To be able to lift the hatchway cover to a higher level, the AB and the fourth engineer had to place their hands over and above the upper safety rope (Figure 7) to access beyond the physical safety barrier and resume lifting unhindered. This operation in itself would have been strenuous to the crew, as the weight of the hatchway cover was not yet taken by the counterweight at that level. The second engineer, at this point, was in a sitting position on the counterweight, with the intention to ease off the weight of the hatchway cover while the crew handle an awkward part of the opening.

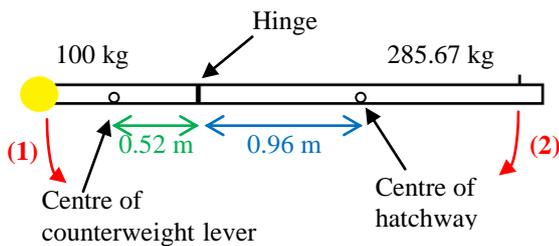
Figure 8: Anti-clockwise and clockwise moments experienced by engine-room hatchway cover

Moment (1) refers to the anti-clockwise rotational force in play by the counterweight, while, moment (2) refers to the clockwise rotational force present by the engine-room hatchway cover.

The calculations revealed that an additional anti-clockwise moment of 2178 Nm would have been required at the engine-room hatchway cover, to open it. This meant that a mass of 231.5 kg would still be required to lift the cover from its front access, despite the counterweight being installed.

Furthermore, whilst noting that this engine-room hatchway cover was fitted with a counterweight, in the opinion of this safety investigation, the counterweight did not prevent straining or endangering personnel while opening it.

06/2020_R2 Reassess the opening procedure of the engine-room hatchway and consider other means to facilitate its opening;
