Stranding and loss of the fishing vessel *Coelleira* (OB 93) Ve Skerries, Shetland 4 August 2019

SUMMARY

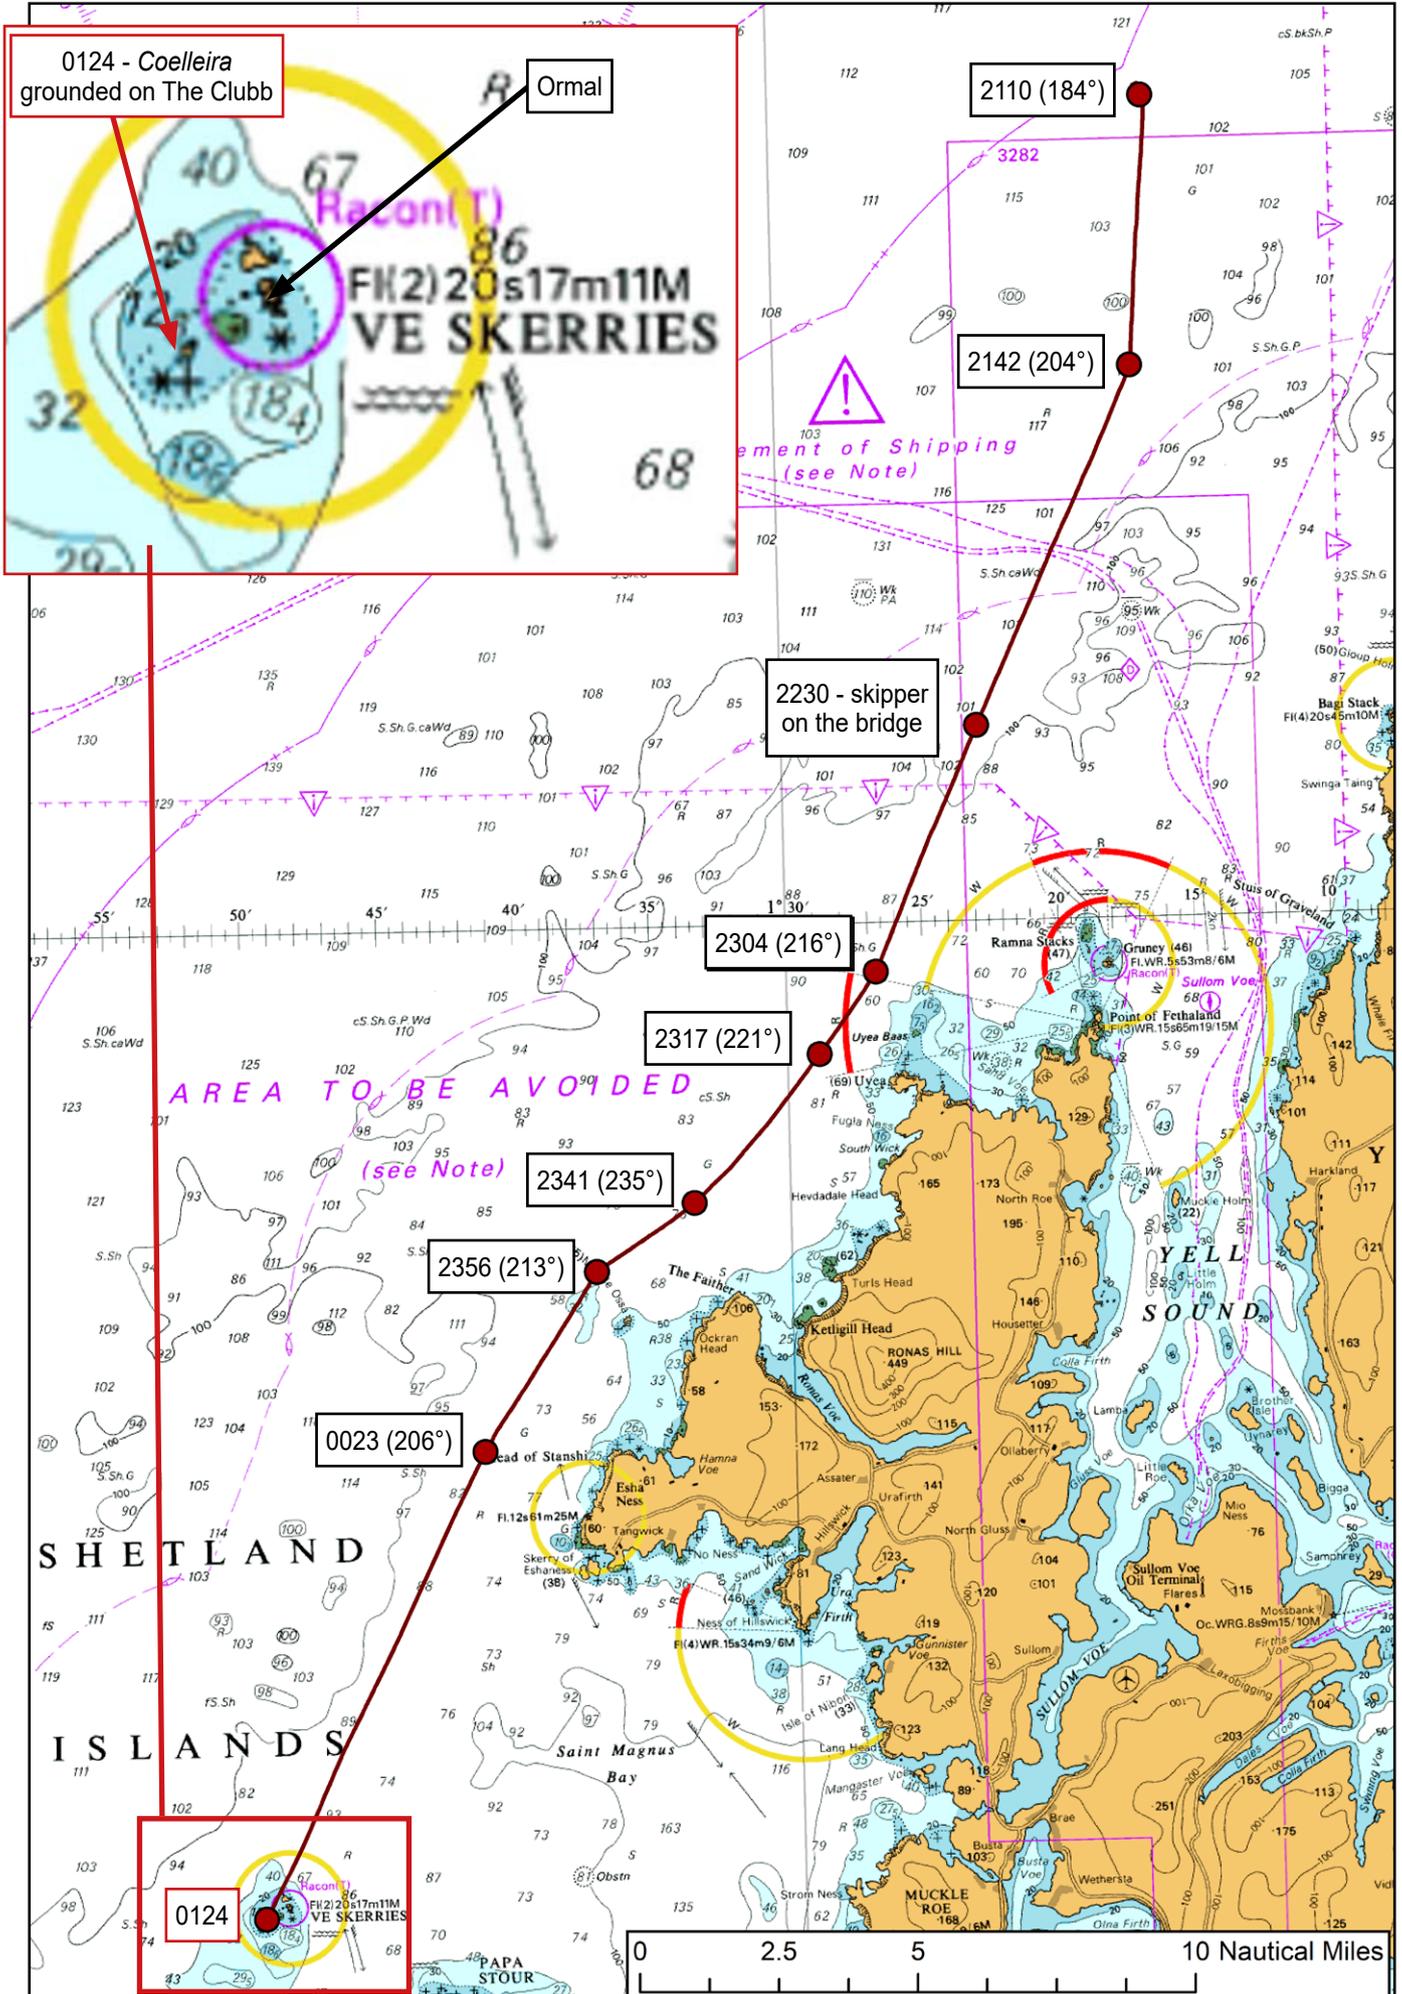
Figure 1: Coelleira's AIS track (inset: detail showing Ve Skerries)

Between 2304 and 0023 the following morning, the skipper adjusted the heading set on the autopilot on five occasions (**Figure 1**), primarily to follow the coastline. During this period, the engine speed was not altered, and the skipper remained in the wheelhouse alone and monitored *Coelleira*'s progress by chart plotter and by radar. He also completed administrative tasks such as fish landing records on a computer sited on the starboard side of the wheelhouse (**Figure 2**). The skipper's frequency of checking the vessel's position is not known.

Sometime later, the skipper left the wheelhouse. He did not specifically check the vessel's position before he left, nor did he note anything of concern or notice the lighthouse light ahead. The skipper was returning to the wheelhouse when, at 0124, *Coelleira* grounded on The Clubb, Ve Skerries (**Figure 1 inset**) at a speed of 10kts. The skipper was confused by the vessel's position.

Coelleira was heading directly towards Ve Skerries as soon as the vessel's heading was adjusted at 0023 (**Figure 1**). During the following hour, in which the vessel made good a course of 206° at a speed of 9-10kts, the skipper did not recognise the impending danger ahead. Although he saw a light off the vessel's port bow during the transit, he did not associate it with the lighthouse on Ormal. The skipper also did not see the racon from the lighthouse or returns from the low-lying reefs on the radar display, Ve Skerries ahead of the vessel on the chart plotter, or, the lighthouse light as he left the wheelhouse. Such omissions reflect a combination of an absence of passage planning, ineffective lookout and position monitoring, and possibly inaccurate or incomplete electronic chart data.

Coelleira's passage plan from the fishing grounds to Scrabster was based on following the Shetland coast (**Figure 1**) rather than a plotted route. The skipper relied on his limited knowledge of the area and adjusted the vessel's heading to remain between 1.25nm and 2nm clear of charted dangers. The five course alterations between 2304 and 0023 indicate that the skipper was monitoring *Coelleira*'s position and was using the radar and/or the chart plotter to monitor distances. They also suggest that the skipper's navigation was reactive rather than planned. The skipper's aim was to arrive in Scrabster as soon as possible, but he chose to follow the coast rather than a more direct and marginally shorter route that was clear of many navigational dangers (**Figure 5**). This decision might have been made because the vessel did not carry a sufficiently small-scale chart.

When *Coelleira*'s heading was adjusted to 206° at 0023, which was an alteration of only 7°, the skipper did not realise he was turning *Coelleira* directly towards Ve Skerries. Ve Skerries were 10nm ahead and therefore would not have been displayed on the radar at the 3nm range scale. Whether or not the reefs were displayed on the chart plotter would have depended on the scale selected and the quality of the electronic chart, and at a range of 10nm the light on Ormal also might not have been readily apparent due to its geographical range (11nm) together with its characteristics (flashing twice every 20 seconds). Although the adjustment of heading was small, and was possibly made in an attempt to save time, the absence of any reference to a small-scale chart and a planned route on either paper charts or in the chart plotter, along with not periodically adjusting the range on the radar display and chart plotter, denied the skipper opportunities to identify the presence of the reefs ahead.

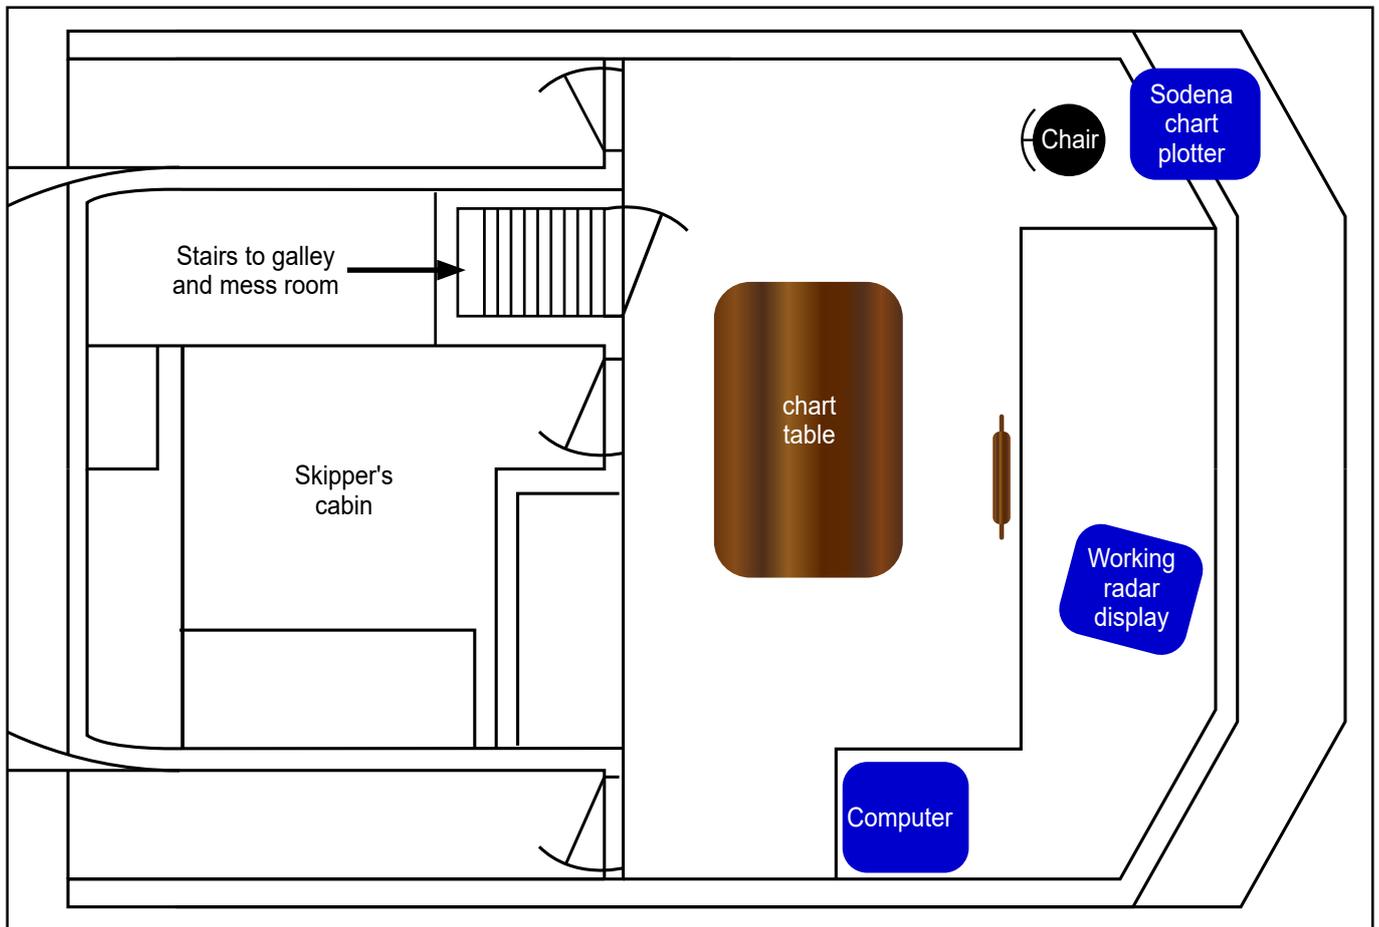
Figure 2: Bridge layout

The navigation equipment fitted in *Coelleira*'s wheelhouse (**Figure 2**) included a Robertson autopilot, a chart table, a global positioning system receiver, Maxsea and Sodena Turbowin electronic chart plotters, and two radar displays. One of the radars was not working because its scanner had been damaged when struck by the rescue boat davit arm. The working radar was usually kept on the 6nm range scale when fishing and on the 3nm range scale when on passage. The vessel also carried an automatic identification system (AIS) transceiver on which the vessel status was set to '*engaged in fishing*'.

Coelleira's primary means of navigation was paper charts. The vessel's chart plotters had been fitted in 2007 to support its fishing operations. However, the Maxsea chart plotter no longer worked and was not used. The Sodena chart plotter used C-Map electronic charts, but no records were available to indicate either which charts were installed or whether those installed had been updated. It was reported that the hydrographic information displayed on the chart plotter was not as detailed as that shown on the paper charts. The intended passage from the fishing grounds to Scrabster was not drawn on paper charts or input into the Sodena chart plotter.

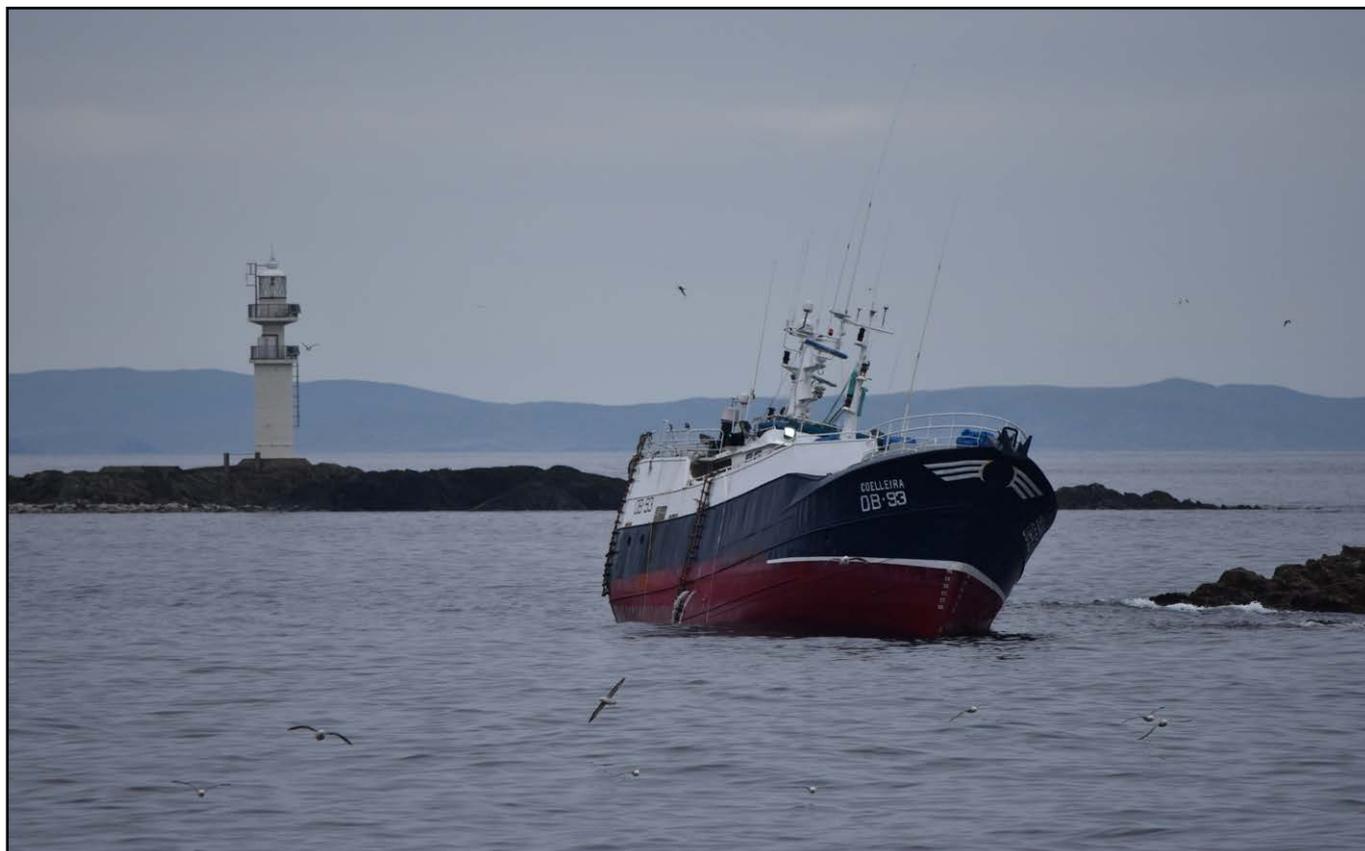
Figure 3: Coelleira aground

During 4 August, *Coelleira* remained hard aground with its generator still running, and diesel oil mixed with the generator's water discharge (**Figure 3**) was spreading around and downwind of the vessel. The Maritime and Coastguard Agency (MCA) Deputy Counter Pollution and Salvage Officer (DCPSO) and the Deputy to the SOSREP⁴ liaised with *Coelleira's* owners, insurers, the Scottish Standing Environment Group and the Shetland Islands Council to assess the vessel's position, condition and the possibility of re-floating. *Coelleira's* owners and insurers contracted *Tystie*, a 56t bollard pull tug operated by the Sullom Voe Harbour Authority in Orkney, to assist. The owner and the vessel's agent also travelled from Spain to Shetland. *Coelleira* was carrying approximately 15 tonnes of fish and 15 tonnes of diesel oil and had a draught of about 4m.

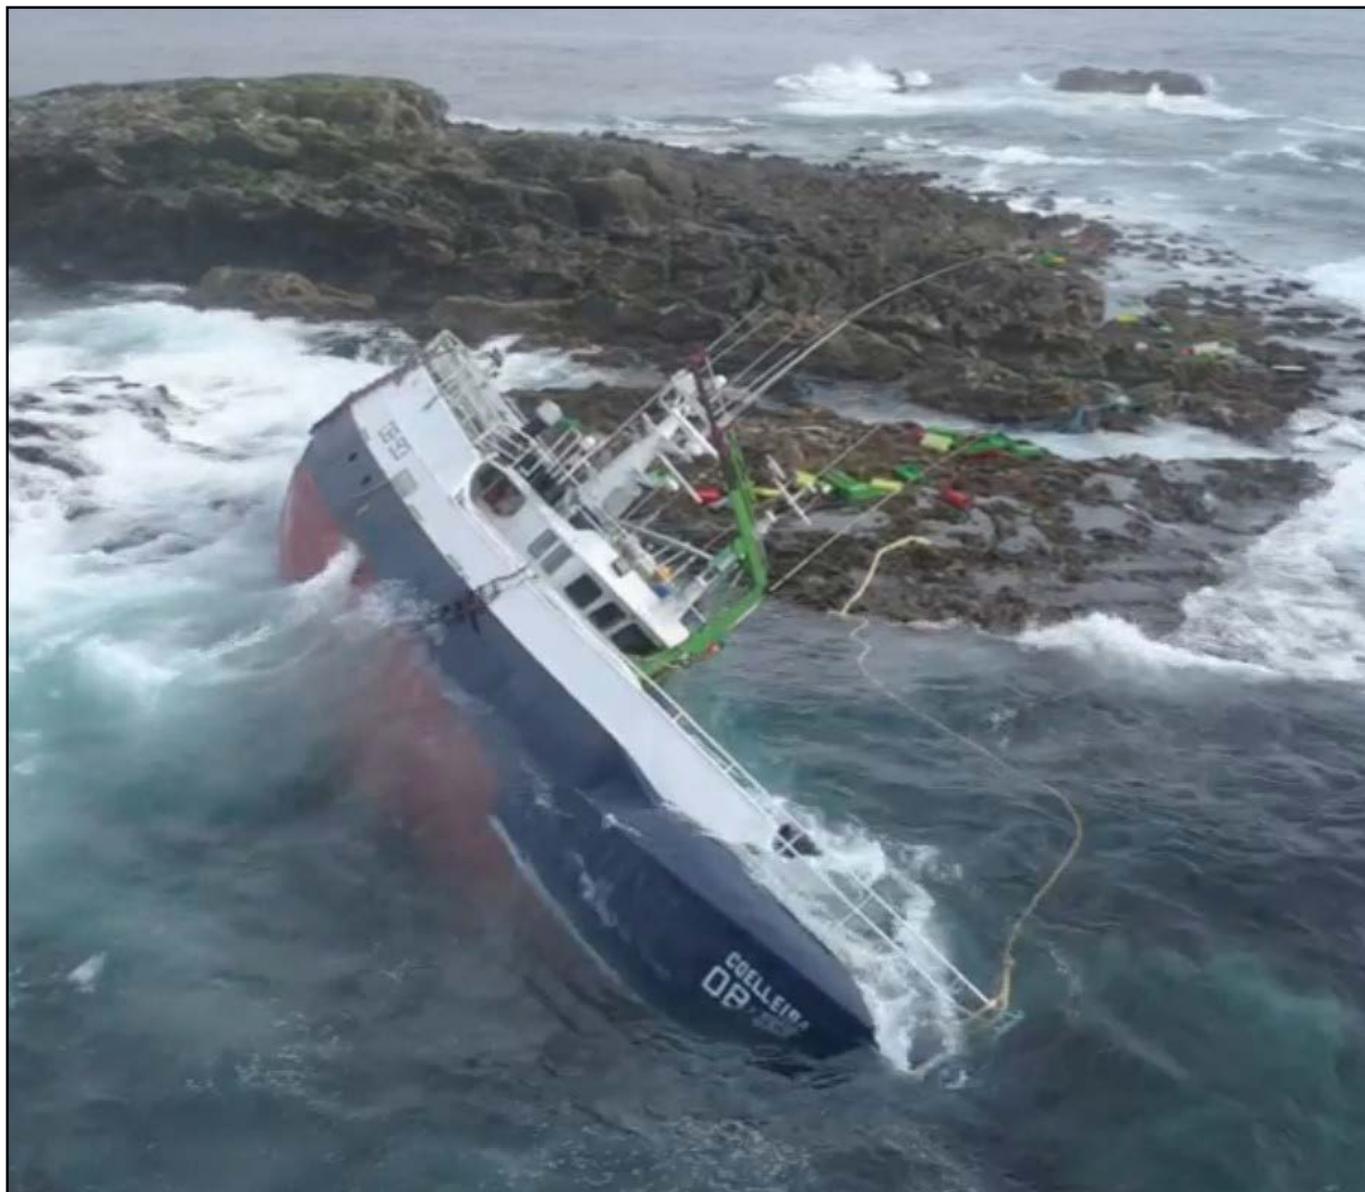
Figure 4: *Coelleira* post-salvage attempt

Between 5 and 6 August, a further onboard inspection was conducted by a surveyor appointed by *Coelleira*'s owner. The owner also appointed salvors, and the SOSREP established a 500m exclusion zone around the vessel. At high water on 7 August, an attempt by *Ievoli Black* to tow *Coelleira* off the rocks was unsuccessful and the fishing vessel developed a 55° list to port (**Figure 4**). The following day, a survey identified a 30cm wide crack extending between 4m and 5m along *Coelleira*'s starboard side. Consequently, with worsening weather and sea conditions forecast, the vessel was declared unsalvageable. MV *Constructor*, a dive vessel, was contracted to act as a guardship, recover debris and remove oil if the weather conditions allowed. However, *Coelleira* soon began to break up and eventually slid off the rocks into deeper water and sank.
