National Transportation Safety Board

Marine Accident Brief

Collision of Towing Vessel *St. Rita* and Tow with Moored Barges, and Subsequent Sinking

Accident type	Collision	No. DCA19FM022
Vessel name	<i>St. Rita</i>	
Location	Lower Mississippi River, mile 132, near New Orleans, Louisiana 30°02.0' N, 090°28.4' W	
Date	March 7, 2019	
Time	1430 central standard time (coordinated universal time – 6 hours)	
Injuries	Minor	
Property damage	\$1.5 million est.	
Environmental damage	No environmental damage reported	
Weather	Partly cloudy, visibility 10 miles, winds south 13 knots, small chop, current 5-6 knots, air temperature 73°F, water temperature 47°F	
Waterway information	The Mississippi River at the La Place fleeting area was at flood stage with an estimated current of 5-6 knots.

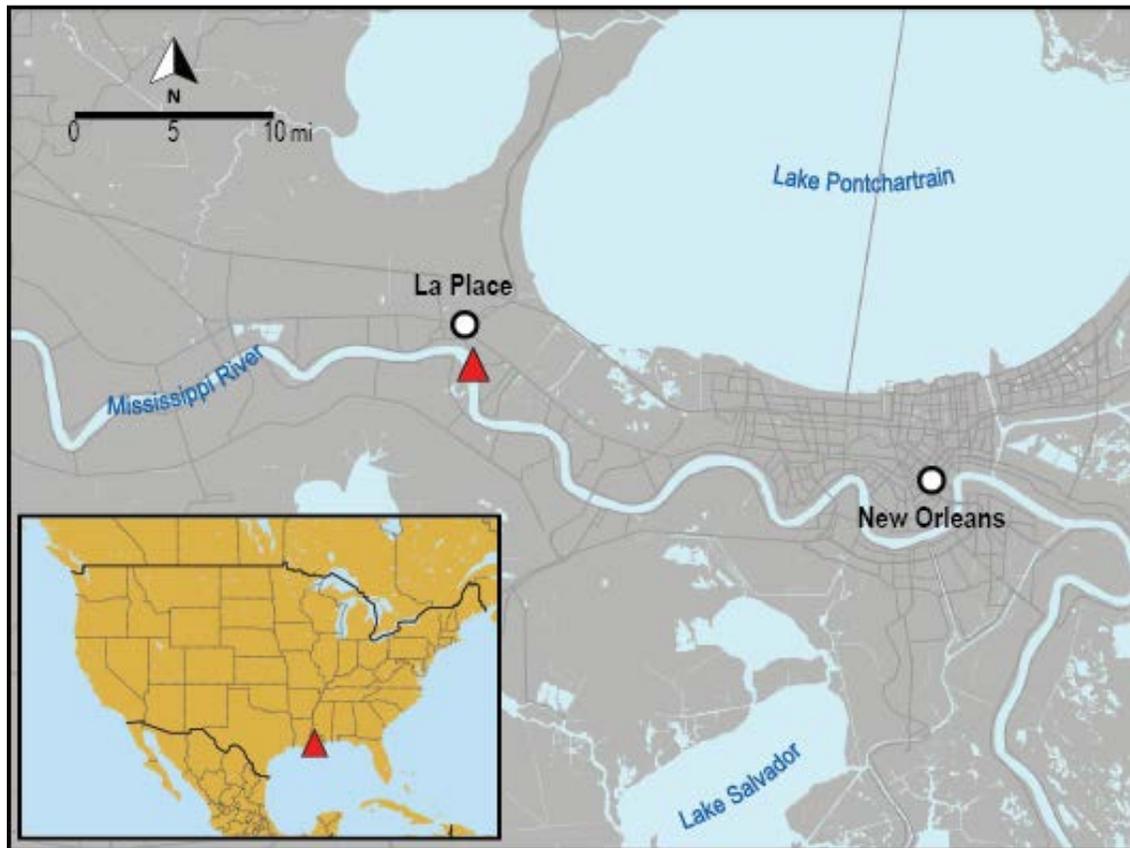
Area of accident where the *St. Rita* flooded and sank as indicated by the red triangle. (Background source: Google Maps)

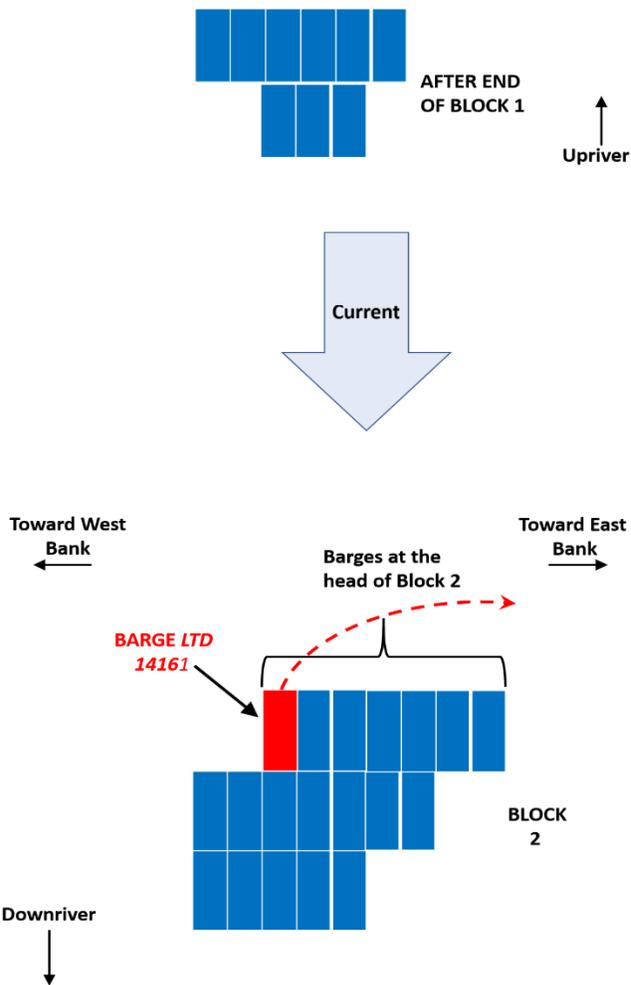
The *LTD 14161* was located on the head of Block 2, which was the row of barges on the upriver part of the block, facing the current. The *LTD 14161* had another barge on its starboard side and a barge tied up astern of it. There was no barge on its port side.

Location of barge *LTD 14161* within Block 2 of La Place fleeting area on the date of accident. A red dashed line shows the approximate intended movement of barge *LTD 14161* (the distance between blocks is approximate).

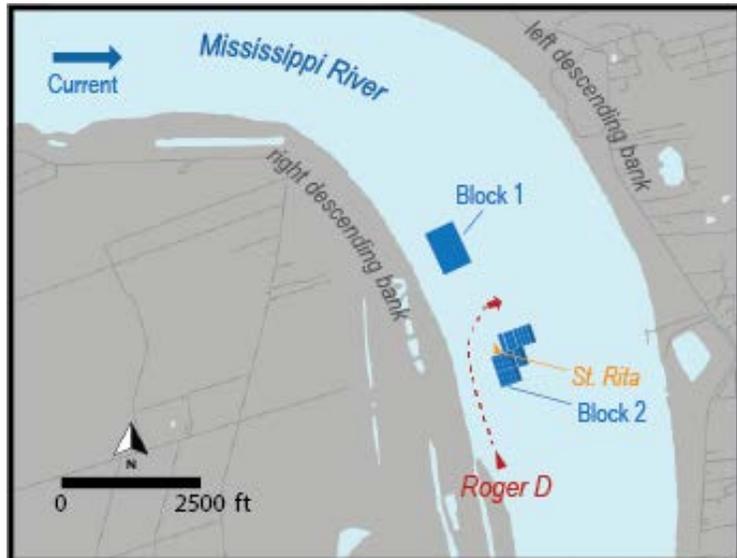
Approximate trackline of the towing vessel *Roger D* as it approached the *St. Rita* and Block 2. (Background source: Google Maps)

The captain of the *St. Rita* intended to directly cross the river, but to do so he had to point upstream. When he turned to starboard to avoid taking the same path as the *Roger D*, which was crossing the river ahead, the current overwhelmed his tow and swept it onto the head of the barge block. The captain of the *St. Rita* said that he was aware that the *Roger D* was nearby but chose not to call the towing vessel via VHF prior to getting under way with barge *LTD 14161*. His assumption that the other vessel would continue heading upriver would have been dispelled if he had called the *Roger D*. He then could have waited to move free of Block 2 with his barge, rather than attempt to change the tow's heading to keep clear of the *Roger D* while coping with a strong current.

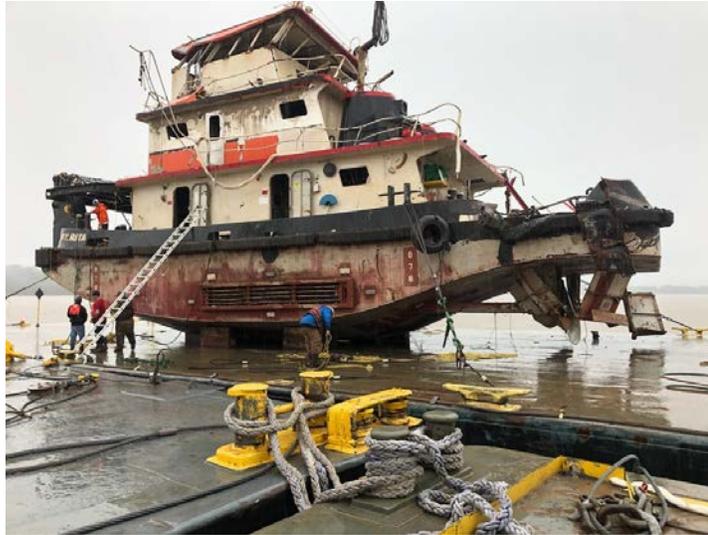
The *St. Rita*, post-salvage, sitting atop a barge (Source: US Coast Guard)
