Report on the investigation of
the man overboard from the dredger

Cherry Sand

resulting in one fatality

in the non-tidal basin at Port Babcock Rosyth,

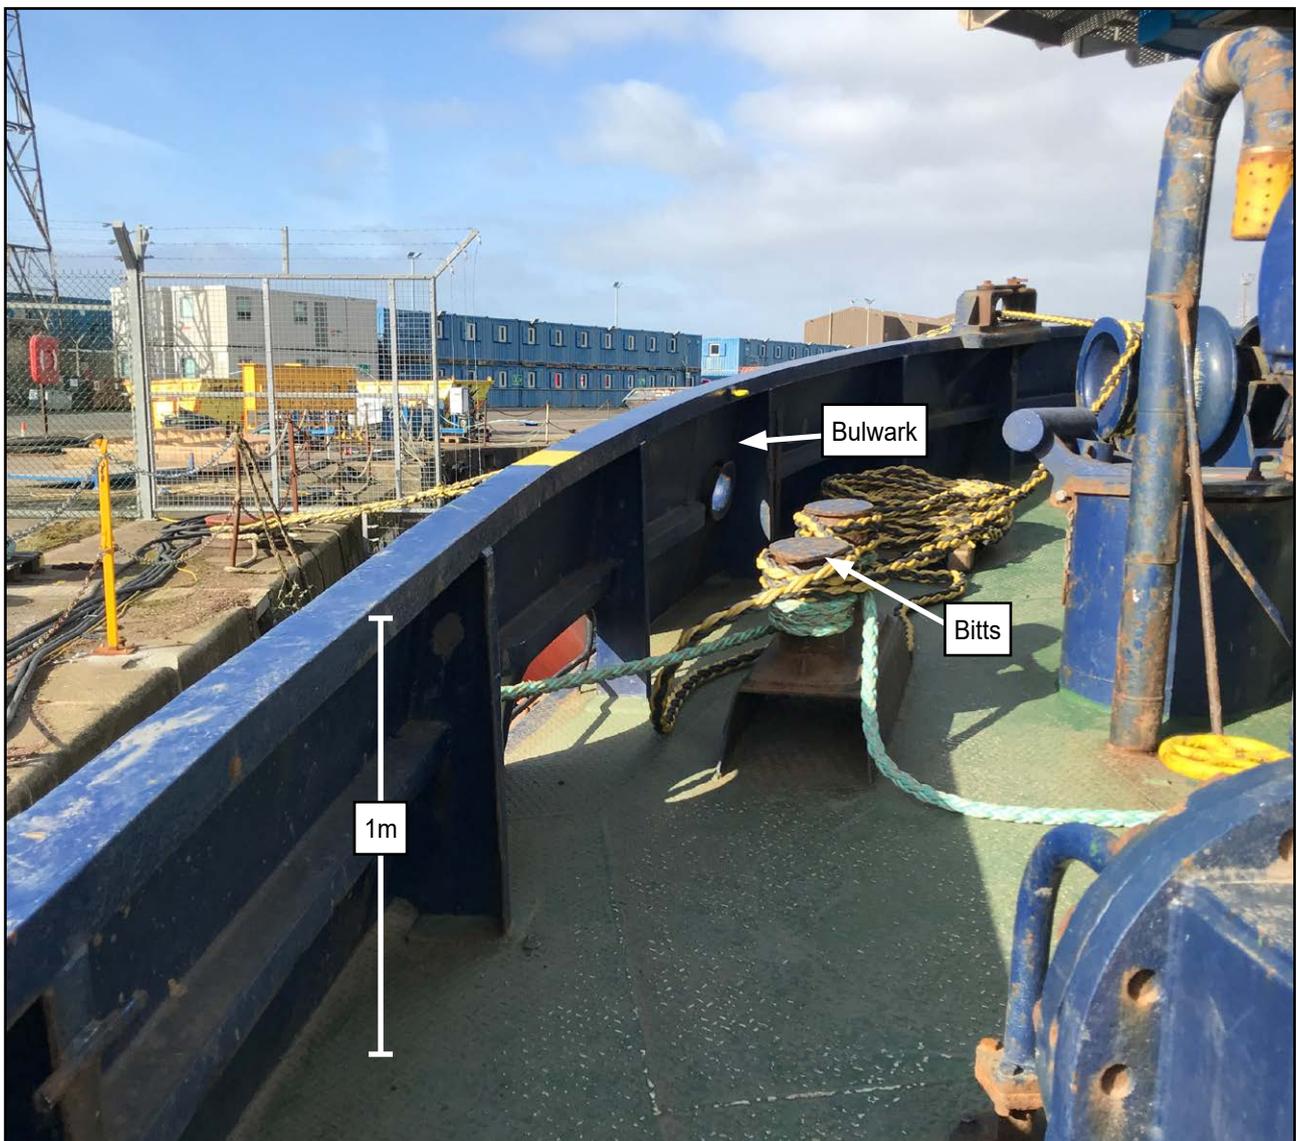
Figure 4: *Cherry Sand* fore deck bulwark and mooring bitts

Shortly afterwards, at 1551.25, the master, who was stationed at the port shoulder with an AB, stood on the mooring bitts⁴ (**Figure 4**) and looked towards the quay. After 7 seconds he stood back down. The chief officer had misjudged the approach, and at 1552 he brought the vessel to a stop in the water. The operations manager then took the con and started to give helm orders to the chief officer. Five seconds later the master briefly looked over the side, once again standing on the mooring bitts before stepping back down to the deck almost immediately. Using the VHF radio, the AB then reported to the bridge that the bow was 3 metres off the berth. The master was standing slightly forward of him but behind the mooring bitts on the port side. At 1552.08 *Cherry Sand* began to move astern as the chief officer realigned the vessel to make another approach. By 1552.30, *Cherry Sand* was again approaching the berth, and the master once again stood on the mooring bitts.

At 1553.02, the master stepped down from the bitts. Twenty three seconds later he stepped up on to the bitts, and at 1553.34 he climbed over the bulwark to stand on the vessel's rubbing band (**Figure 5**). He then stood with his back to the bulwark, facing the direction of travel, with his hands holding on to the bulwark.

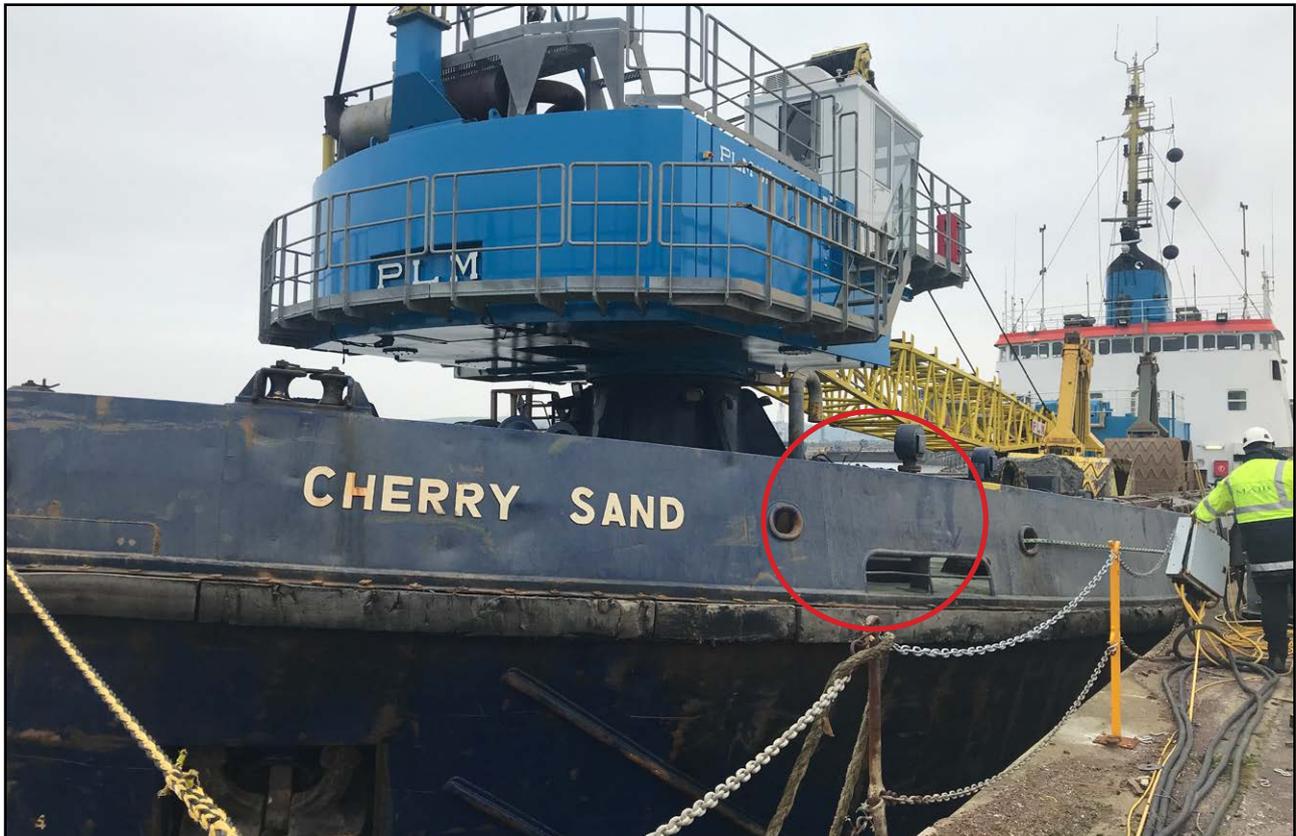
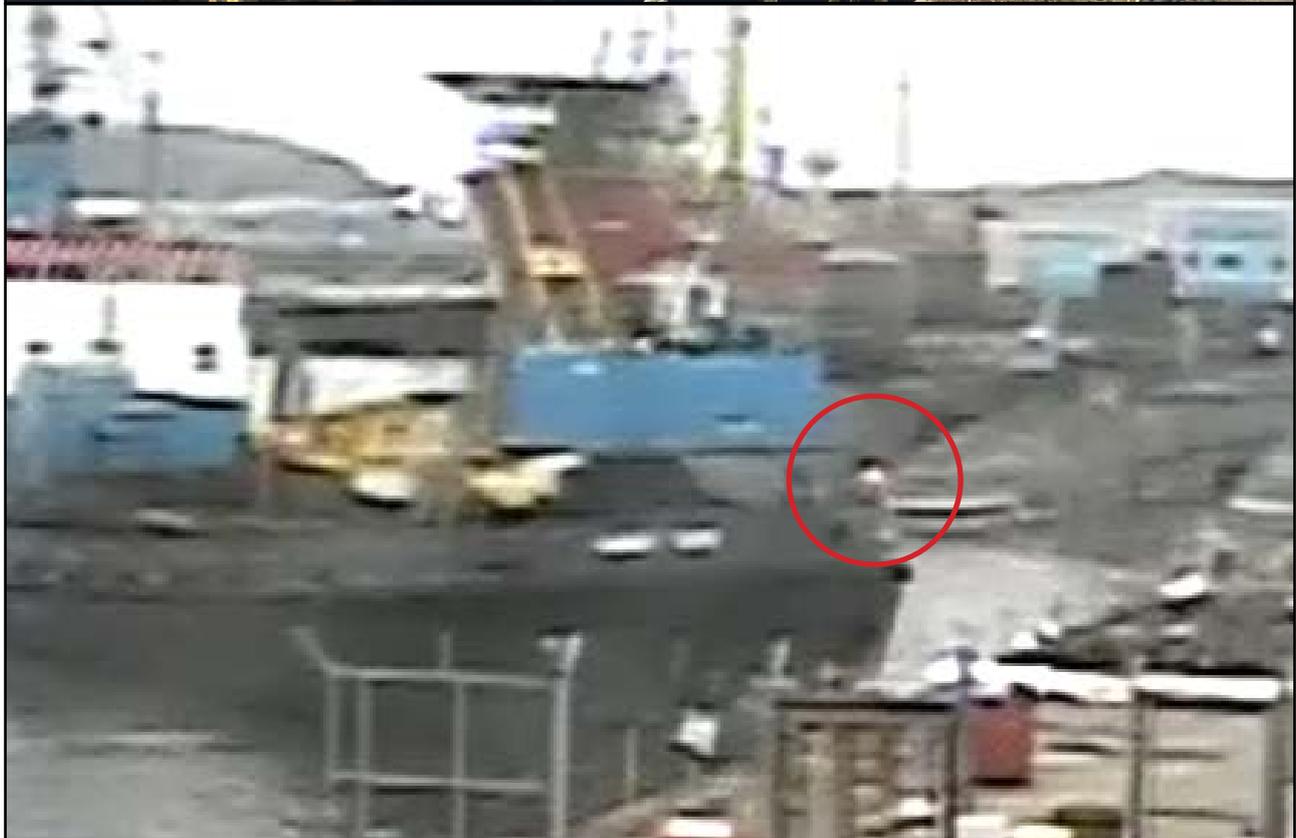
Figure 5: Master's location at the break of the forecastle

The operations manager attempted to call the master back in board using the VHF. The AB also advised him that it was too early to step outboard, but the master assured him that he would wait until the vessel was alongside before stepping ashore. By that time *Cherry Sand* was closer to the quay and closing the berth at a slow but steady pace. At 1554.08, some 33 seconds after he had climbed on to the rubbing band, the master held on to the bulwark with his right hand and extended his left leg towards the quay. One second later, as the master moved towards the quay, he fell. The master's foot missed the quay, and his torso hit the chains and quay edge (**Figure 6**) before he bounced between the dredger and the quayside and disappeared from sight.

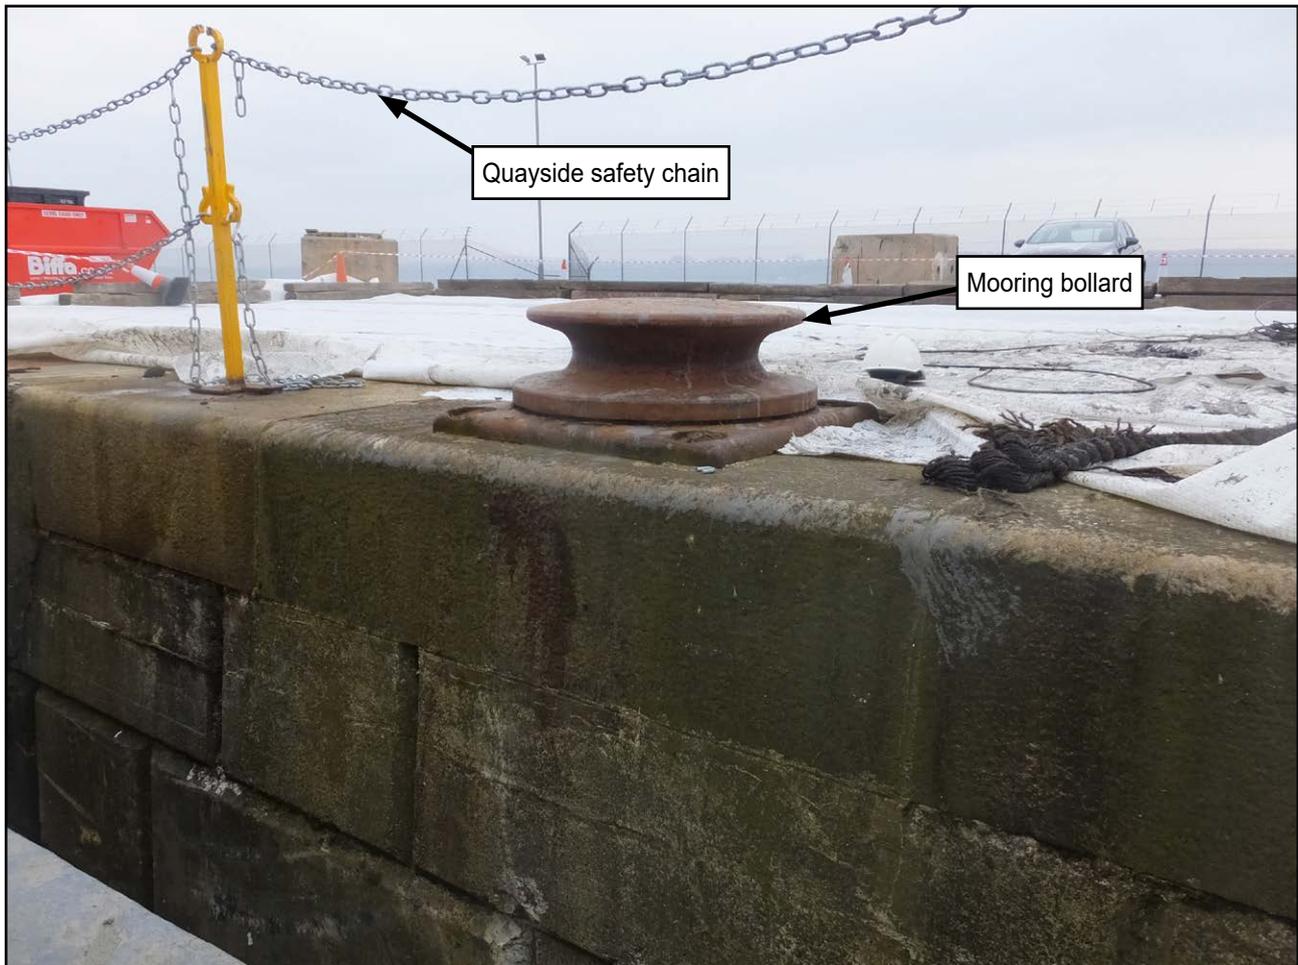
Figure 6: Quayside where the master was attempting to step ashore

It is possible that the master misjudged the distance to the quay. He required a prosthetic lens for his right eye, without which his depth/distance perception would have been negatively affected. The postmortem report makes no reference to the presence of the prosthetic lens in his right eye, but as the master's lens case was empty when found, and he might have lost the lens during the accident, there can be no certainty that he was not wearing it when he attempted to step ashore.

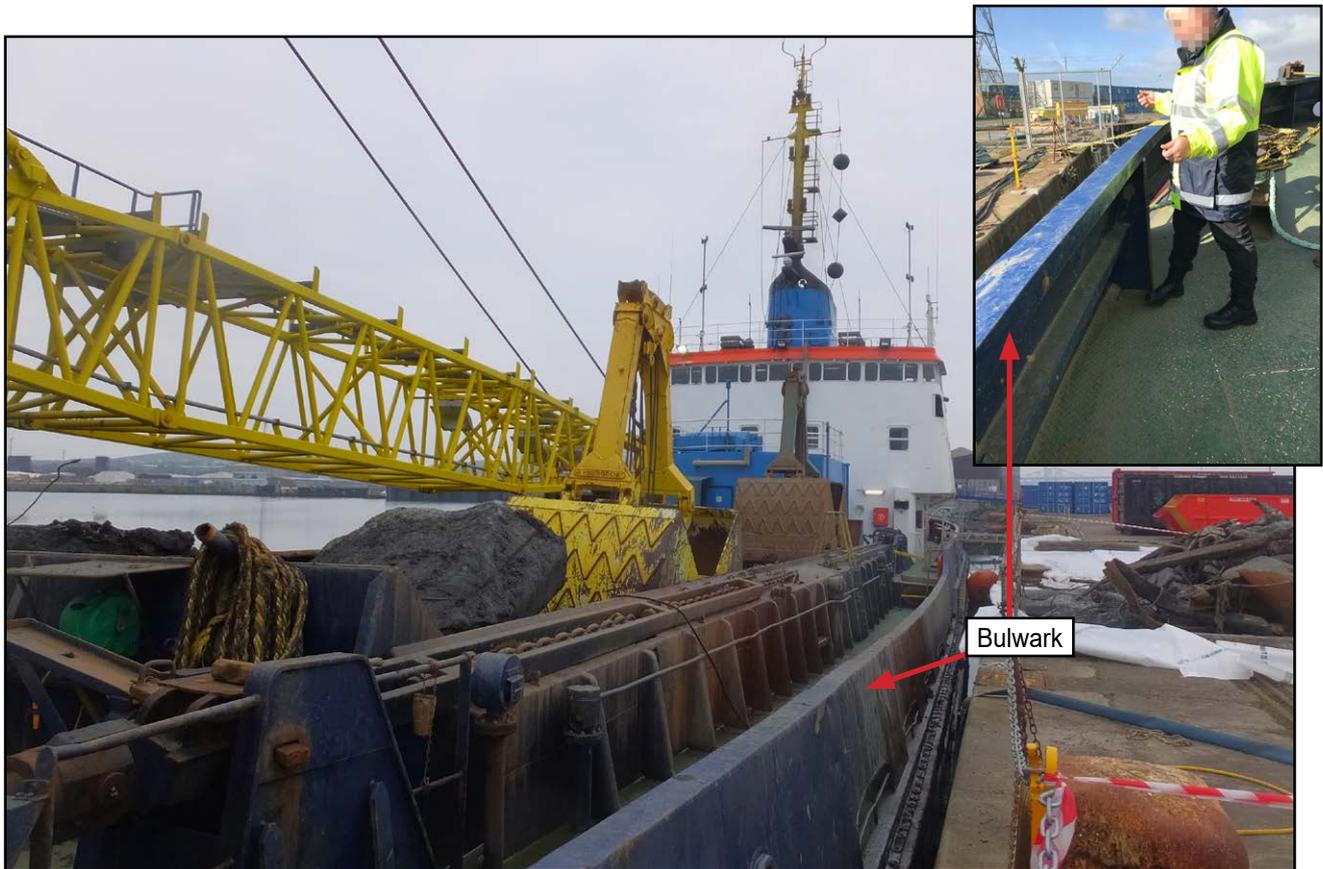
Figure 7: *Cherry Sand*'s bulwark

Cherry Sand had a 1 metre high solid steel bulwark (**Figure 7**), which encircled the freeboard deck. There were openings for the running of mooring lines and to allow water to run off the deck. There were no bulwark gates or identified boarding station.

6. *Cherry Sand* did not have any gates in the bulwarks nor any mechanism for safely crossing the bulwark. Once outboard, there were no suitable footplates that crew could stand on safely prior to stepping ashore. These were significant material deficiencies that should have been identified during risk assessment. [2.6.1]

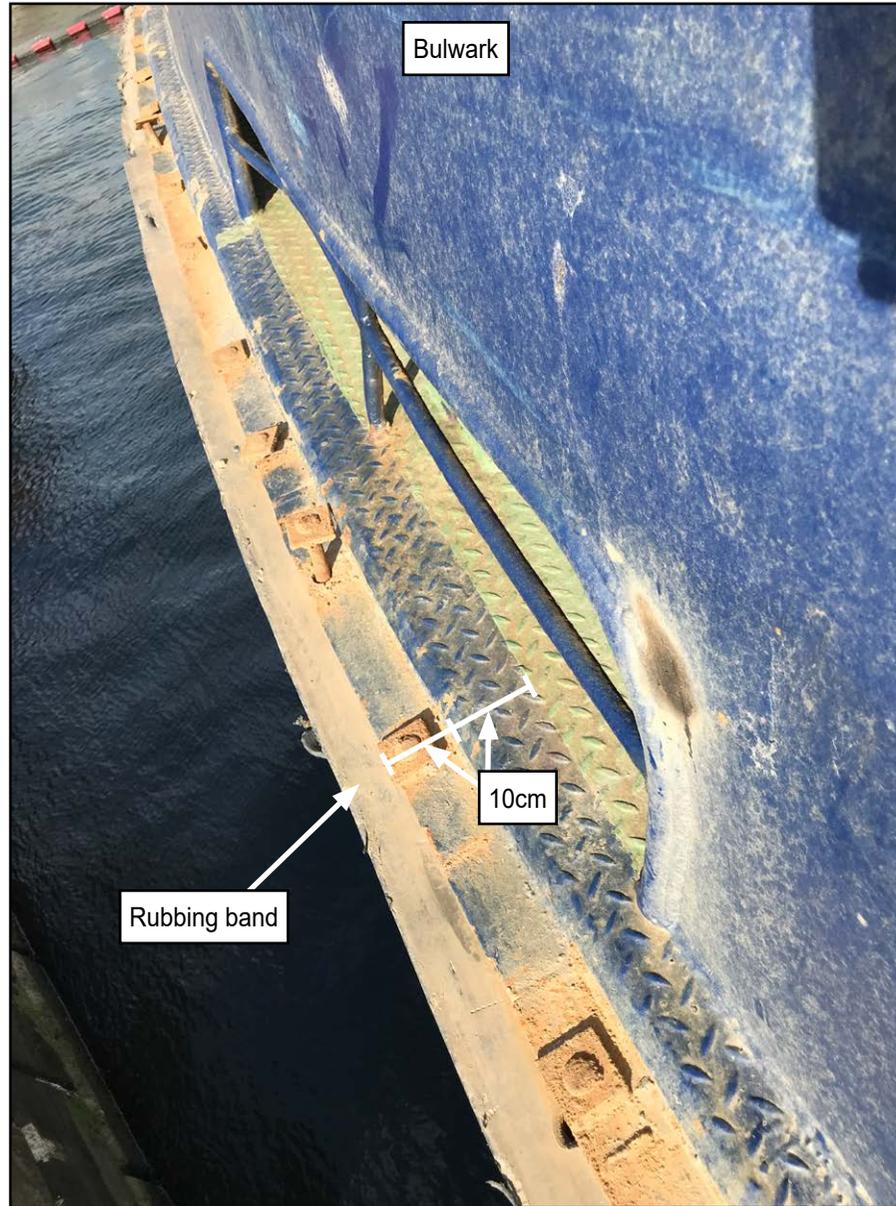
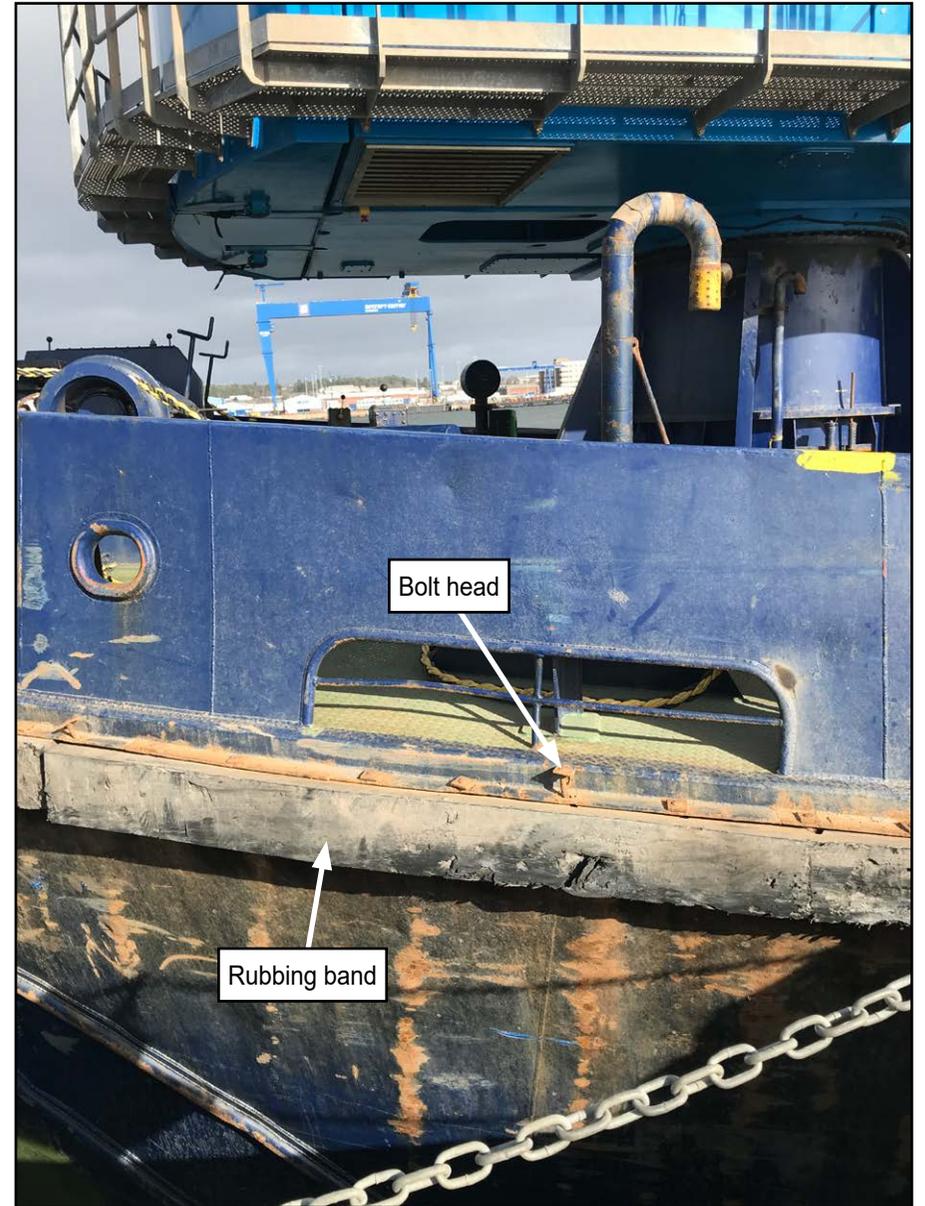
Figure 11: *Cherry Sand* fore deck bulwark and rubbing band

The rubbing band was not a safe place for crew to stand, nor was it a safe place from which to step ashore. The deck edge was narrow; the bolts holding the rubber banding to the securing flanges on the hull created an uneven surface and in some areas a trip hazard; the paint had no non-slip properties; and the entire rubbing band, including the rubber, was too narrow and uneven to create a safe platform on which to stand (**Figure 11**). Once on the rubbing band, there was no barrier to prevent a fall from height, and the task of stepping ashore precluded the crew from wearing either a fall restraint or fall arrest equipment.

were no suitable footplates that crew could stand on safely prior to stepping ashore. These were significant material deficiencies that should have been identified during risk assessment.
