2 Synopsys

On Sunday, November 10th 2019, around 15:30, the fv Z.15 – ZILVERMEEUW moored at Milford Docks, Wales, UK. An additional crewmember was to embark and the catch was to be landed. The crew also wanted to take advantage of the time in port to carry out some repairs to the fishing gear.

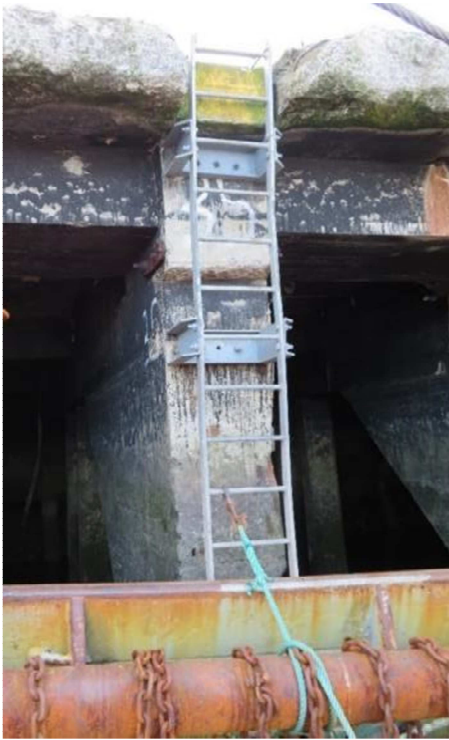
Figure 4 – Quay side ladder at the berth of fv Z.15 - ZILVERMEEUW

Even in ideal conditions, the quay side ladder was awkward to climb, and its design did not encourage use:

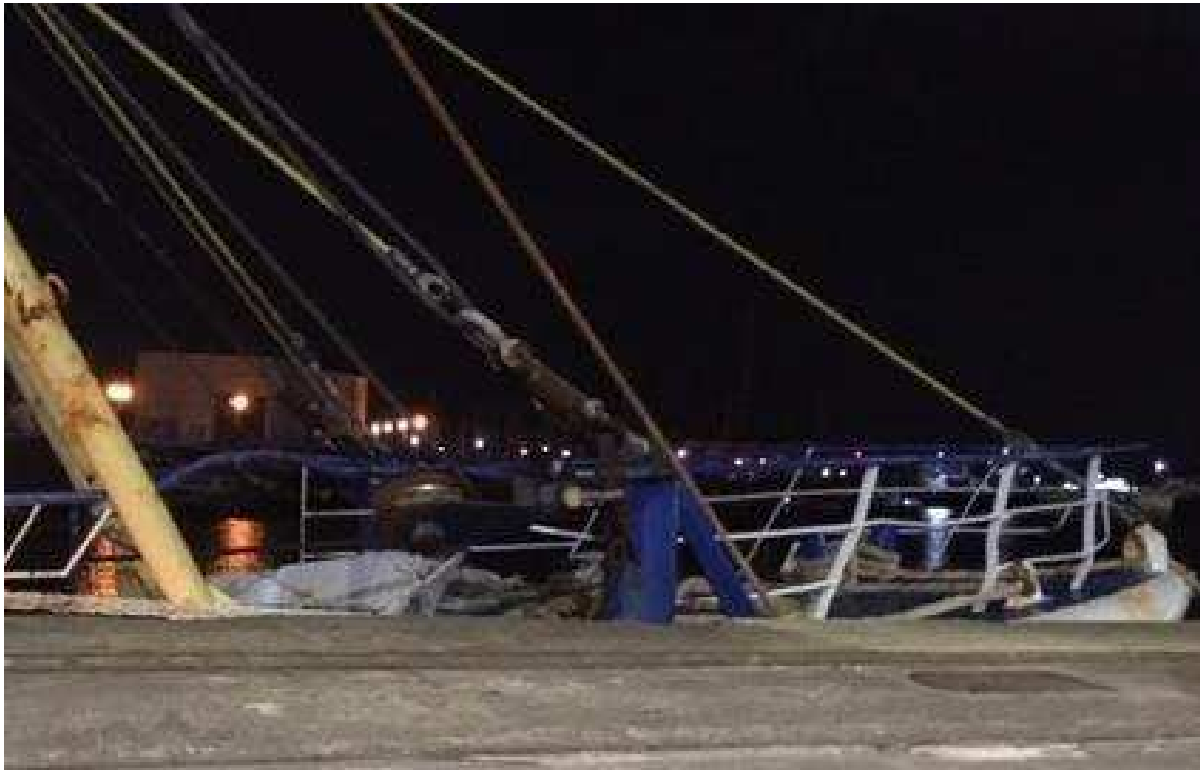
Figure 6 – Point of boarding at the forecastle

The second crewmember boarded via the forecastle immediately thereafter. The first one assisted him to get on board by lending him a hand. Once on board further assistance from the first crewmember was refused. The second crewmember was holding onto one of the wires of the mast when he was on board. He started stepping sideways on the small strip of the deck between the ship's side and the guardrail, subsequently slipped and fell into the water.

The absence of a safe access point to the vessel caused the fall into the water. Boarding at the forecastle was considered safer/more comfortable than boarding by the quay side ladder at low tide and considering the distance between jetty and vessel.

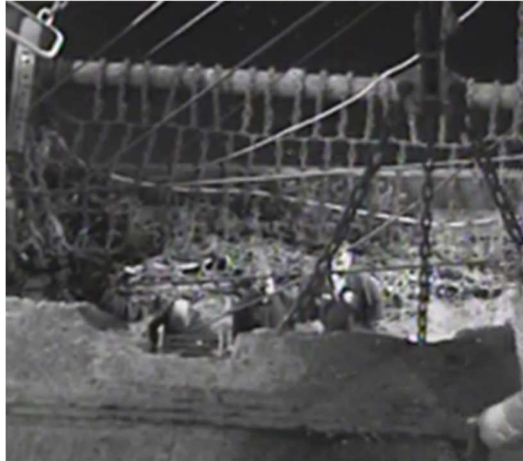
Figure 9 - Chains of fishing gear obstructing quay side ladder (1)

- Fishing gear obstructed easy access, as well as from the jetty (chains) as from deck (see
- Figure 9, Figure 10 and
- Figure 11).
- The distance to the ladder increased when the mooring lines were slack, a rope attached to the ladder could (partly) prevent this (see
- Figure 11).

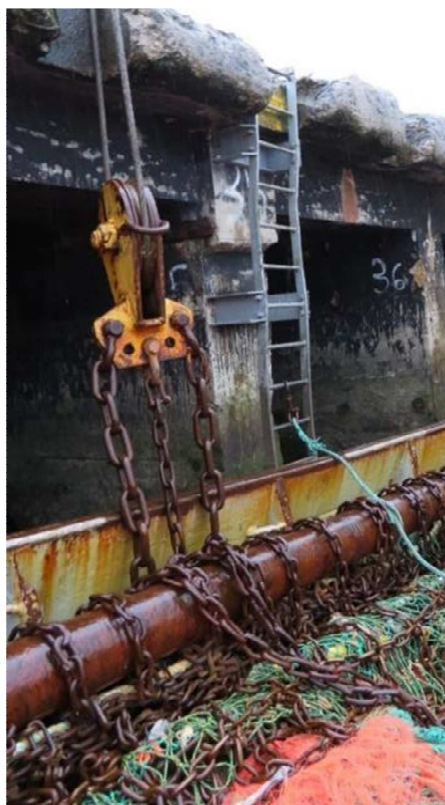
Figure 11 - View from vessel to quay side ladder

The rope had been attached to the quay side ladder after the accident

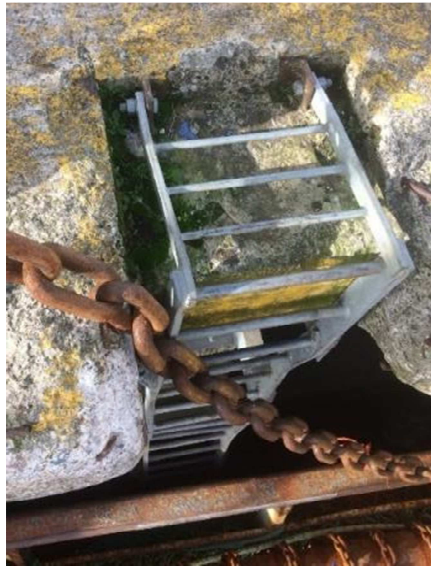
Figure 12 - Quay side ladder - no handles on top

- No handles were in place at the jetty to get on the ladder. One had to crawl on his or knees to get one's feet and hands on the supports, see Figure 12. This design allowed hand grip when climbing up the ladder and also allowed mooring ropes to pass over without catching hold of any part of the ladder.

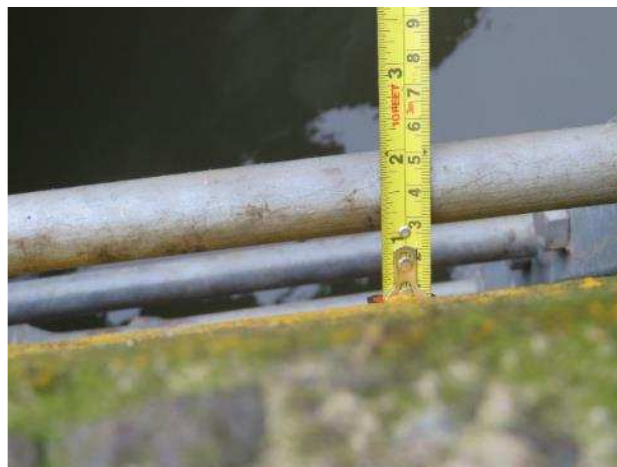
Figure 13 - Quay side ladder detail - Distance between concrete and supports

- At the top of the ladder, there was limited space between the supports and the concrete of the jetty. Only the tip of a shoe could rest on the rungs of the ladder, see

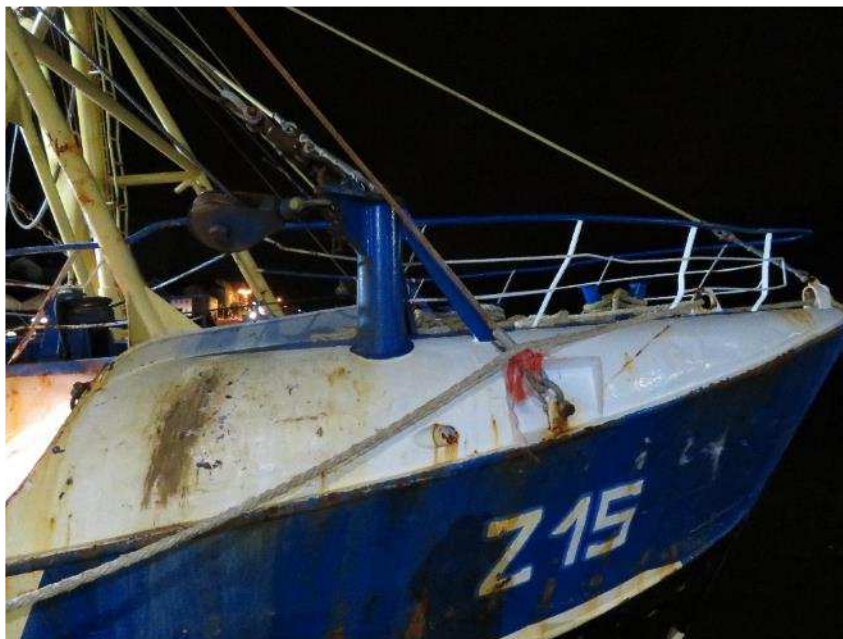
Figure 14 - Shape of the forecastle

- The ship's side curved inwards at the forecastle. There was some obstruction by wires and a blue post. Only when the vessel's head touched the quay under a certain angle,

was it possible to step on board in front of the blue post, on the small strip of the deck outside of the guardrails.

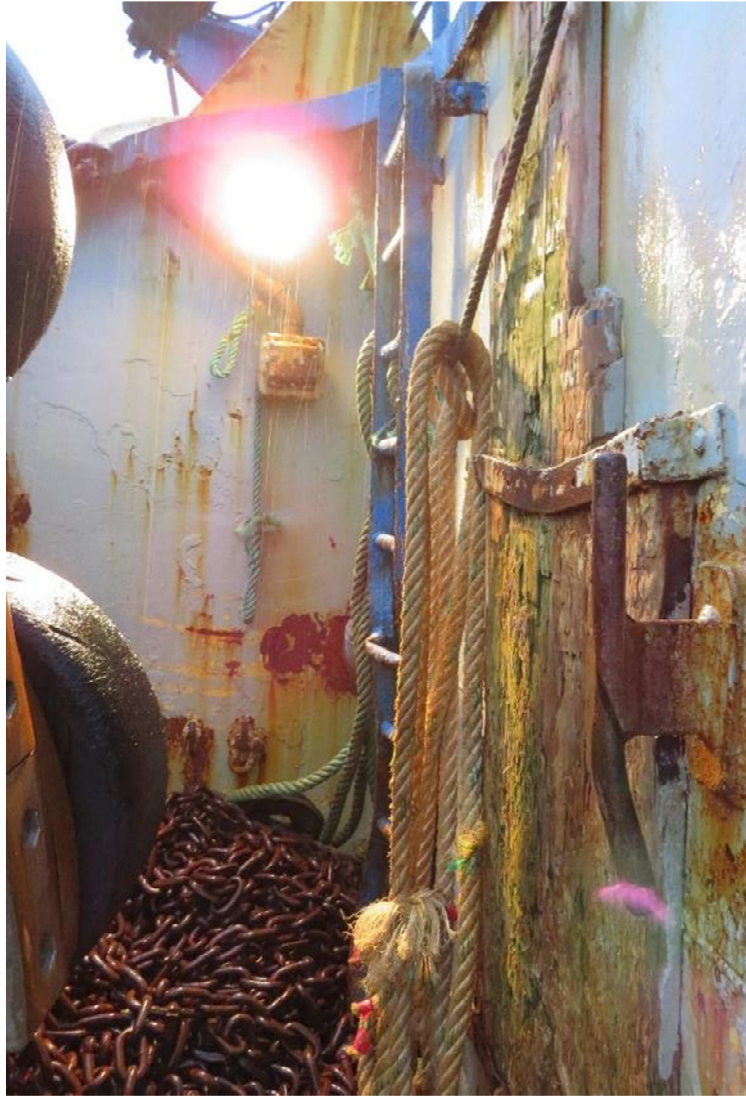
Figure 15 - Access ladder to forecastle

- Once on board, one could stand on a small strip of deck, but it was still required to climb over the guardrail
- From the forecastle, a small ladder gave access to the deck below. This passage was obstructed by fishing gear
