SAFETY INVESTIGATION REPORT

REPORT NO.: 14/2020

May 2020

MV LEOPOLD STAFF **Damage to equipment leading to the inadvertent release of the FFLB in position 15° 59' S 019° 18' W** **25 May 2019**

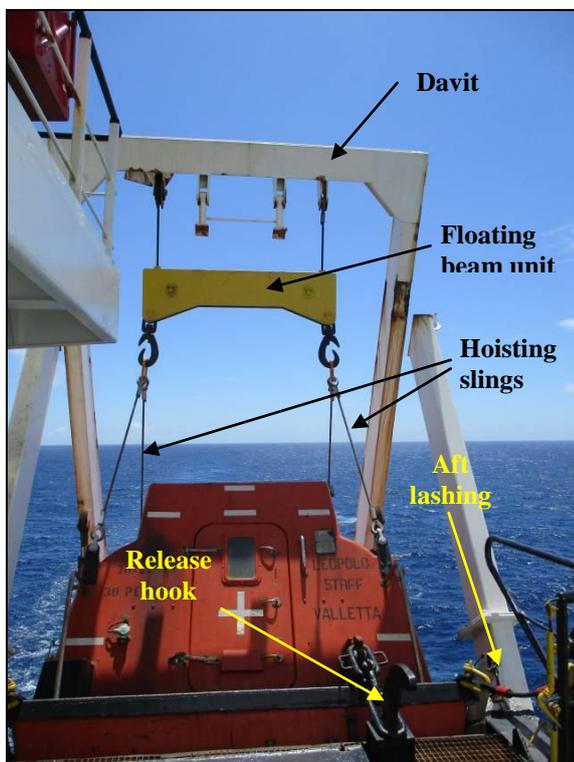
At 1030 before starting the maintenance works, the chief officer, the third officer and the bosun carried out a visual check on all the lashing arrangements and hoisting wires and found them in good condition. The chief officer asked the bosun to start the davit winch, to enable them to lower the floating beam unit and connect the hoisting slings to the lifeboat (Figure 1).

Figure 1: FFLB as seen from its stern

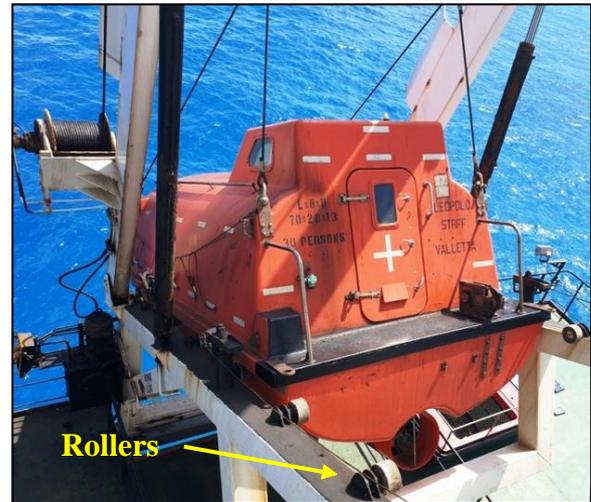
The chief officer instructed the bosun to lower the lifeboat back on the ramp and slide it down, to allow for maintenance works on the rollers. The bosun lowered the lifeboat to a distance of about two metres (Figure 2). As soon as the bosun stopped lowering, it was observed that the hoisting slings were slipping from their ferrule, one by one. In that moment, the floating beam unit recoiled and, at around 1040, the lifeboat slid down to the water.

Figure 2: Position of lifeboat when the hoisting slings started to slip

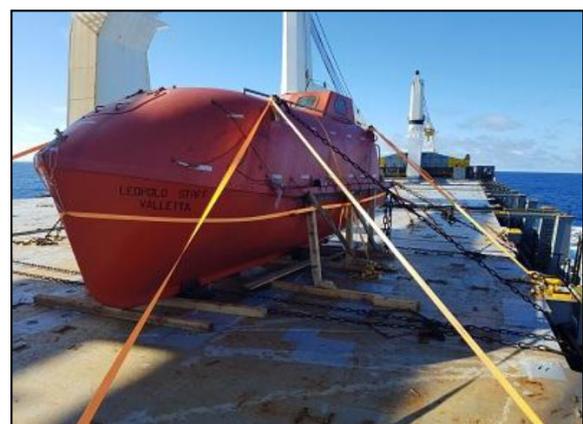
Due to the three metre swell that was rolling the vessel slightly and due to the absence of sound hoisting slings on board, the master assessed that the recovery of the lifeboat by using the lifeboat's davit, was dangerous². In view of the situation, he decided to secure the lifeboat on deck by the use of the vessel's cargo crane (Figure 3).

Figure 3: FFLB secured on deck

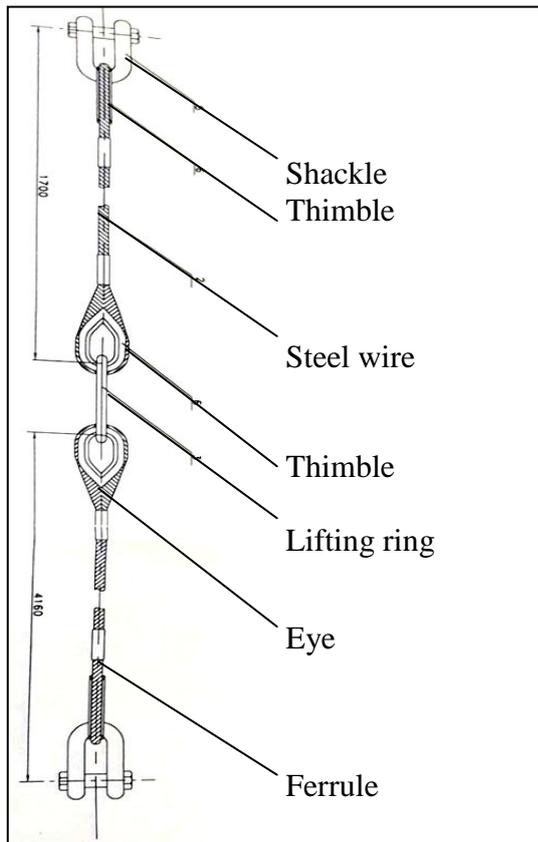
The hoisting slings consisted of two sets, each made up of two steel wires of different lengths, ending with hard eyes (Figure 4). The two steel wires were connected by a lifting ring. Each set of hoisting slings had a shackle on each end – one connected to the fore part of the lifeboat and the other to the aft part (Figure 1).

The steel wires were galvanised, had a rope construction of 18*7 with a steel core, and were of 16 mm diameter. The Minimum Breaking Load (MBL) of the steel wire was indicated to be 165 KN³. A pair of this assembly was connected on both port and starboard sides of the lifeboat, for hoisting.

Figure 4: Assembly of hoisting slings

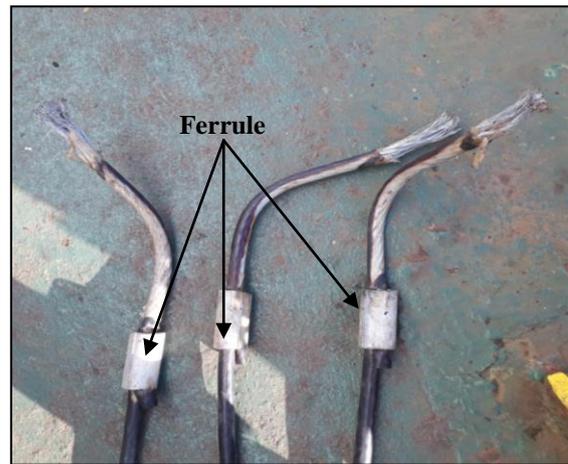
No damages to the FFLB were noticed following this occurrence. However, all four hoisting slings were found to be damaged in the same manner. The steel wires, which were turned in on themselves to form an eye and then clamped with a ferrule, had slipped from their ferrule (Figures 5 & 6).

Figure 5: Showing three of four damaged hoisting slings that were connected on the FFLB

Evidence suggested that the steel wire had slipped from the ferrule. This further suggested that the ferrules and the steel wires passing through them were not fused together. The MSIU believes that this could have occurred due to:

- inadequate pressure applied during swaging; and/or
- the presence of sheathing inside the ferrule.

After this occurrence, the Company decided to henceforth procure from one specialized service provider hoisting slings that conform to design requirements and additionally to a recognised international standard.

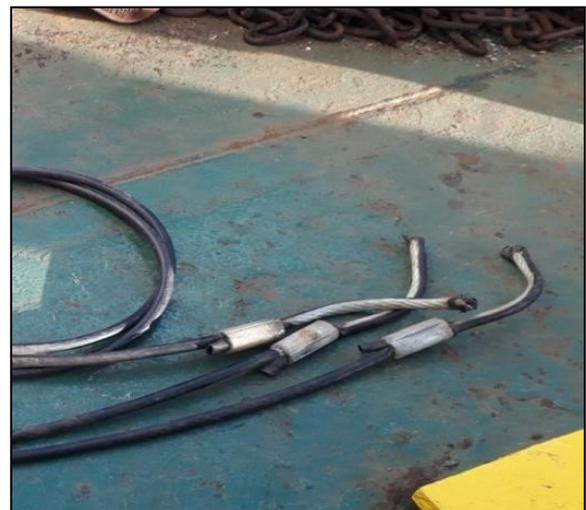
Figure 6: Showing three of four damaged hoisting slings that were connected to the floating beam unit

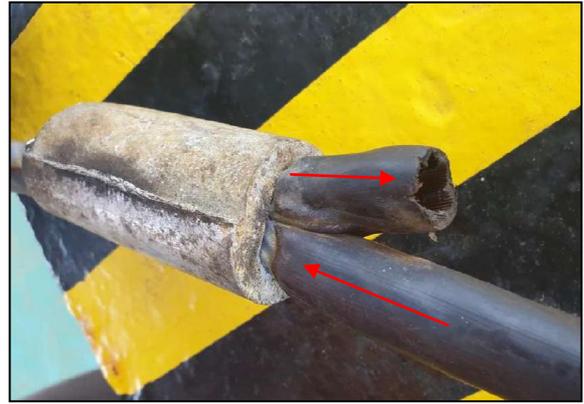
The hoisting slings were completely covered with PVC sheathing. This sheathing was also found to be covering the section of steel wire forming the eye and passing through the ferrule (Figure 7).

Figure 7: Sheathing passed through the ferrule in both directions

European Standard EN 13411-3+A1:2008 – “Terminations for steel wire ropes: Safety. Ferrules and ferrule-securing” specifies that if a rope end is to be pressed within the ferrule, the serving shall consist of only a strand or wire.

During the course of the safety investigation, the Company requested all vessels in the fleet to verify that the composition of the hoisting slings did not clamp any insulation material into the ferrule. Furthermore, the Company requested the vessels to check the conditions of the swaging of the hoisting slings. The Company also reminded the fleet of the importance of carrying out maintenance on the slings and the safety concerning all operations involving davits / lifting slings of life boats, rescue boats and liferafts.

14/2020_R1 Publish an information notice, highlighting the dangers of sheathed steel wires on board ships due to restricted access to the wire rope for a thorough inspection;
