National Transportation Safety Board

Marine Accident Brief

Contact of *Mary Lucy Lane* Tow with Markland Locks and Workboat *Gibson*

Accident type	Contact	No. DCA19PM011
Vessel names	Towing vessel <i>Mary Lucy Lane</i> and workboat <i>Gibson</i>	
Location	Ohio River, mile 531.5, Markland Locks & Dam, Warsaw, Kentucky (about 30 miles southwest of Cincinnati, Ohio) 38°46.44' N, 084°57.34' W	
Date	December 18, 2018	
Time	1555 eastern standard time (coordinated universal time – 5 hours)	
Injuries	0	
Property damage	\$2.1 million est.	
Environmental damage	None	
Weather	Visibility 10 miles, sunny skies, south winds at 8 mph, air temperature 52°F, water temperature 45°F	
Waterway information	The navigable Ohio River is 981 miles long, starting at mile 0 in Pittsburgh, Pennsylvania, and ending at mile 981 in Cairo, Illinois, where it flows into the Upper Mississippi River. ¹ The Markland Locks & Dam has an upper pool and a lower pool used to maintain the navigable channel.

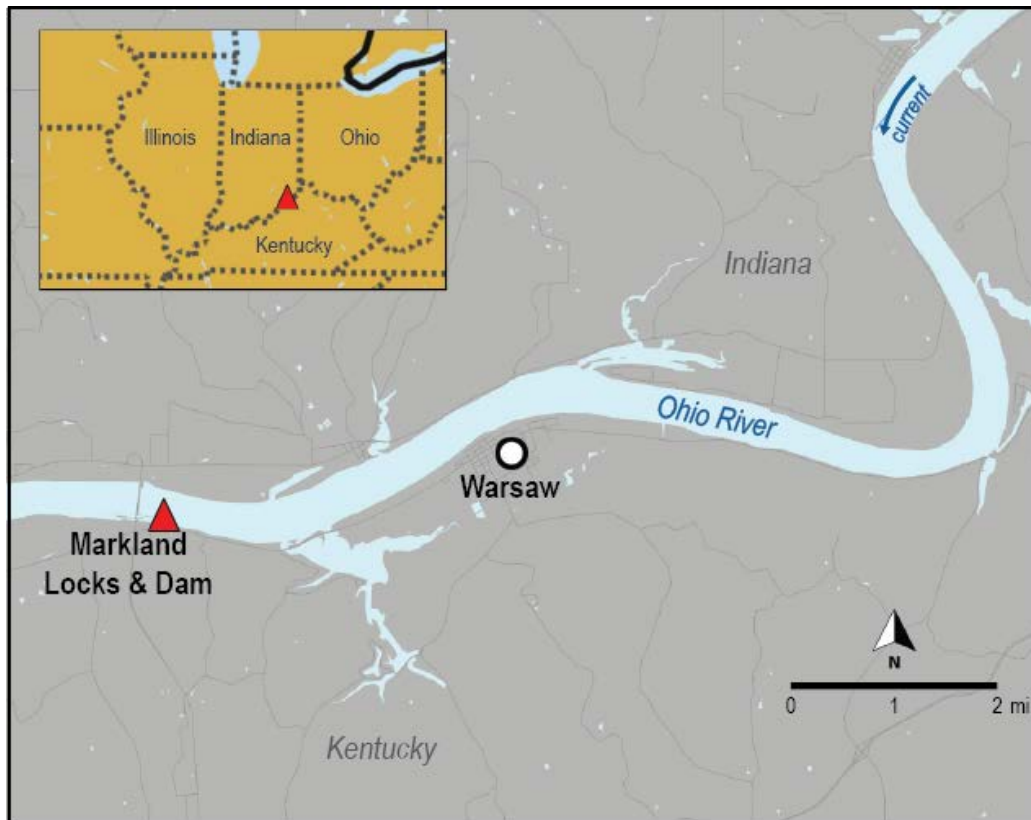
Area where the *Mary Lucy Lane* contacted the Markland L&D and the Corps of Engineers workboat *Gibson*. The site of the accident is marked by a red triangle. (Background Source: Google Earth)

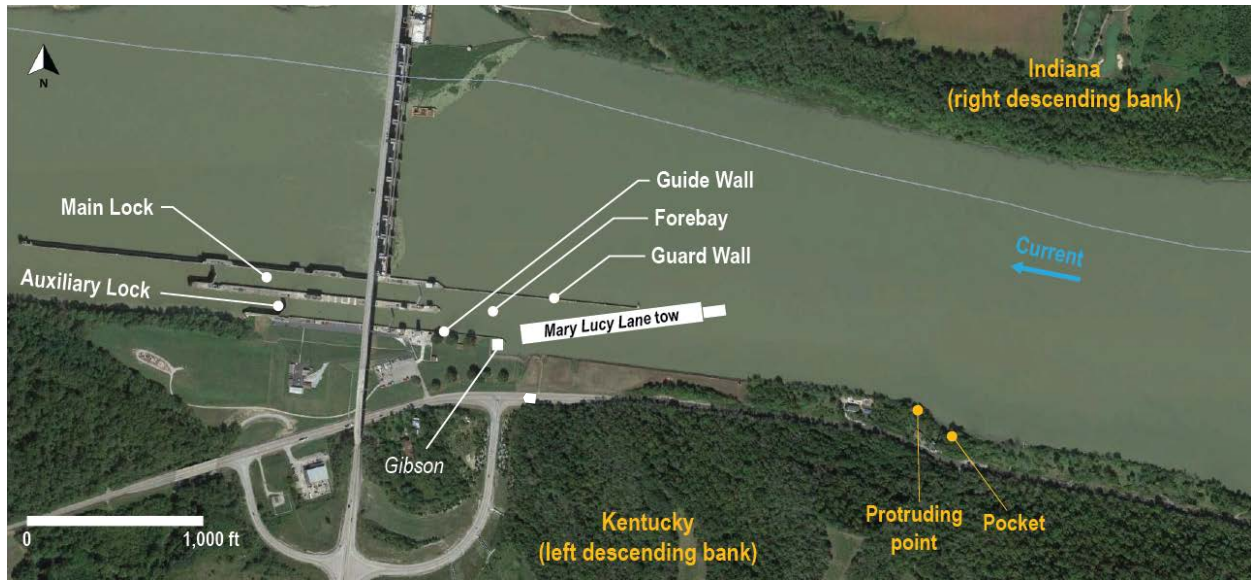
wires.⁷ The pilot applied full-ahead on both engines to move the rest of the tow into the forebay and away from potentially being swept into the dam gates. As the end of the tow was about to clear the guard wall, the pilot reversed propulsion to full astern. Despite this, at 1542:25, the center string's lead barge, *WCAO 116*, struck the protective bullnose on the shoreside guide wall, and a large chunk of concrete broke off in the collision. The guide wall stopped all forward motion of the center string and the *Mary Lucy Lane*; however, the towing wires on the portside string parted, and the four portside barges continued forward into the sheltered area behind the guide wall where the *Gibson* was moored. At 1542:36, the lead port barge *ART 36109* struck the *Gibson*'s stern.

Approximate positions of the *Mary Lucy Lane* tow and the workboat *Gibson* about 1555, when the tow contacted the guard wall. (Background source: Google Earth)

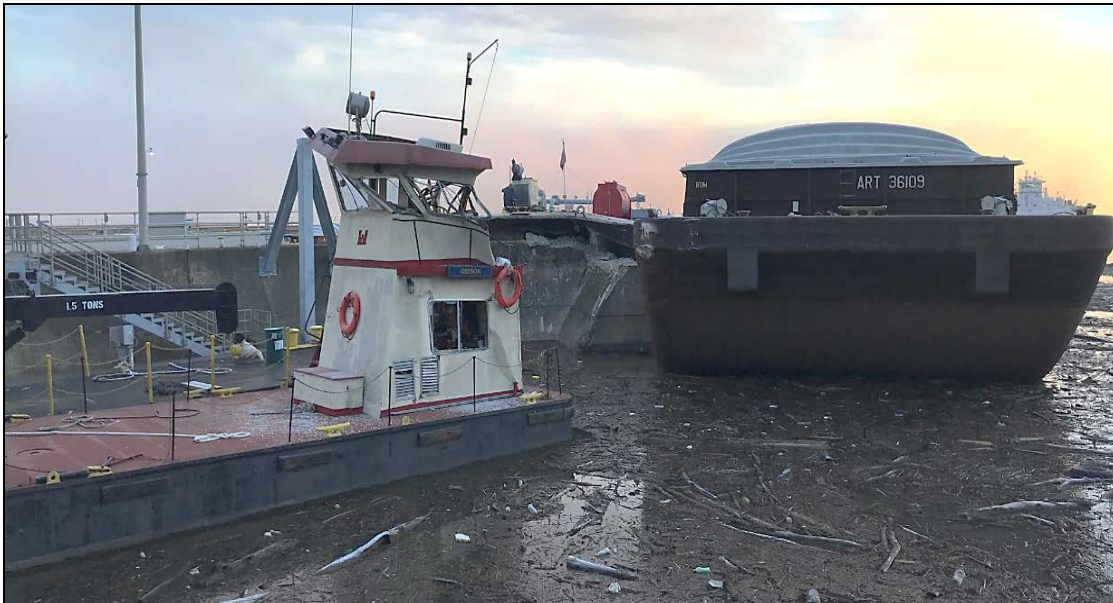
Damage. A damage survey of the *Mary Lucy Lane* and its tow was conducted on December 20, 2018. Four of the vessel's winches were damaged, and the starboard string of barges that struck the guard wall's protective bullnose—the *CBC92*, *CBC1341*, and the *CS1319*—had minor scraping damage.⁸ The *ART 36109*, which struck the *Gibson*, had estimated damages of \$6,500. The *WCAO 116*, which was impaled on the guide wall bullnose, sustained a 5-foot-wide-by-10-foot-high hole in the bow rake.

The guide wall's bullnose armor steel plate edge broke off, and the underlying 17-foot-long-by-24-feet-thick concrete was damaged up to a depth of 6 inches. A 2-foot-thick-by-5-foot-long section of the concrete cap of the wall extending shoreward broke off and fell into the harbor pool. The *Gibson's* pilothouse and deckhouse were crushed, and portions of the aft deck were buckled by the impact with the *ART 36109*; the Corps of Engineers estimated the cost to replace the *Gibson* at \$1.8 million. The total estimated damages for the *Mary Lucy Lane*, the barges, and the dam were \$321,943.

The *Gibson* and barge *ART 36109* three days after the accident. (Source: Coast Guard)
