SAFETY INVESTIGATION REPORT

REPORT NO.: 11/2020

May 2020

MT ALYARMOUK **Damage to equipment, leading to a fall from a height on deck,** **in position 06° 20' N 079° 34' W** **10 May 2019**

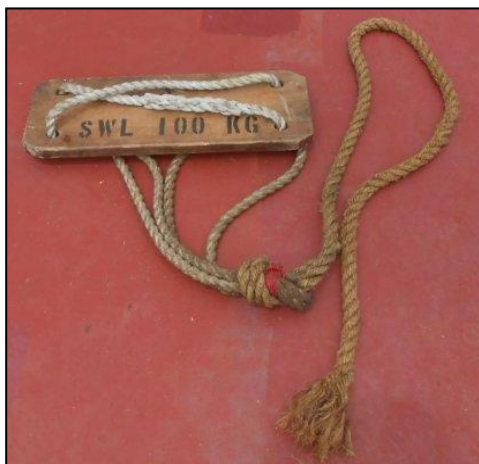
Figure 2: The bosun's chair

The bosun's chair was marked with a safe working load (SWL) of 100 kg (Figure 2); however, there was no evidence available to the safety investigation which could help indicate how this SWL had been determined.

The rope and the bosun's chair were subjected to a load test of 250 kg, although the certified strength of the rope was not known and the SWL of the bosun's chair was identified at 100 kg. Although this test (250%) had no direct bearing on this accident, the safety investigation believes that unless the minimum breaking strength and the safe working load of the rope and the bosun's chair are known, overloading during such tests may occur, potentially weakening and damaging the equipment.

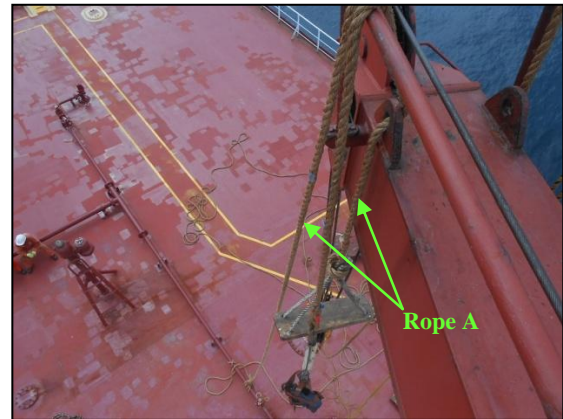
Figure 4: Simulation of rigging arrangement for the bosun's chair

The ropes used were manila (natural fibre). The equipment was rigged by passing rope 'A' over the lower course of the guard rails, which were fixed to the jib of the crane, through a pad eye on the jib and tied to the bosun's chair (Figure 4).

The point of failure of the rope was found to lie in the vicinity of the pad eye of crane jib through which the rope was passed to carry out the task (Figure 4).

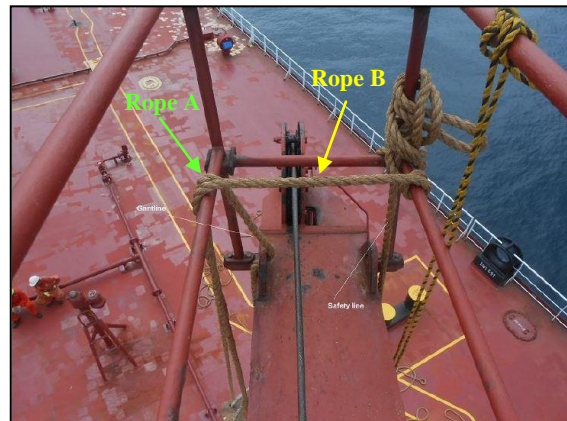
Figure 5: Simulation of rigging arrangement for the safety harness (the yellow-black line was used to hoist/lower tools for the task).

For the safety harness, rope 'B' was passed over the opposite guard rails and then over the same lower course of the guard rails as rope 'A'. As an additional precaution, rope 'B' was secured onto the opposite guard rail (Figure 5).

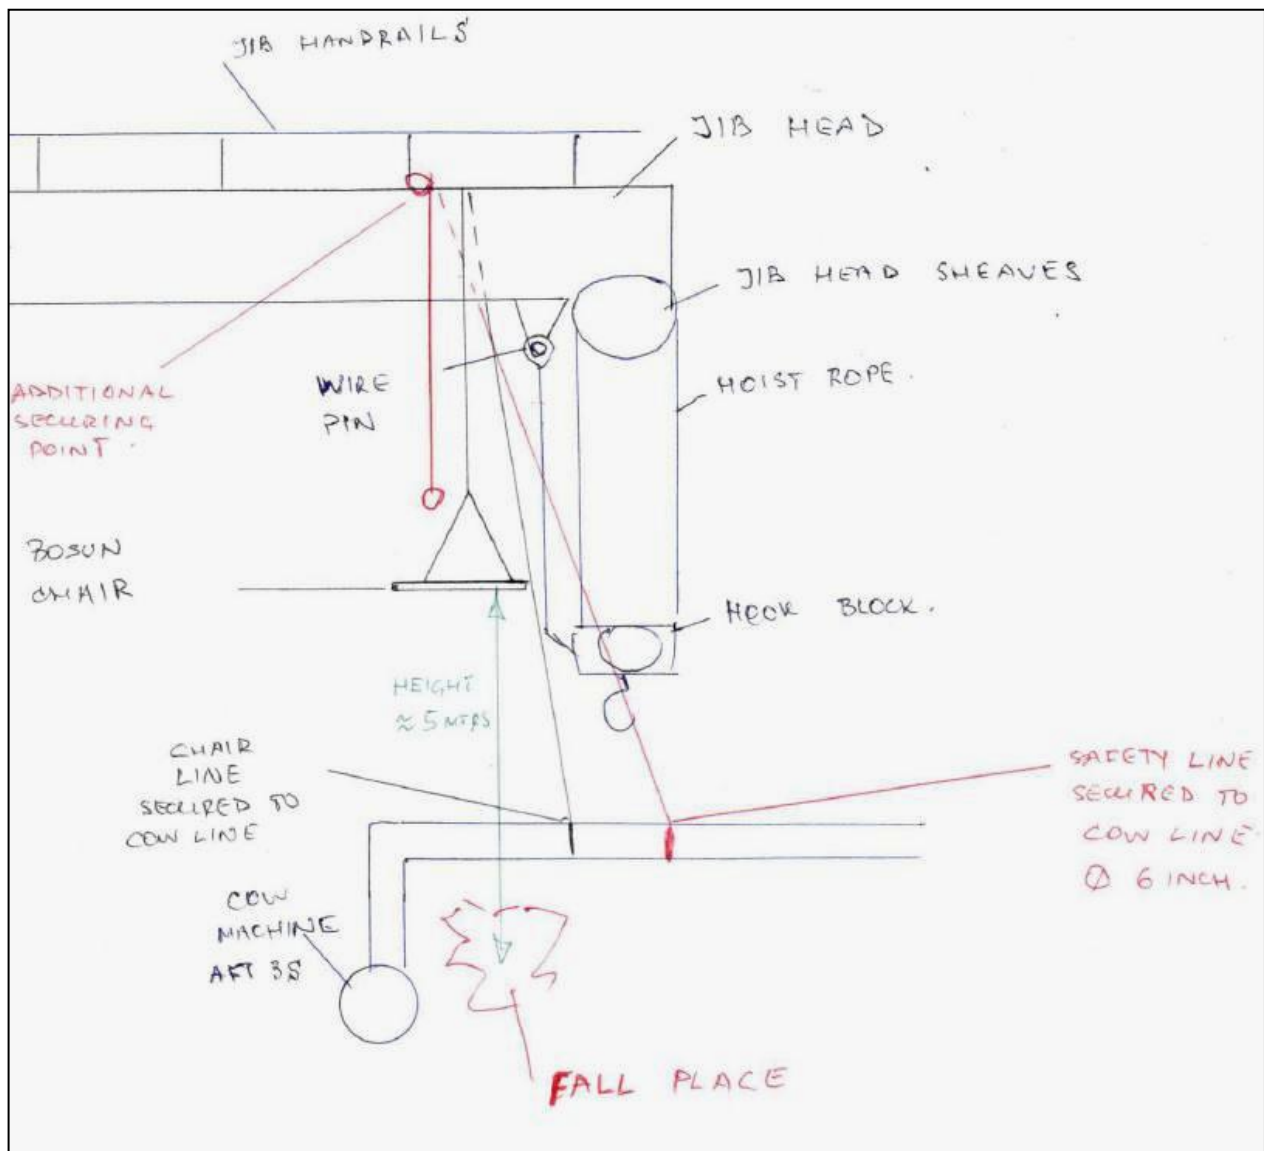
Figure 6: Rough sketch, showing the entire bosun chair's arrangement

The free ends of ropes A and B were secured to a crude oil washing (COW) branch line of the vessel, which ran on the main deck, as seen in Figure 6.

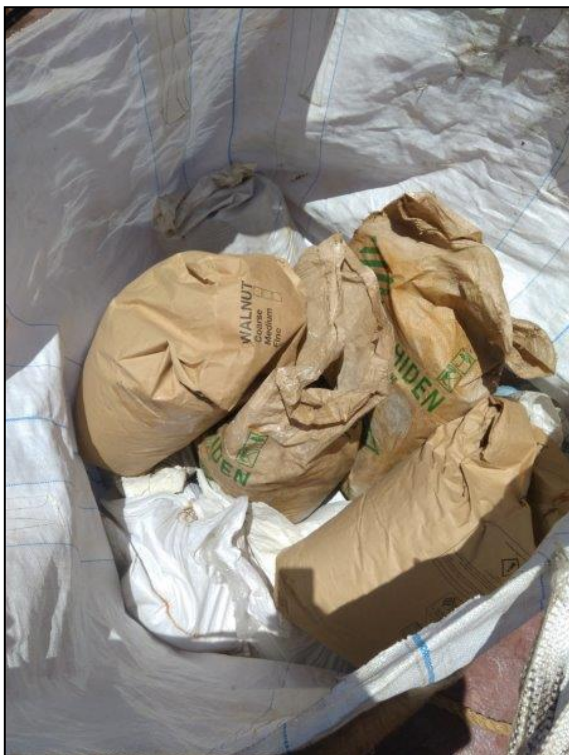
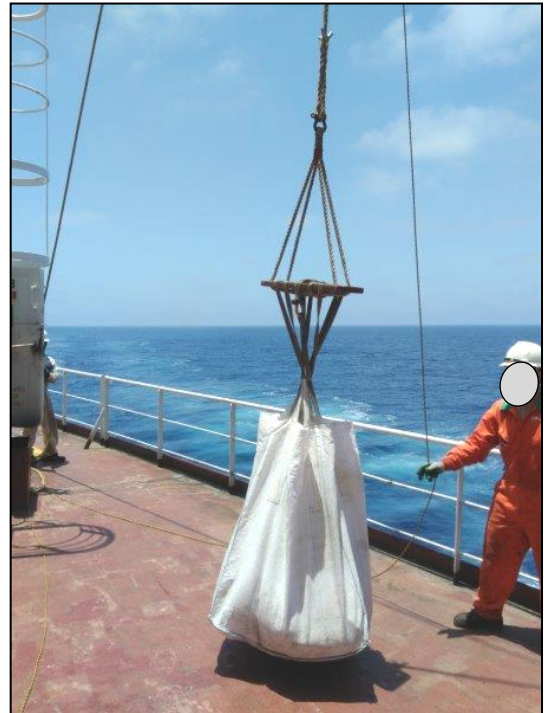
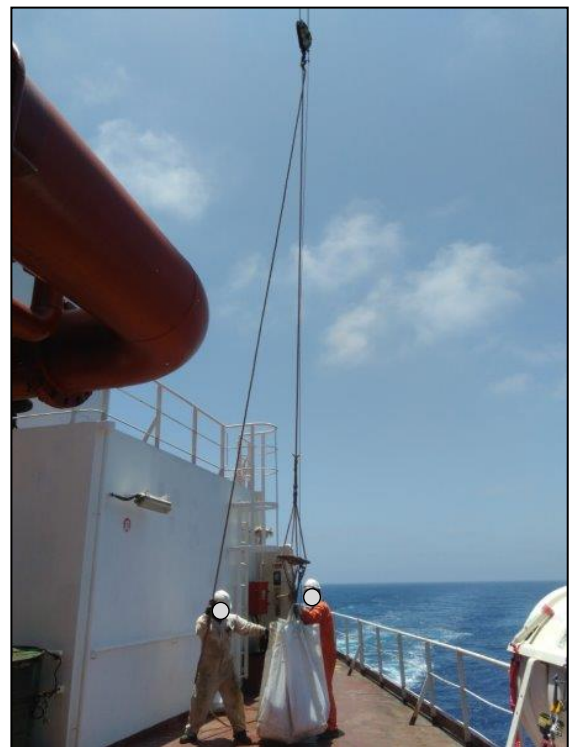
Prior to being used for the task, on the same day, the bosun's chair and ropes 'A' and 'B' were reportedly tested by suspending a load of 250 kg from the rigging equipment, for a period of 10 minutes. Bags of cement, weighing 50 kg each, were used as the load (Figures 7, 8 and 9).

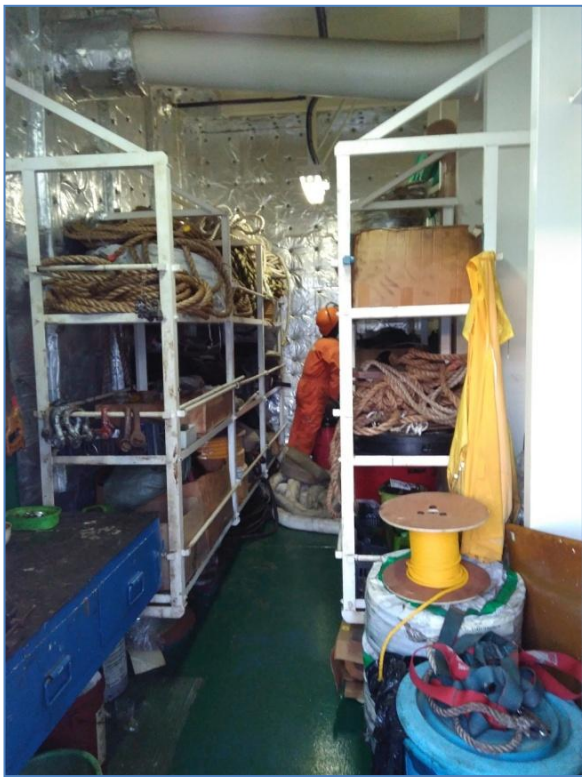
Figure 10: Storage space of the ropes

It was reported that the ropes in use at the time of this accident, were stored on racks in one of the vessel’s stores (Figure 10).

Evidence available to the safety investigation did not suggest that the location and method of storage of the ropes had a direct bearing on this accident.

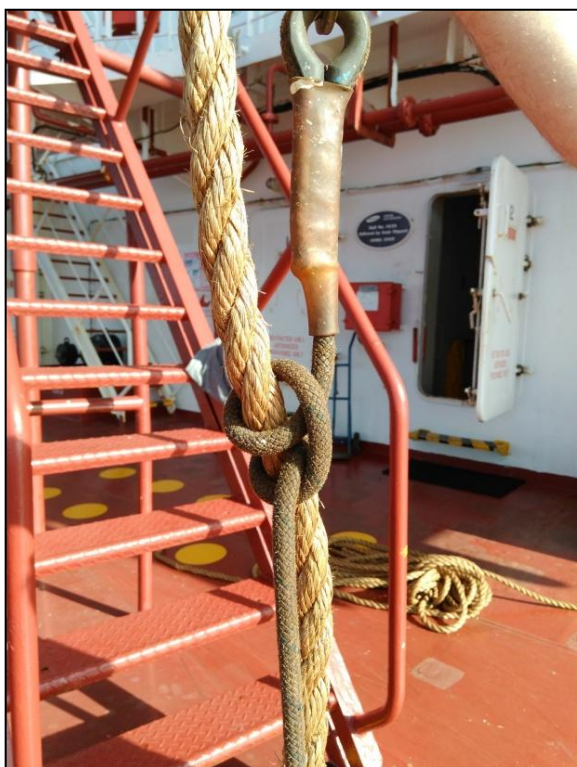
Figure 13: Simulation of safety harness secured to rope B during lowering.

The bosun released the safety harness from rope 'B', following which, the end of rope 'B' was lowered to the main deck. The bosun tied a clove hitch around a point along the length of rope 'B' (Figure 13), and the able seafarer and the ordinary seamen, who were positioned on the main deck, then started to slowly lower the bosun's chair.

Furthermore, the bosun had re-secured the safety harness to rope B using a clove hitch, before the bosun's chair was lowered. The securing knot slid along the length of rope B and did not arrest his fall.

A clove hitch is a common, easy-to-tie (and untie) knot used to secure a rope to a horizontal pole or a ring. However, as it would tend to slip, especially when repeatedly subjected to varying levels of load, this knot is not recommended to be used on its own. Moreover, when secured to a vertical pole or along a freely hanging rope, it will have a tendency to slide down the surface in the absence of any tension on it.

The safety investigation believes that a clove hitch was chosen by the crew members as it would tend to slide down easily along the length of the rope while the bosun's chair was being lowered, thereby removing the requirement for rope B to be tended to. Evidence suggested that the bosun expected the clove hitch would have been sufficient to arrest a fall.

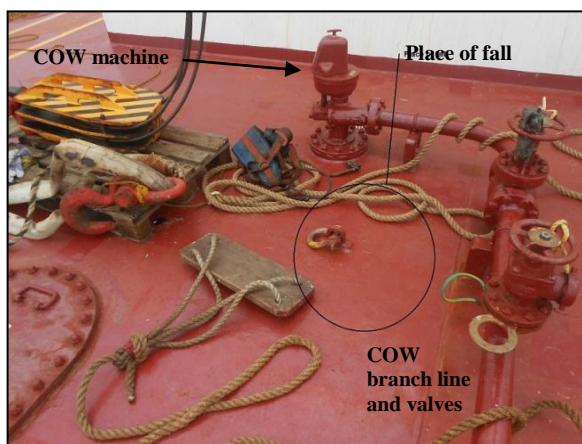
Figure 14: Location where the bosun fell

At around 1105, when the bosun's chair was lowered by about 3.0 m, rope 'A' parted from about 1.5 m above the point where it was connected to the chair. This resulted in the bosun's chair and the bosun, falling to the main deck (Figure 14) from a height estimated to be about 3.7 m (Figure 15), while the knot of the safety harness slid down along the length of rope 'B'.

The fractured ribs were most probably caused by the various fittings, such as the COW machine, branch line, valves, manhole cover, *etc.*, which were in the proximity of his fall (Figure 14).

The safety investigation is of the view that had such safeguards been in place, taking into account the fittings on deck that were located in the vicinity below the workspace, the fall of the bosun could have either been arrested or cushioned, thereby reducing the severity of the injuries suffered by him.

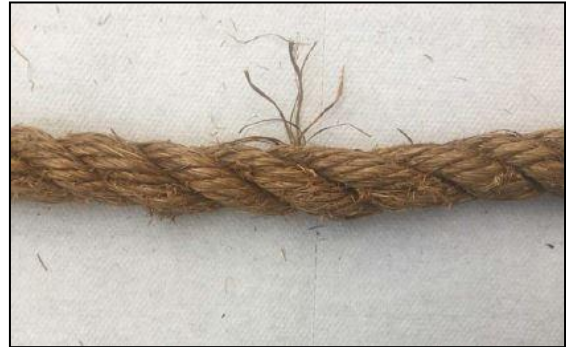
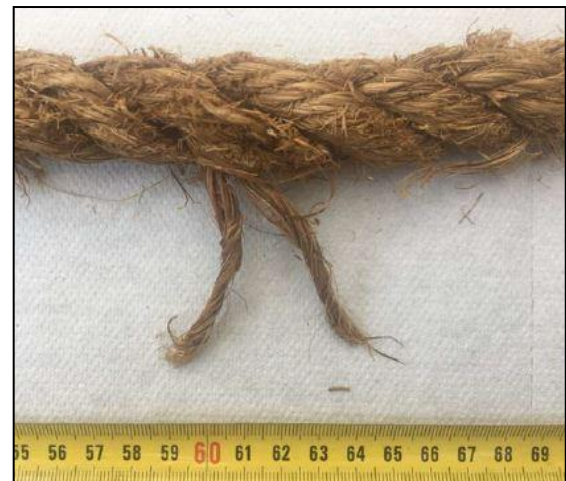
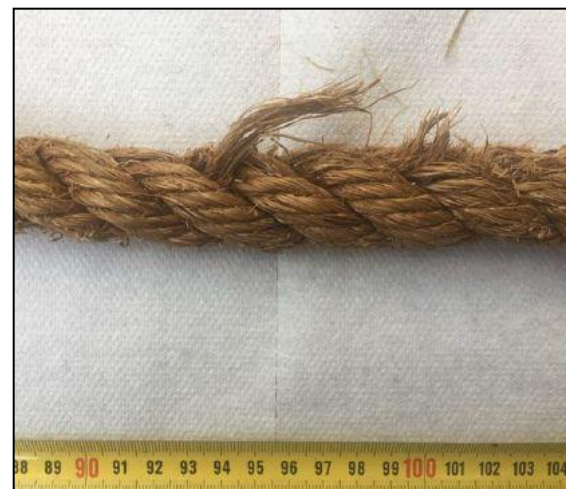
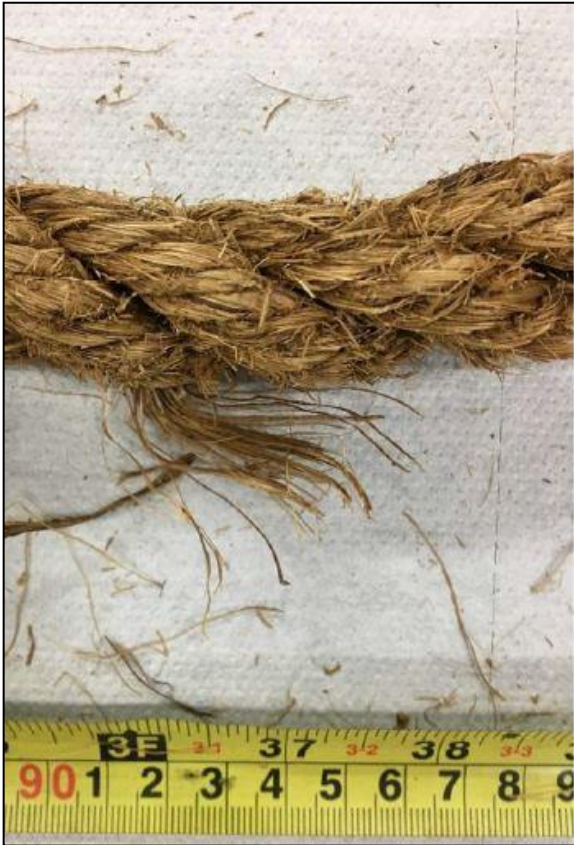
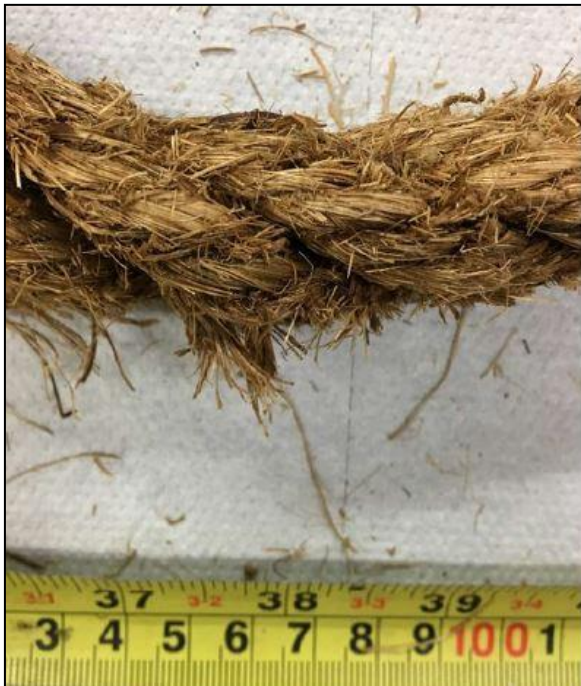
Visual inspection of the rope sections showed signs of fraying, weathering and the presence of some damages, in the form of worn down or cut fibres and strands, along their lengths (Figures 16 to 20).

The laboratory analysis concluded that the failure of the rope was caused by localised abrasive damage.

While some signs of fraying and overall signs of wear were noticed along the entire lengths of the two rope sections, fragmentation of fibres was observed close to the point of failure. This fragmentation of fibres and the texture of the rope indicated localised contact with a hard surface, which caused severe abrasive damage and led to failure of the rope.

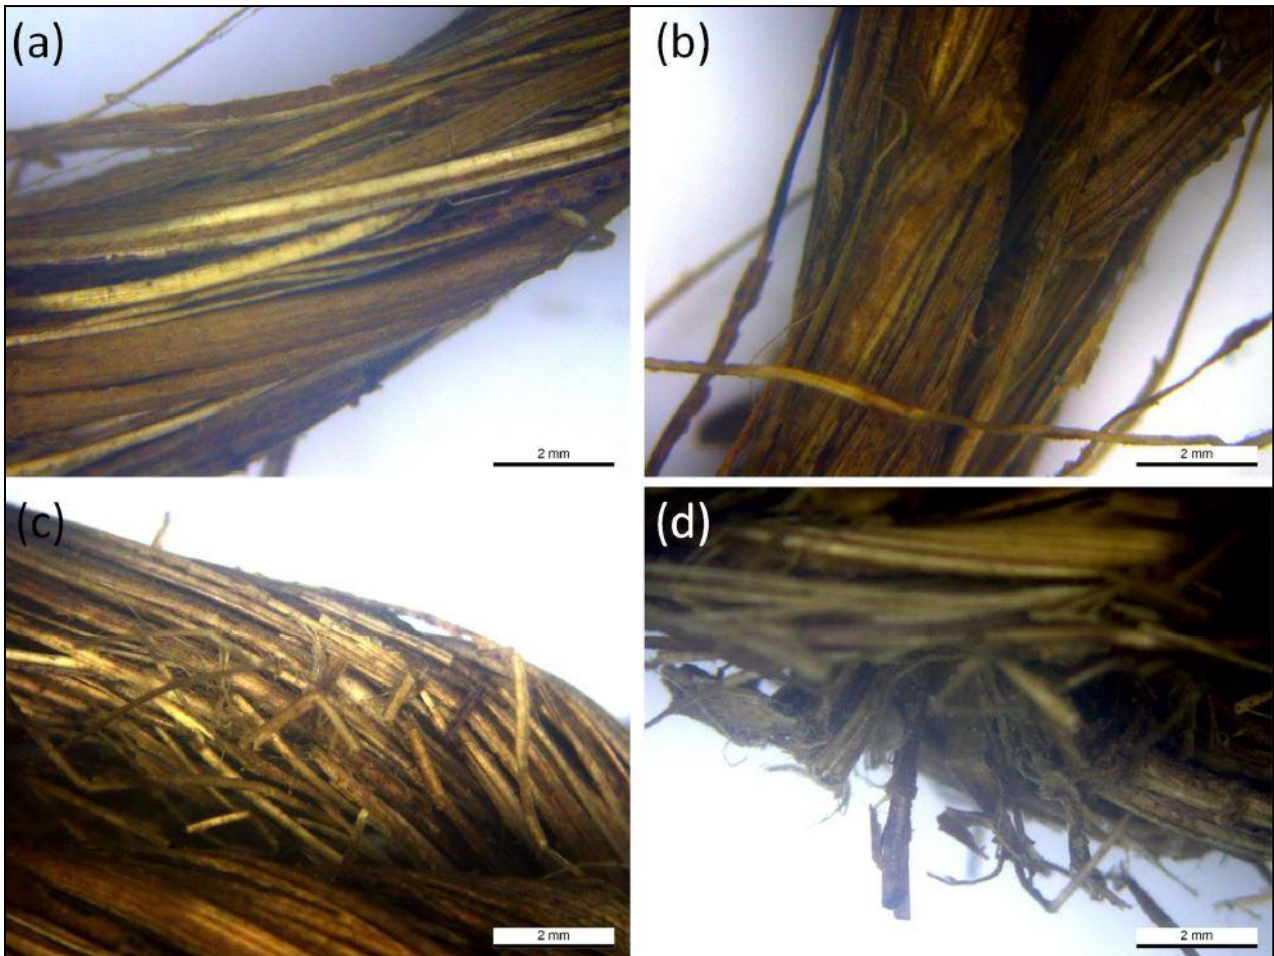
Figure 21: (a) Undamaged internal strands; (b, c and d) abraded fibres near the point of failure

Low-magnification stereomicroscopy of the rope filaments revealed extensive damages in the vicinity of the point of failure. Individual filaments of the rope sections were either broken or had a furry appearance, both of which are common signs of abrasion (Figure 21). No signs of extensive weathering or rotting were observed, which suggested that the rope had experienced damage primarily in and around the ultimate point of failure.

The rubbing of a rope against a surface may lead to progressive weakening of the fibres, particularly if the rope is loaded, thus partially unwound, and bent at the same location along its length.

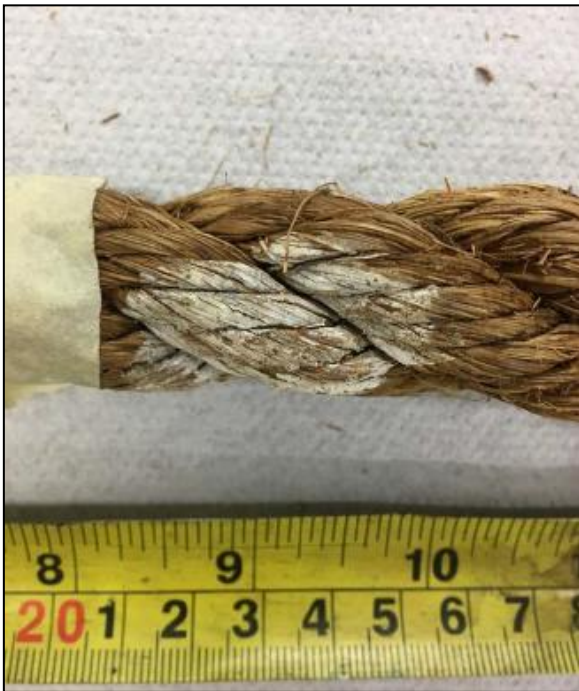
Figure 22: Paint residue on rope sample

Paint residue was noticed on the sample of the rope received by the MSIU – at a distance of about 0.8 m from the point of failure (Figure 22). This indicated that the ropes were not free of paint, as was indicated in the inspection records and the risk assessment, raising doubts on the thoroughness of the on board inspections.
