SAFETY INVESTIGATION REPORT

REPORT NO.: 10/2020

FV ZAIRA

Foundering in Marsascala Bay

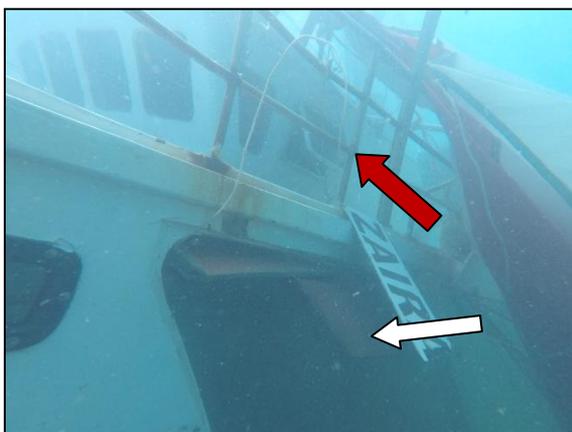
The fishing vessel *Zaira* was refloated on 09 May 2019. The divers employed for the salvage reported that all the hatches and wooden doors on board *Zaira* were found open (Figures 7, 8 and 9).

Figure 7: Port side of *Zaira*, red arrow showing the bridge hatch open, white arrow showing the port side bulwark hatch missing

10/2020_R2 install weathertight doorways, to reduce the risk of ingress of water into the vessel's lower compartments.

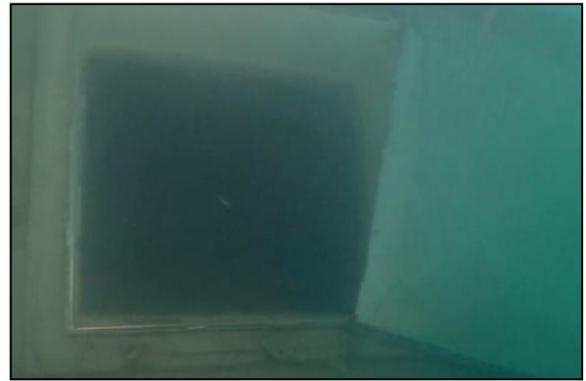
Figure 8: Hatch on port side freeboard deck in way of the fish hold found open

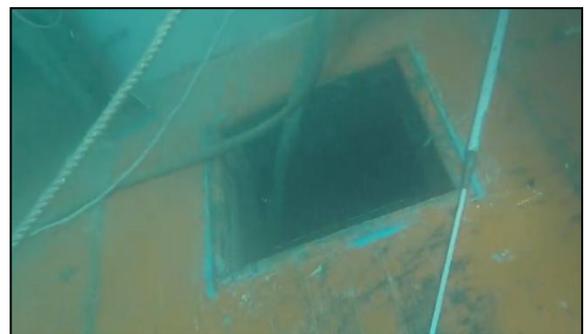
Figure 9: Hatch on freeboard deck leading to the stern tube found missing

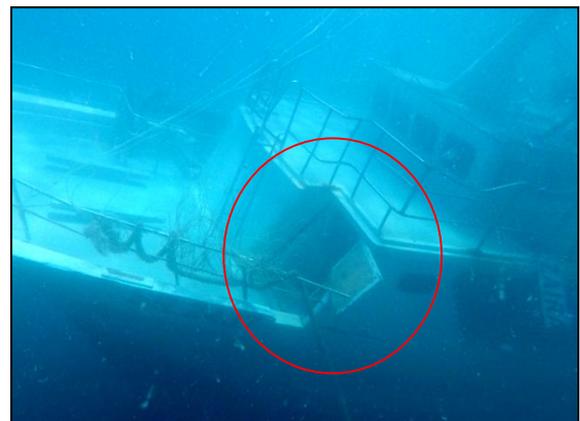
Furthermore, it was reported that the salvors found the door leading from the raised forecandle deck to the freeboard deck in two pieces (Figure 10).

Figure 10: Door leading to the port side deck found in two pieces

Furthermore, the door from the raised forecastle deck to the port side deck was found in two pieces (Figure 10). This would have allowed the water shipped over the raised forecastle deck, to flow down to the port side deck, adding to the water being shipped over the poop deck.

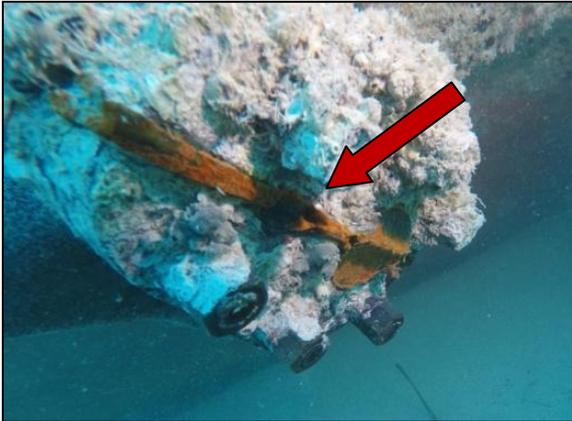
The MSIU was informed that the salvors may have not been the first divers to have visited *Zaira*, as items were reported missing to the police (Figure 11).

Figure 11: Rudder was not found by the salvors and was reported to have been stolen

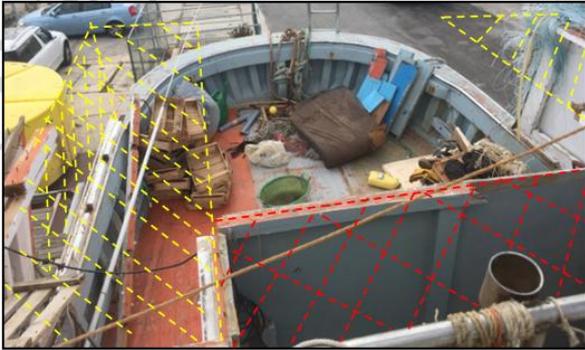
The poop deck was not entirely open to sea as it had a sheltered deck covering over the sides and the engine-room, and an extended bulwark on the starboard side (Figure 12).

Figure 12: The poop deck of Zaira, showing a reconstruction of the sheltered deck (in yellow) and a reconstruction of the engine-room deckhead (in red)

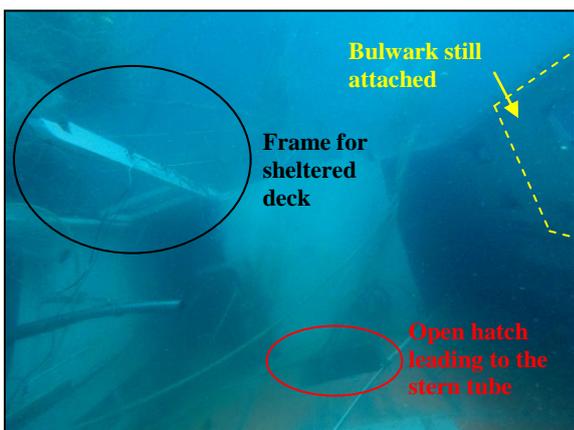
It is not known whether the sheltered deck was lost in the rough weather, or when the vessel started sinking. Available information, however, suggested that the destruction of the sheltered deck was caused by the battering waves on the starboard side. The missing bulwark in Figure 12 was still attached to the vessel, while she was resting on the bottom of the seafloor (Figure 13).

Figure 13: Underwater photograph of the poop deck area

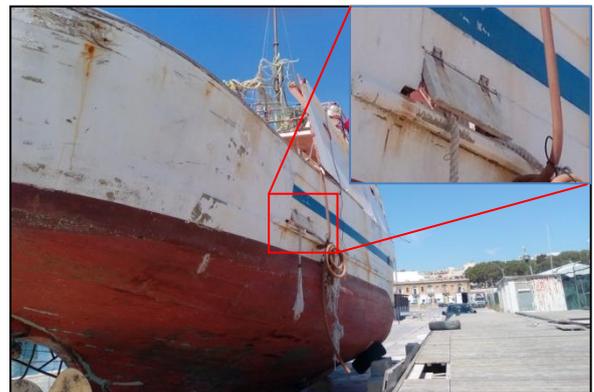
Figure 14: Magnified photo shows starboard side's freeing port. An identical freeing port was on the other side

Assuming that the freeing ports were clear from any obstructions, water would have generally cleared through them. However, it was doubtful whether these freeing ports would have been sufficient to drain the large volumes of water from the deck before more green seas were shipped by the next wave. This would have allowed significant volumes of water to collect between the raised forecastle deck and the bulwark, eventually finding its way into other compartments.

10/2020_R3 increase the number of freeing ports on the freeboard deck to avoid water collection.

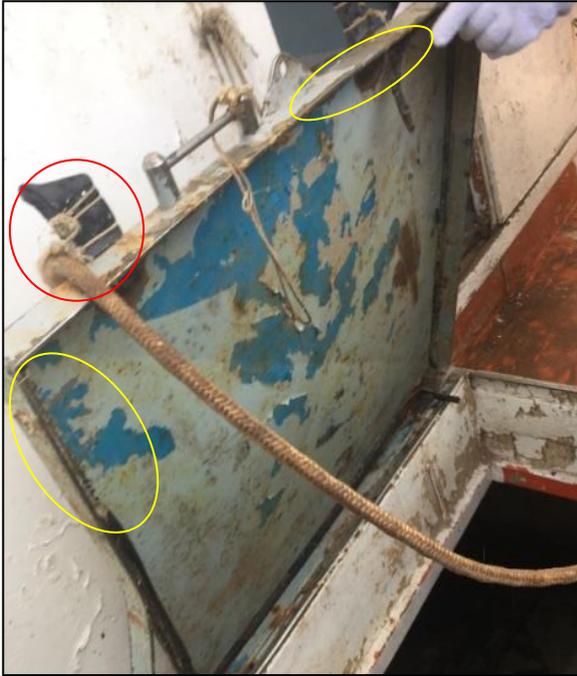
in a good condition before this occurrence. However, the fish hold hatch cover's rubber inserts were noticed to be worn out (Figure 15), suggesting that the hatch cover was not weathertight.

Figure 15: Hatch cover in way of fish hold, showing worn out rubber inserts (in yellow) and rubber strips around the securing points (in red)

10/2020_R1 install a watertight hatch cover in way of the fish hold.

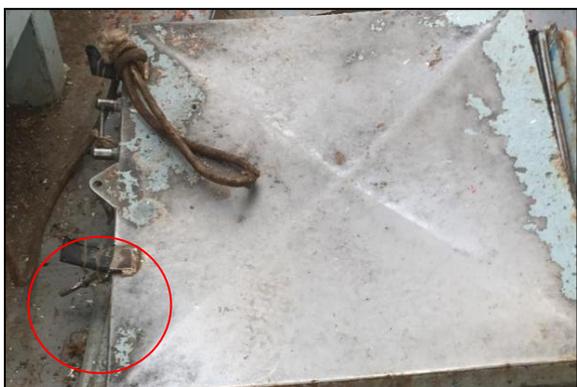
It was considered probable that the securing arrangements were not being used to fully batten down the hatch cover. Furthermore, black rubber strips were wrapped around its securing points (Figure 15 and 16). It was reported that these were present to prevent the fishermen from injuring themselves while walking past.

Figure 16: Rubber strips wrapped around securing points and securing dogs lying on the side

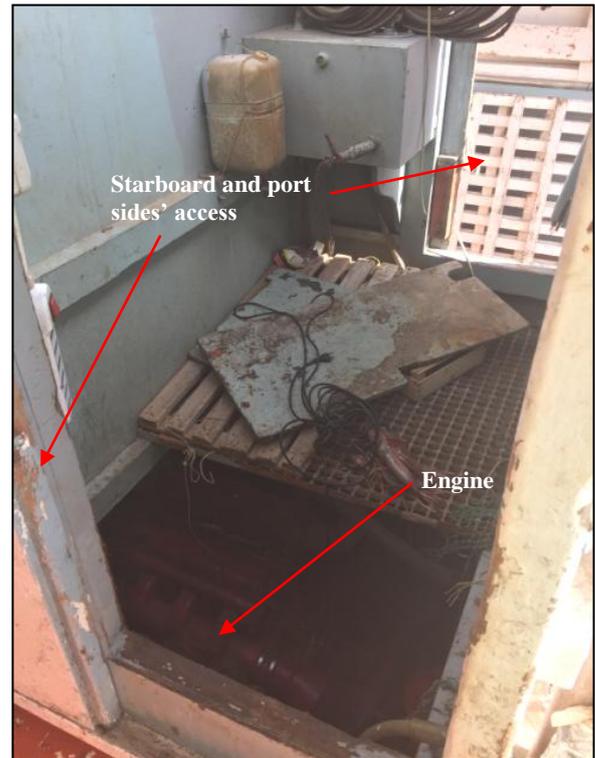
Zaira's engine-room access openings (Figure 17) were found open during the salvage, which would suggest that once on deck, water was free to enter the engine-room. It is not known when the deck ceiling of the engine-room broke away from its fittings (Figure 12). However, considering that this might have occurred during the sea passage, it would have contributed further to water ingress into the engine-room space.

Figure 17: Starboard and port side engine-room access
