National Transportation Safety Board

Marine Accident Brief

Grounding and Sinking of Recreational Vessel *Silver Lining*

Accident type	Grounding	No. DCA19FM044
Vessel name	<i>Silver Lining</i>	
Location	Hood Canal, southwest of Hood Canal Bridge; Puget Sound, Washington 47°51.82' N, 122°38.24' W	
Date	July 23, 2019	
Time	1500 Pacific daylight time (coordinated universal time – 7 hours)	
Injuries	None reported	
Property damage	\$500,000	
Environmental damage	None	
Weather	Clear, visibility 10 miles, winds west-southwest at 5 mph, air temperature 71°F, water temperature 56°F ¹	
Waterway information	Hood Canal is a 70-mile-long-by-1.5-mile-wide fjord within Puget Sound with a mean depth of 177 feet.

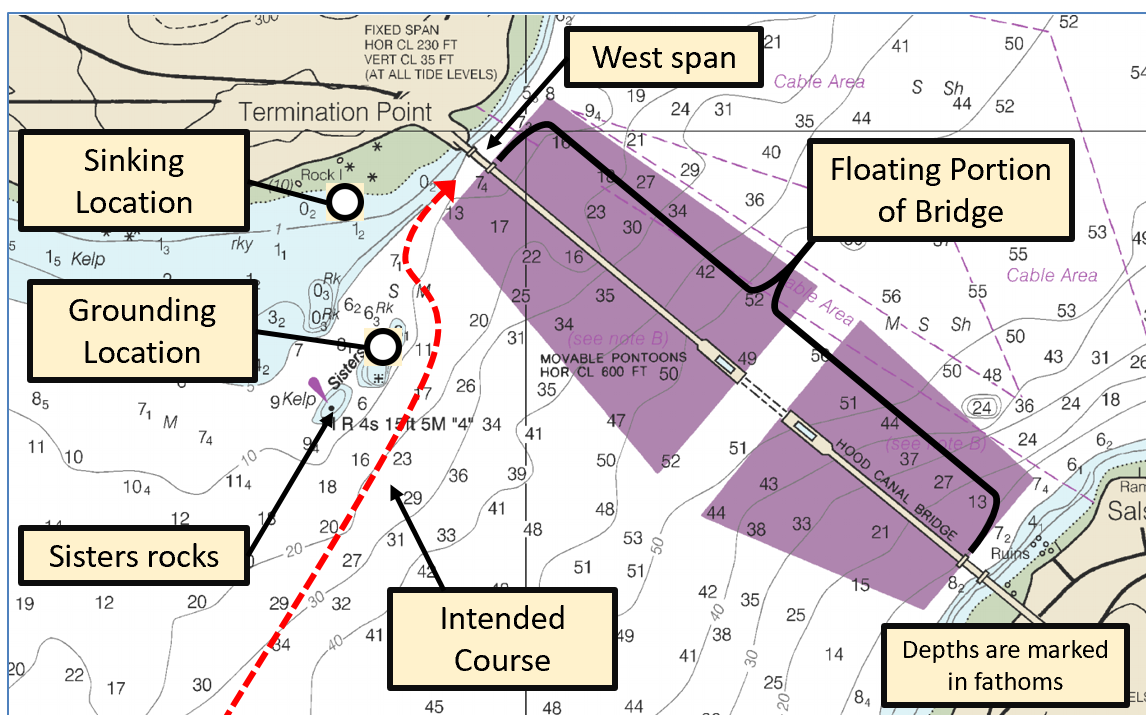
Map of the Hood Canal Bridge, including an estimated trackline of the *Silver Lining's* intended course. (Source: National Oceanographic and Atmospheric Administration [NOAA] Chart No. 18476, annotated by NTSB)

Canal Bridge. There was no GPS unit on the flying bridge, and he had a paper navigation chart for reference. He used the dinghy that was being towed astern as a reference point to verify that the *Silver Lining* had passed the Sisters rocks. After he saw that the dinghy had passed the number 4 navigation aid marker, he thought it was safe to turn to port to line the vessel up to pass under the west side of the Hood Canal Bridge. However, the 100-foot tow line, in addition to the location of the flying bridge where he was driving the vessel, put the owner approximately 140 feet away from the 12-foot dinghy. Therefore, based on the charts of the Sisters, when the owner turned the vessel after the dinghy passed the navigation marker, the *Silver Lining* had not yet completely passed the southern Sister, and the northern section of the Sisters was still ahead of the vessel to the port side. Per the *US Coast Pilot*, he would have needed to advance 600 feet (an additional 460 feet) to pass both rock pinnacles.

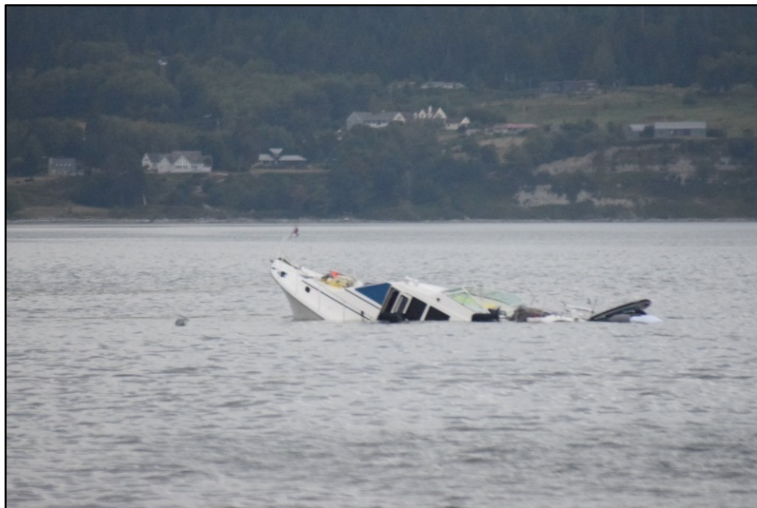
***Silver Lining* following the accident. (Source: US Coast Guard)**

owner and sheriff returned to the *Silver Lining* and saw that it was even lower in the water, and there was no way to enter it.

About 1700, about 2 hours after the vessel started taking on water, it sank with just the bow still visible above the surface and still adrift. A salvage company arrived approximately 1800 and moved the vessel to a shallower area of water closer to shore by Rock Island so that it could be salvaged and refloated.

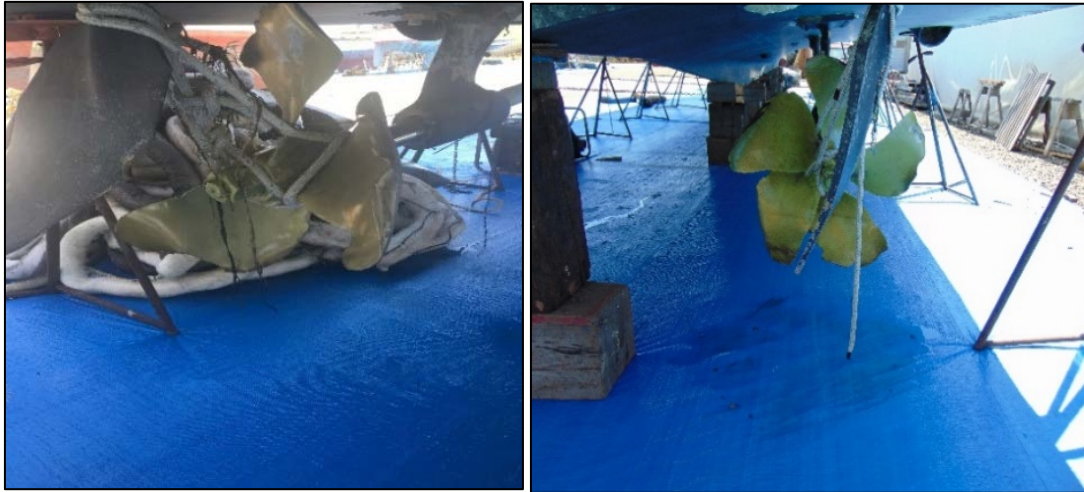
Damage sustained to the port propeller and rudder (left) and starboard propeller and rudder (right) of the *Silver Lining* following the accident.

The vessel had a listed draft of 5.5 feet, which was the maximum estimated depth of the area it grounded in at the time, accounting for the tide. Investigators found that the damage to the propellers and rudder was consistent with the vessel grounding. They also found that the propeller contact caused the shafts and the external strut bearings to be pushed into the hull, causing hull damage that would have allowed water to enter the vessel, in addition to the flooding from hull damage.

Based on the owner's interview and the propeller damage, it is most likely that the *Silver Lining* turned between the southern and northern Sisters, and that its starboard propeller first came into contact with the northern Sister rocks, which shut down the starboard engine. As the vessel proceeded, the keel from midships to the stern came in contact with the rocks at least three times, causing the vessel to rapidly slow down and the damaged hull to start taking on water. At the same moment, the port propeller also contacted the rocks, causing additional damage and shutting down the port engine.

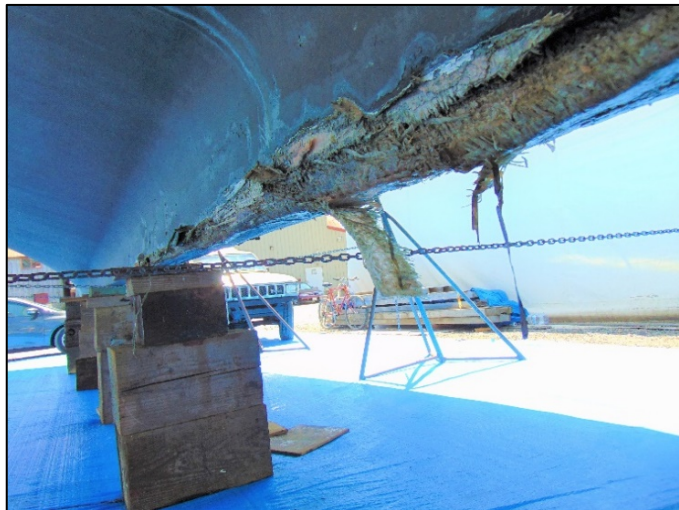
The keel, with a draft of 5.5 feet, was approximately 12 inches deeper in the water than the rest of the vessel, excluding the propeller and rudder. The damage to the keel started just aft of the vessel's midships and continued aft to its termination forward of the propellers. The keel damage was determined to have compromised the watertight integrity of the hull and would have allowed water to enter the vessel.

Damage to the keel of the *Silver Lining* postaccident.
