Fatality in the elevator trunk on board *OOCL Kuala Lumpur*

8.5 nautical miles south-east of Port Botany on 3 June 2018

ATSB Transport Safety Report
Marine Occurrence Investigation
345-MO-2018-009
Final — 2 June 2020

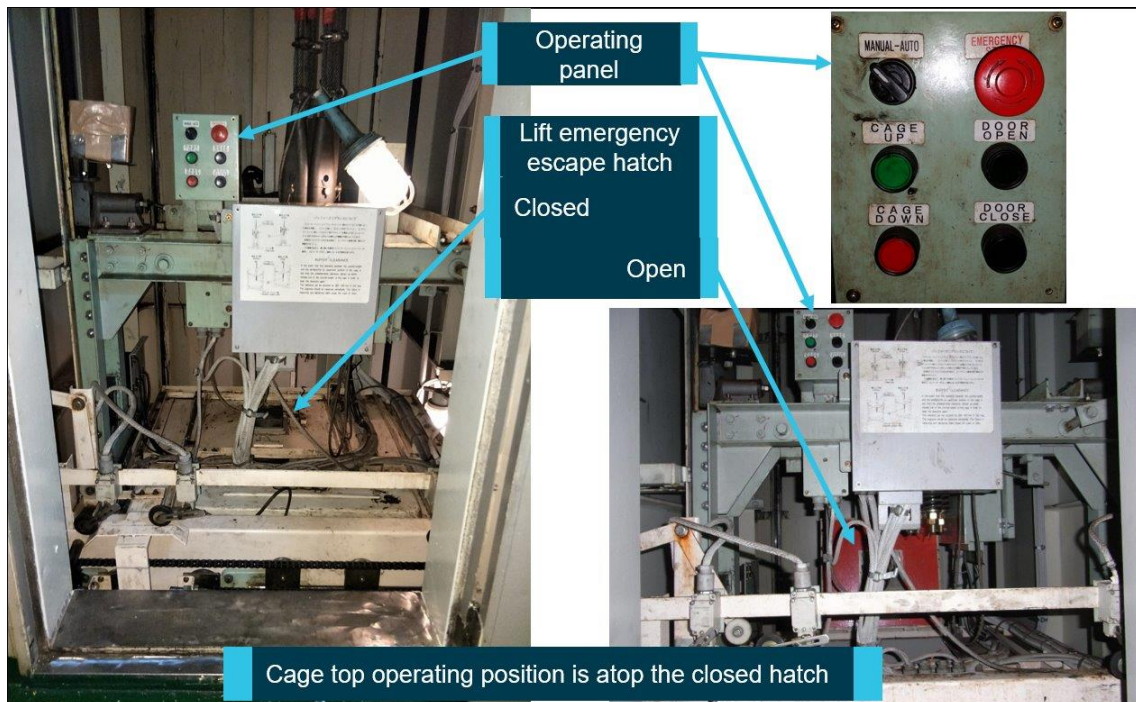
Figure 2: Elevator cage top from entrance door (forward)

The chief engineer authorised the EWP at 0820. The requirements of the task were discussed and the ETO showed the chief engineer the chain drive sprocket and explained the repair. They discussed how the work was to be completed, agreeing that the ETO would isolate the elevator and access the elevator cage top (Figure 2) through the engine room second deck elevator entrance door, and the fitter would complete the repair. The ETO undertook to notify the chief engineer when the repair work was complete and testing would proceed. The ETO and fitter went to do the work and the chief engineer turned his attention to the imminent main engine movements.

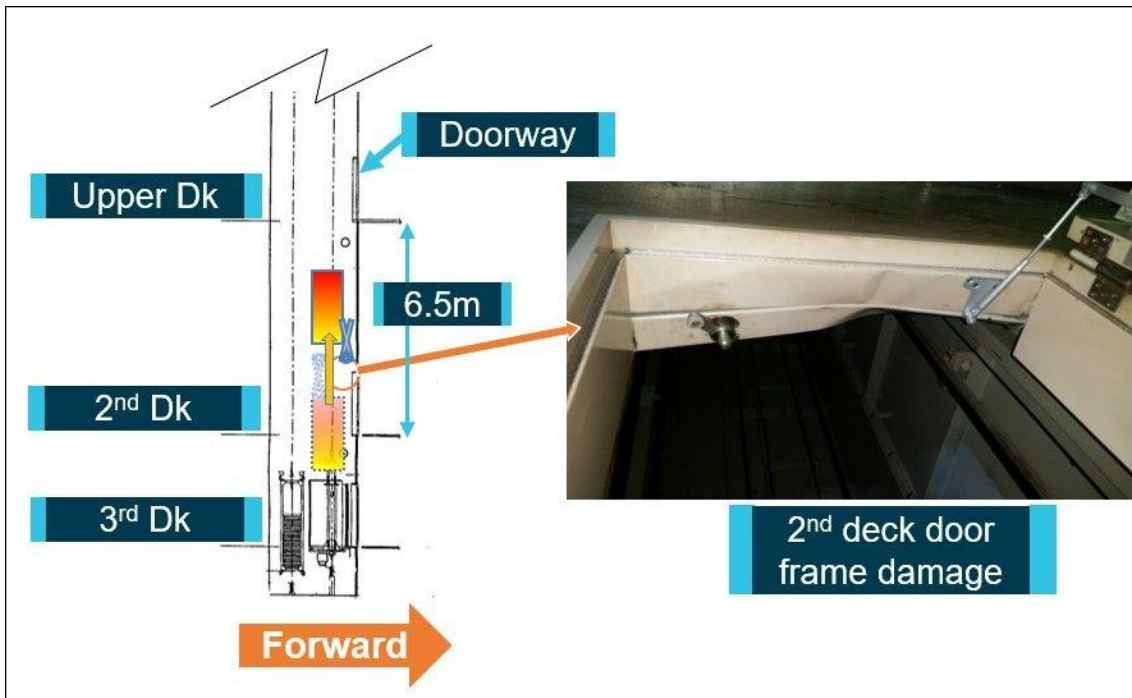
Figure 4: Accident location and damage to second deck elevator landing door frame

After the accident, the ETO was found on the forward side of the elevator, toward the port side, in an inverted position. The top plate of the second deck landing door frame was found damaged and bent upwards with the door position micro-switch dislocated and the door closer damaged (Figure 4). This indicated, that, at some stage after the second deck elevator access door was closed, the ETO moved away from the cage top safe zone to a position that exposed him to a crush hazard beyond the side of the cage. It was not possible to determine the reason for this re-positioning.

The elevator travelled several metres vertically from its original location until the cage bottom was about 0.5 m above the second deck doorway top plate. The push-and-hold design of the manual control buttons meant that if the ETO had been driving the cage manually, it should have stopped once he was struck and his finger was removed from the button.
