National Transportation Safety Board

Marine Accident Brief

Collision Between Fishing Vessels *American Eagle* and *Koorale*

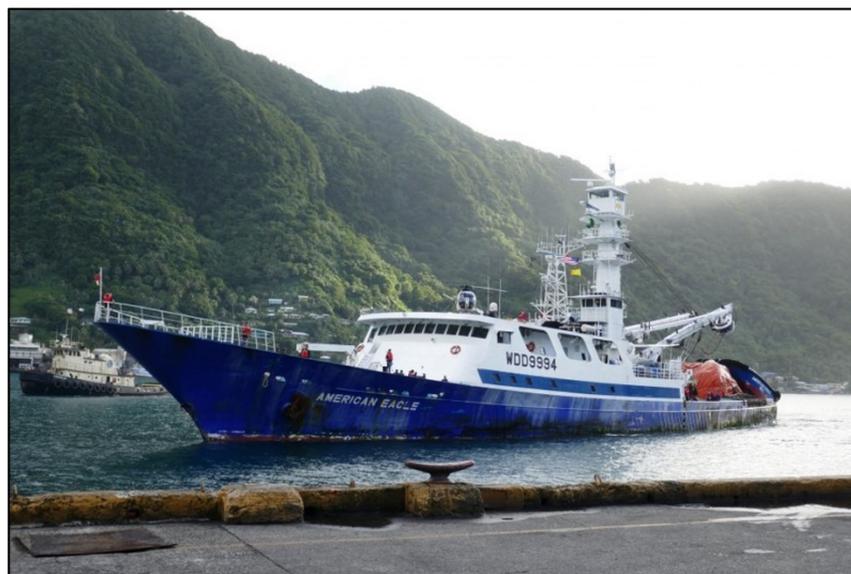
American Eagle approaching berth in Pago Pago, American Samoa after collision. (Source: *American Eagle* Fishing, LLC)

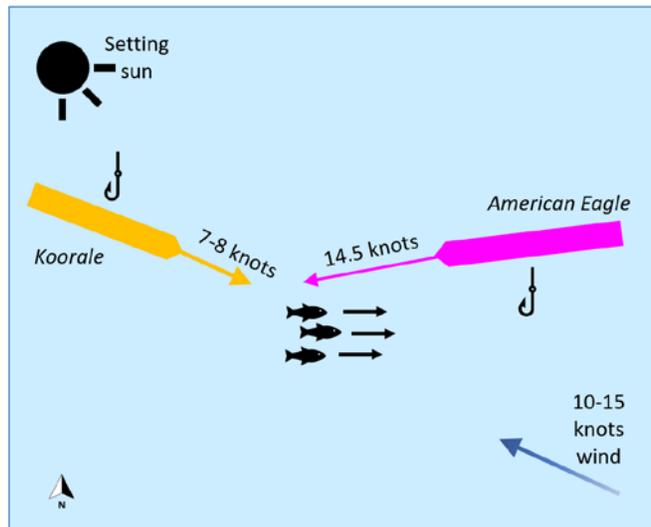
Estimated locations of the vessels and fish approximately 10 minutes prior to the collision. Not to scale.

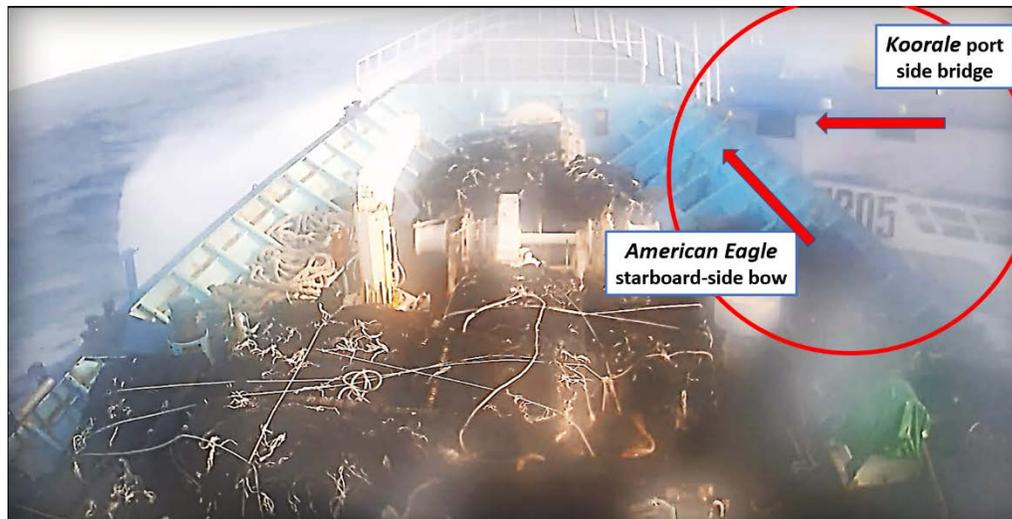
Still image captured from the bow CCTV camera aboard the *American Eagle*. (Source: *American Eagle*, annotated by NTSB)

Video footage from the *American Eagle* bow camera showed the *Koorale* coming into the frame from the right 10 seconds before the collision. About 1704, the *American Eagle* and *Koorale* collided, with the *American Eagle*'s starboard bow making contact with the port side of the *Koorale*. The *American Eagle*'s bow crushed down the port side of the *Koorale*'s wheelhouse. The vessels came together for several seconds and then separated.

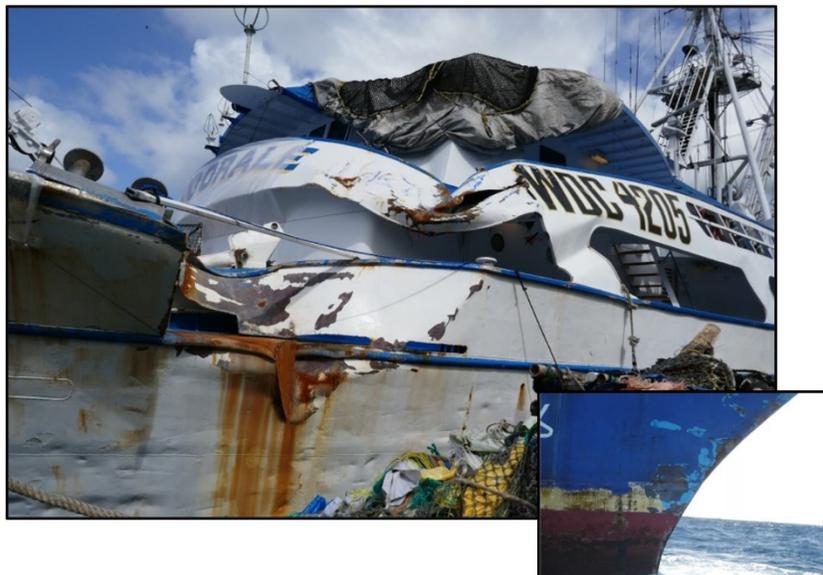
Damage sustained to both vessels. Bow of the *American Eagle* shown in the lower right and the *Koorale* center. (Source: *American Eagle* Fishing, LLC)
