National Transportation Safety Board

Contact of Crane Barge *U1510*, Pushed by Towing Vessel *Goose Creek*, with Overhead Powerlines

Accident type	Contact	No. DCA19FM041
Vessel names	<i>Goose Creek</i> and crane barge <i>U1510</i>	
Location	Elizabeth River, Chesapeake, Virginia 36°45.95' N, 076°17.91' W	
Date	June 20, 2019	
Time	1134 eastern standard time (coordinated universal time – 4 hours)	
Injuries	None	
Property damage	\$226,204 est. (transmission lines \$102,487; crane \$123,717)	
Environmental damage	None reported	
Weather	Temperature 84°F, partly cloudy skies, southwesterly winds at 8–10 miles per hour, water temperature 78°F	
Waterway information	Southern Branch of the Elizabeth River. Observed water level at Money Point, 3 miles north of the accident location, was 1.08 feet above mean lower low water at 1136 with 0.3-knot flood current. ¹

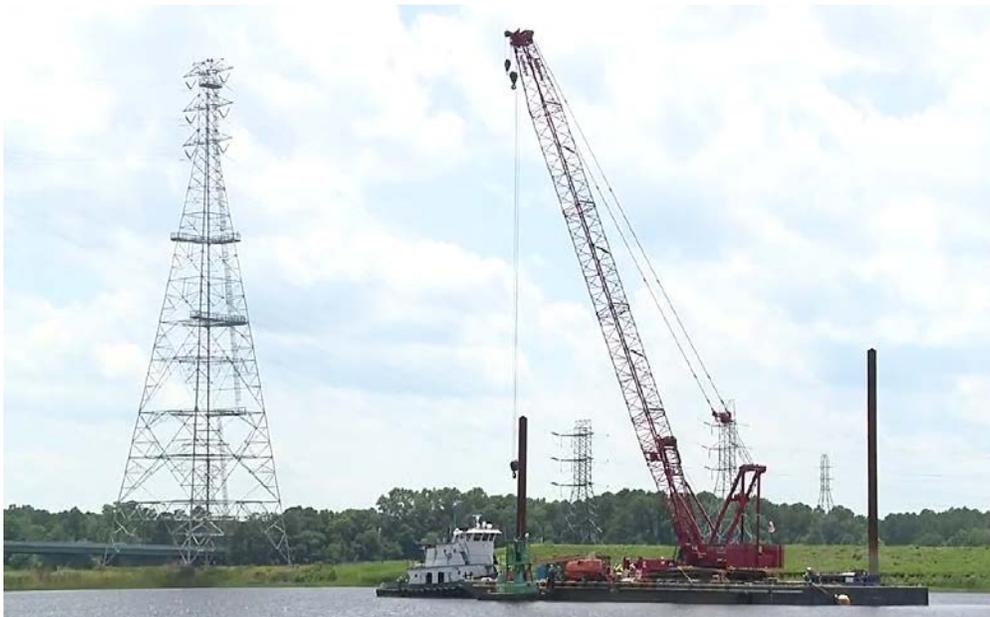
Towing vessel *Goose Creek* and crane barge *U1510* spudded down in Chesapeake, Virginia, after the accident.

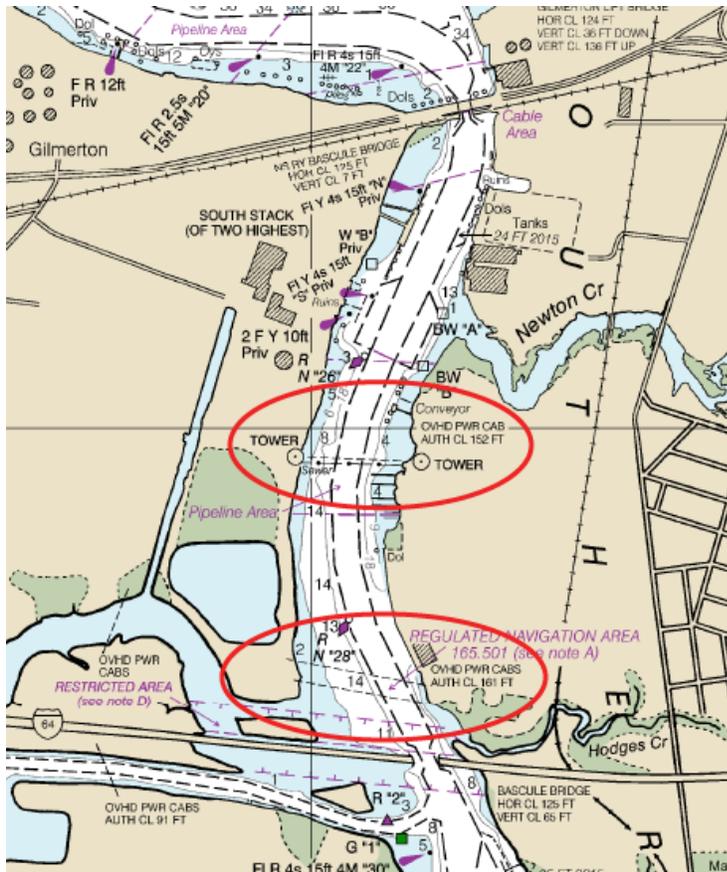
Precon Marine was located between two sections of overhead high-voltage (115 KV) transmission lines that crossed the Southern Branch Elizabeth River between the Gilmerton Bridge and the I-64 High Rise Bridge. The vertical clearance of these lines was marked on the *Goose Creek* crew's onboard National Oceanic and Atmospheric Administration (NOAA) chart for the area (chart 12253, *Norfolk Harbor and Elizabeth River*). The chart displayed the vertical clearance in feet above mean high water (MHW) of overhead cables for the lowest set of wires. According to the 52nd edition of *U.S. Coast Pilot 3*, this clearance was authorized and permitted by the US Army Corps of Engineers.⁴ The northern section, known as transmission lines no. 120, had a charted vertical clearance of 152 feet and crossed the river north of Precon Marine.

NOAA chart 12253, which the crew used to navigate on board the *Goose Creek*. The powerlines are circled in red. (Annotated by NTSB)

The southern section, lines no. 164, had a charted authorized vertical clearance of 161 feet at MHW and crossed the river between Precon Marine and the I-64 High Rise Bridge. Each transmission line consisted of three conductors, or “phases.”

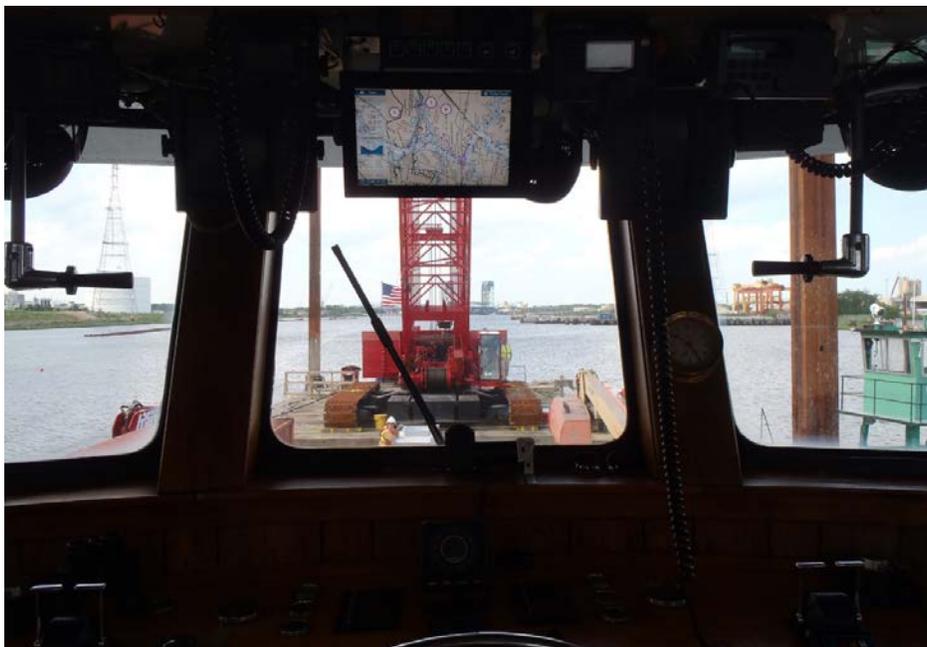
View from *Goose Creek's* wheelhouse after the accident facing north towards Gilmerton Bridge and no. 120 transmission tower on the left (west) with the Maniwoc crane (centered) and *Heidi C* (right) moored to crane barge *U1510*. (Source: US Coast Guard)

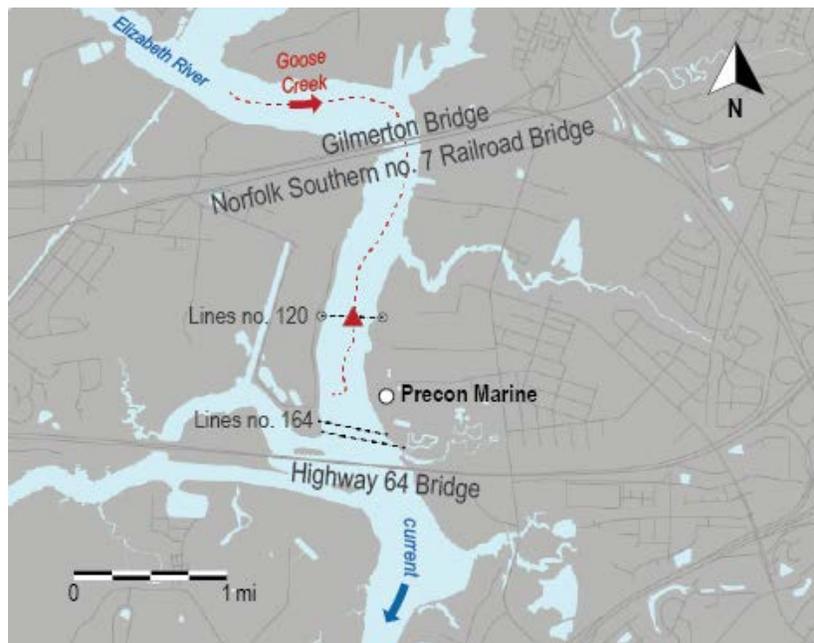
Map of the accident area showing the *Goose Creek* and crane barge *U1510* trackline (red dotted line) crossing under high-voltage transmission lines no. 120 (black dotted lines). (Background source: Google Maps; trackline: terrestrial AIS data)

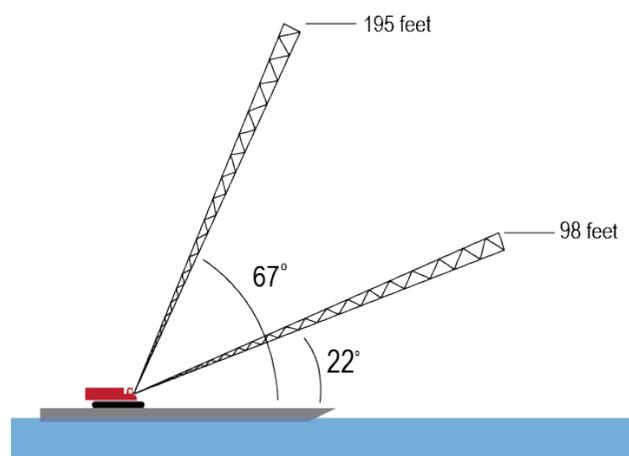
Representation of the Manitowoc M2250 crane on barge *U1510*, with the crane boom elevation shown when stowed at 22° and as determined after the accident with an angle of 67° ; drawing not to scale.

The crane boom's angle indicator read 67° postaccident, indicating the air draft was approximately 195 feet at the time of the accident, which exceeded the charted 152-foot vertical clearance of the transmission lines no. 120 by 43 feet. The captain was aware that the construction workers intended to raise a spud as evidenced by his response to the crane operator's question as to which spud to use for anchoring. The captain and crew were hailed by the *Island Girl*, warning them of the nearby powerlines. However, the captain allowed the construction workers to continue raising the crane boom while approaching the powerlines, and the captain, superintendent, and crane operator all proceeded on the intended route. The captain, who was responsible for ensuring that the vessel was safe to transit the intended route, did not conduct effective voyage planning because he did not consider all overhead obstructions and identify his tow's air draft restrictions for each along the intended route prior to getting under way.

Regardless of requirements, planning and preparation before a tow commences is critically important, including the identification of charted authorized overhead vertical clearance along the route. Overhead powerlines pose a risk to vessels and tows with high air drafts. Owners and operators should develop voyage plans that assess operational risks and hazards, to include air draft relative to overhead powerlines and bridges along the intended route.
