National Transportation Safety Board

Marine Accident Brief

Contact of Tanker *Dank Silver* with Sunshine Bridge

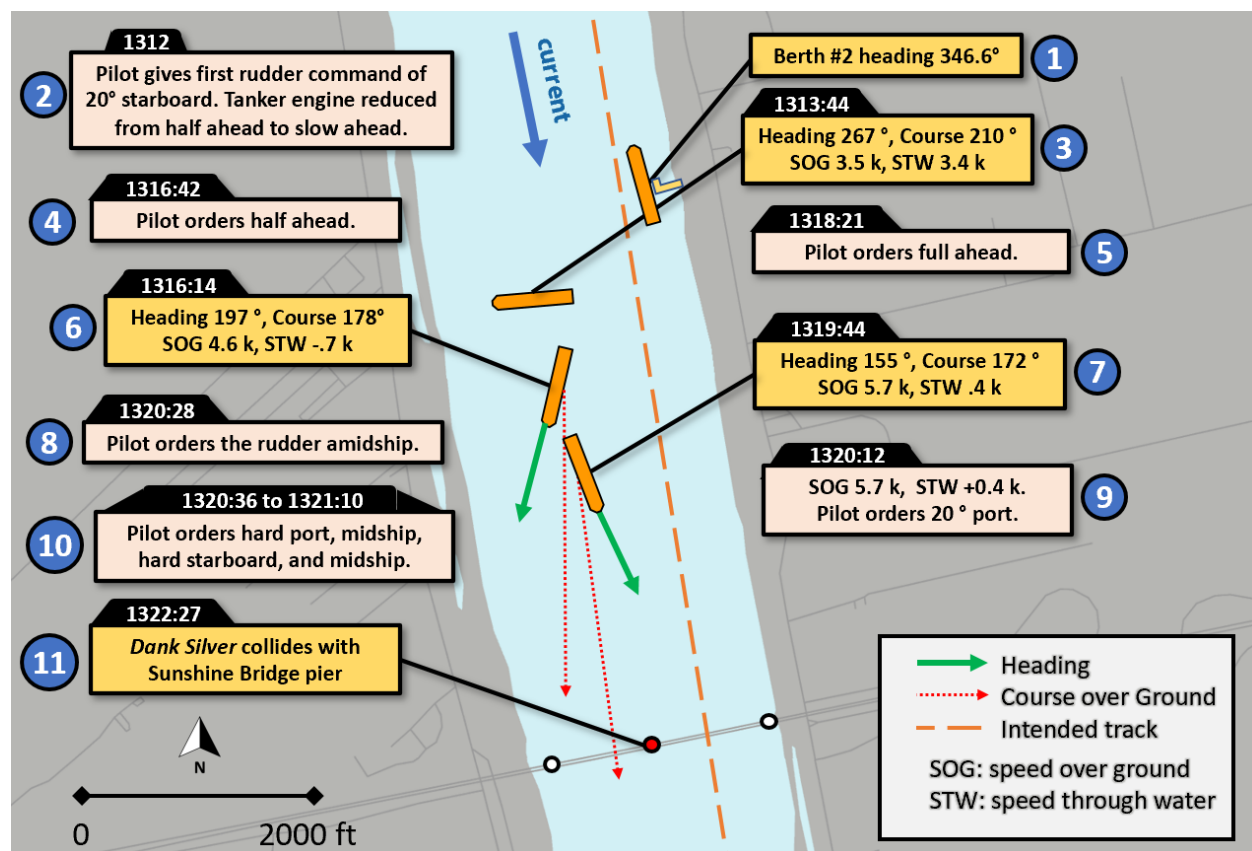
Course of the *Dank Silver* from ECDIS data. (Background source: Google Maps)

Ultimately, because the pilot decided to turn the ship immediately off the dock rather than heading upriver to turn, he had less distance to gain control of the movement of the ship above the bridge.

The National Transportation Safety Board determines that the probable cause of the tank vessel *Dank Silver*'s contact with the Sunshine Bridge was the pilot's decision to turn the vessel off the dock instead of going upriver to gain sufficient steerageway to maneuver downriver through the bridge.

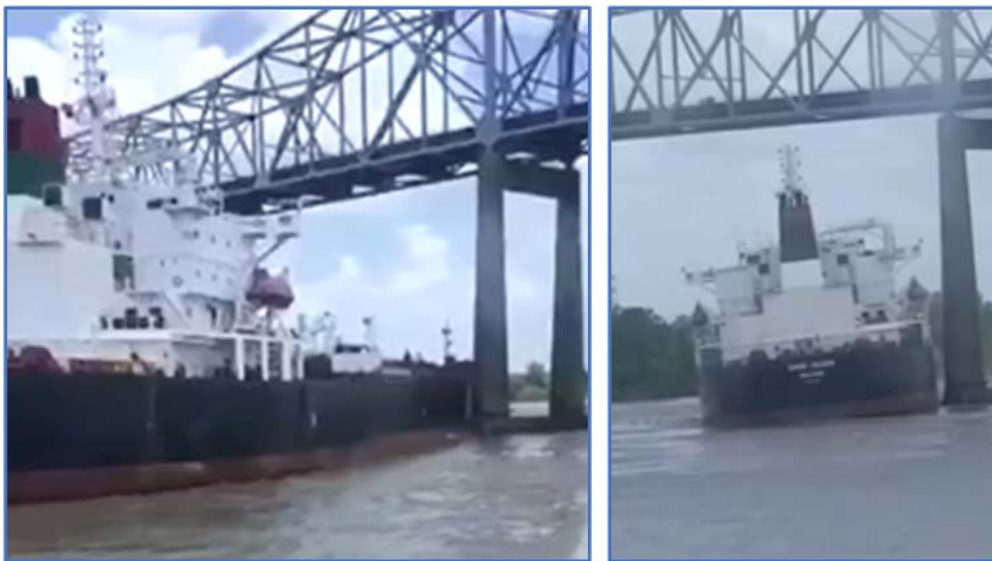
At 1322:27, the forward part of *Dank Silver*'s starboard side struck the western pier to the channel span of the Sunshine Bridge. The strike caused about \$3.5 million in damage to the bridge fendering system. Four of the tanker's water ballast tanks sustained deformation damages to the hull plating and internals, but damage did not reach the cargo tanks. Additionally, the hull plating comprising one of the ballast tanks was breached.

Photos showing the *Dank Silver* striking the Sunshine Bridge. (Source: Crescent Towing)

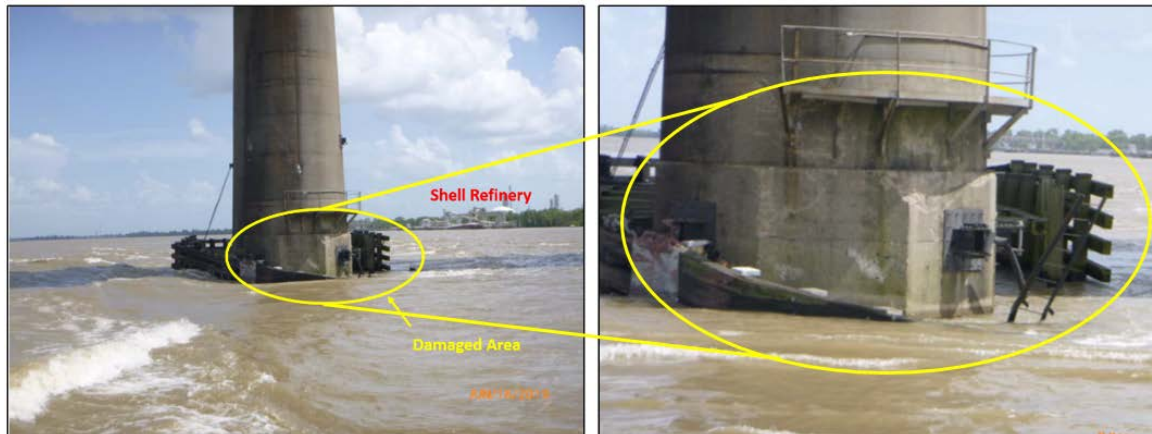
Damage to the fendering system for the western pier of the Sunshine Bridge, from the north. (Source: Louisiana Department of Transportation and Development)
