REPUBLIC OF THE MARSHALL ISLANDS

AL RAWDAH CASUALTY INVESTIGATION REPORT

Fall and Fatality of Wiper

Port Des Galets, l'île de La Réunion | 30 January 2019

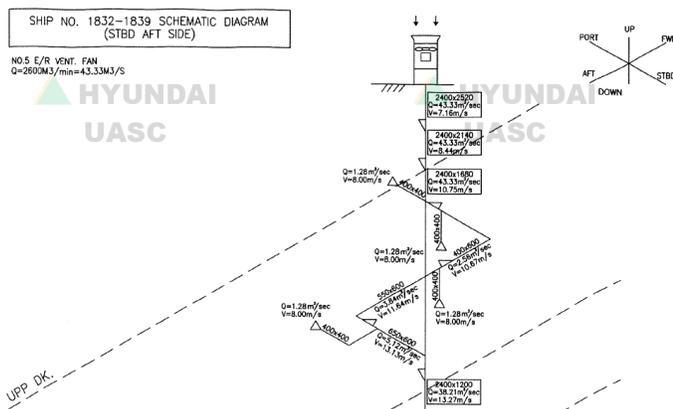
Figure 1: Schematic Diagram for No. 5 Starboard Engine Room vent duct.

1. Ship particulars: *see* chart to right.
2. In October 2018, damage to the impeller for the No. 5 Starboard Engine Room ventilation fan was observed by the crew of AL RAWDAH. The necessary spare parts that were ordered were delivered on board on 19 December 2018.
3. It was determined by the Chief Engineer (C/E) that the replacement of the damaged impeller would be conducted while the ship was in port alongside and conducting cargo operations.
4. The impeller is coupled to an electric motor, mounted vertically in the fan duct, which is about 20 m deep (*see Figure 1*). The motor is connected to the duct shell door. The door is mounted with hinges on one side and secured by bolts and nuts on the other three sides. The door provides direct access to the motor and impeller. The fan duct is not fitted with fall protection or anchor points for a safety line.

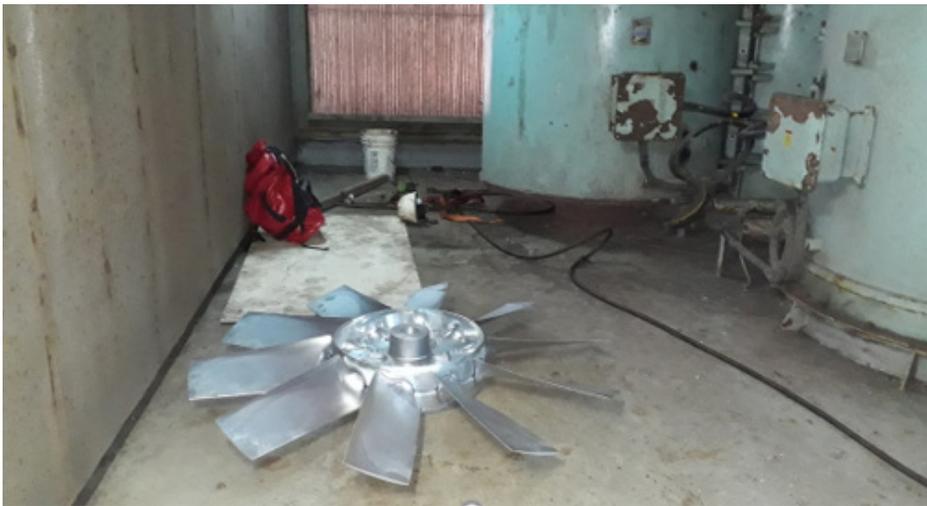
10. Shortly after the Toolbox Talk, the impeller was safely lifted to the Fan Room (*see Figure 2*). All crewmembers assigned to complete this task signed the risk assessment form at the conclusion of the Toolbox Talk.

Figure 2: Fan Room with the No. 5 Starboard Engine Room ventilation fan open and the replacement impeller on the deck after lifting.

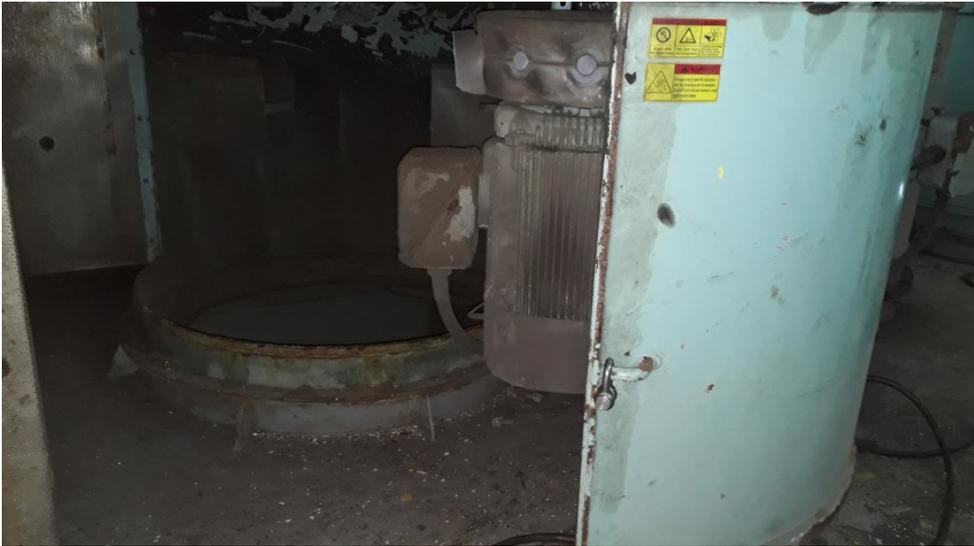
11. At approximately 1315, the crew began working to replace the damaged impeller. The bolts of the No. 5 Starboard Engine Room fan duct door were removed. Two chain hoists were then used to swing the door open so the crew could have direct access to the impeller. Once the door was open and the fan motor and impeller were clear of the duct, the crewmembers decided that they would protect the open duct by securing ropes across the opening.

Figure 3: Open duct for the No. 5 Starboard Engine Room ventilation fan. The Wiper was standing between the motor and the opening.

12. At approximately 1330, the Wiper fell into the duct, presumably while pushing the fan duct door open in order to loosen the nuts and bolts holding the damaged impeller to the motor (*see Figure 3*).

The cause of the Wiper's fall into the open fan duct cannot be determined since there were no direct witnesses. However, it is presumed that the Wiper lost his balance while working and fell into the open duct.

The Company's SMS required that safety harnesses be worn whenever there is a risk of falling more than 2 m. Given the depth of the ventilation duct, a safety harness was required to have been worn by any crewmembers working near the opening. In addition, this fall risk would have triggered the requirement for a PTW.

1. Additional safety training was conducted for AL RAWDAH crewmembers regarding the proper use of PPE.
2. Safety awareness of all crewmembers to be increased by continuous training during shipboard visits by office staff, seminars, and shore based briefing sessions.
3. The promotion and evaluation system for officers was amended to include an increased focus on safety awareness and risk management for senior officers.
4. Grating was installed in the ventilation ducts of AL RAWDAH to prevent another fall into the casing.
