Marine Transportation Safety Investigation Report M19P0078

STRIKING OF SHORE CRANE

Container vessel *Oakland Express*
Fraser Surrey Docks, British Columbia
05 April 2019

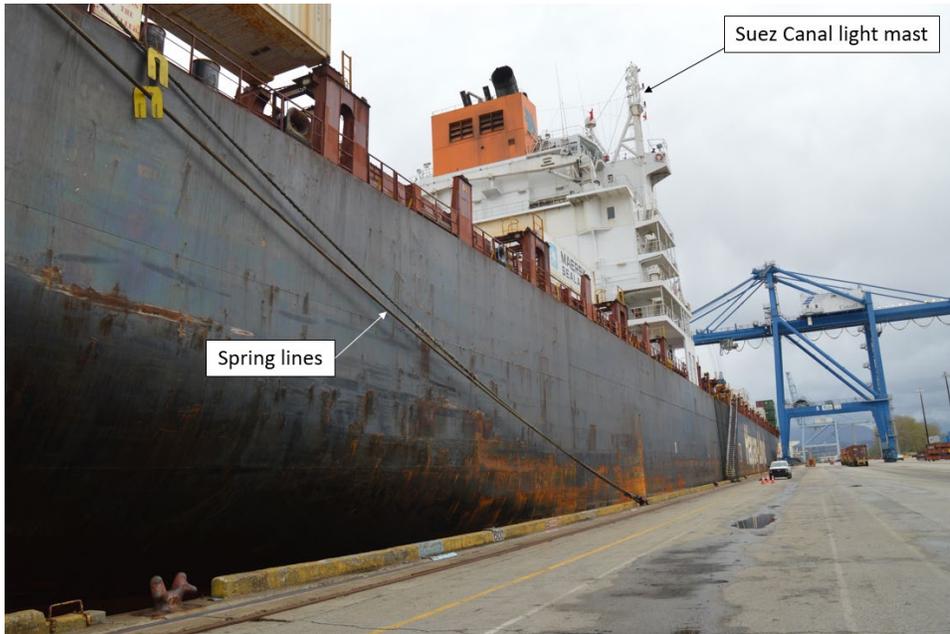
The vessel was constructed in 2000 in Korea by Hyundai Heavy Industries Ltd. and is one of 7 sister ships built for Hapag-Lloyd AG. In addition to a main mast on the vessel's centreline, the *Oakland Express* and its sister vessels have another mast on their starboard side. At the top end of this mast is located the Suez Canal lights³ (Figure 1).

On the *Oakland Express*, the Suez Canal light mast extends 53.75 m above the keel. The outermost portion of the light fixtures on the mast are approximately 1 m inboard of the vessel's starboard side. The majority of container vessels have Suez Canal lights incorporated into their main mast, which is typically located on the vessel's centreline.

Figure 1. Starboard side of the Oakland Express while berthed at Fraser Surrey Docks (Source: TSB)

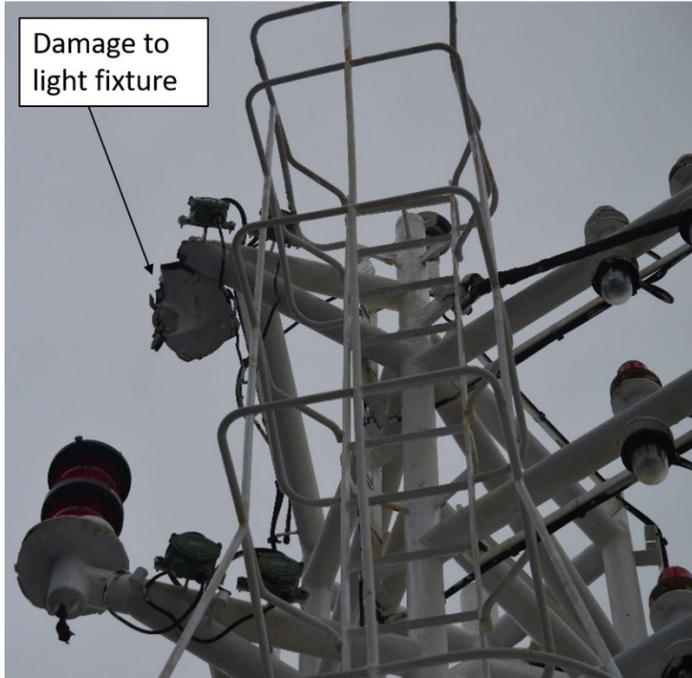
The light fixture on the Suez Canal light mast sustained damage as a result of the striking (Figure 2), and the festoon rail on Crane 4 was bent over a distance of approximately 4 m and became misaligned with the horizontal section located under the beam (Figure 3).

Figure 2. Damage to light mast (Source: TSB)

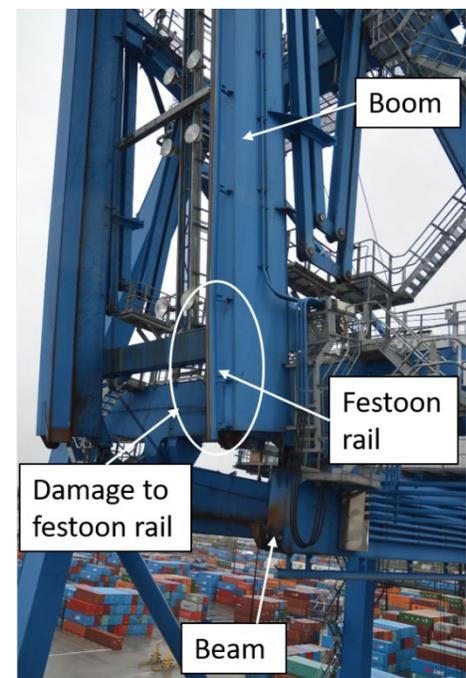
Figure 3. Damage to crane (Source: TSB)

- revised the procedure for crane positioning prior to berthing and unberthing vessels,
- initiated a requirement for the superintendents to be present at the berth and equipped with VHF radiotelephones to communicate with pilots for all vessel movements,
- reviewed the incident with the Fraser River pilots and commenced bi-annual meetings to discuss areas of improvements and future plans, and
- revised the procedure for when a crane is passing a vessel's mast or superstructure while transiting along the berth.

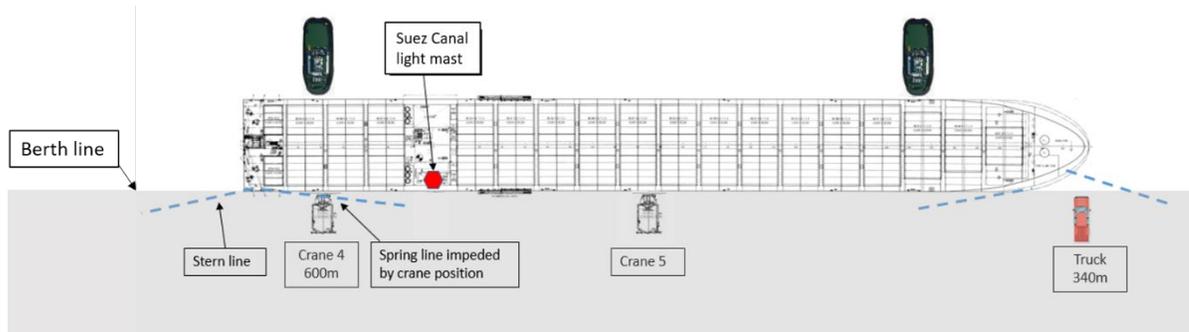
The superintendents had planned for the *Oakland Express* to be berthed with the bow at the 340 m mark (Figure 4). Crane 4 was to be positioned in the vicinity of the bays just aft of the accommodation in order to service these bays. This plan was conveyed verbally to the head linesman prior to the vessel's arrival.

Figure 4. Diagram illustrating the original berthing plan for the *Oakland Express* (Source: TSB)

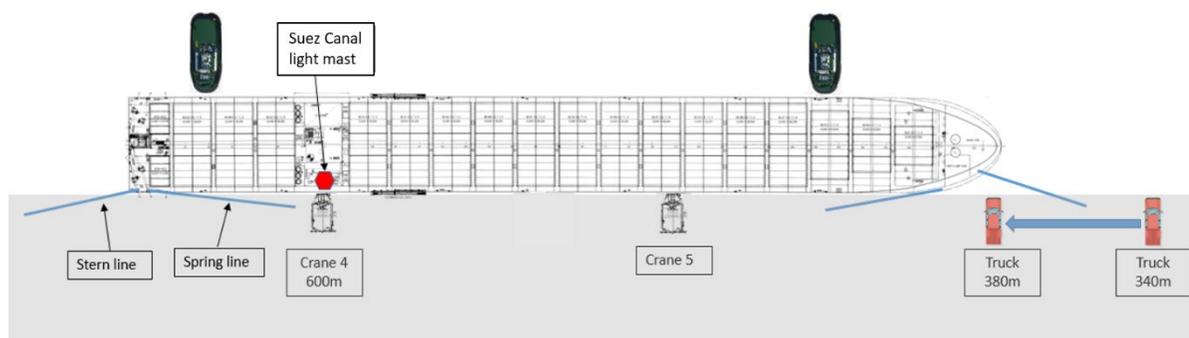
At the time of berthing, it was observed that the position of Crane 4 would impede running the aft spring lines from the vessel to the shore bollards. The head linesman amended the berthing position by 40 m to the 380 m mark to facilitate running the aft spring lines (Figure 5).¹⁴

Figure 5. Diagram illustrating the modified berthing plan for the *Oakland Express* (Source: TSB)

The amended position was passed on to the mooring boat and subsequently to the pilot by VHF radiotelephone. The amended position was not communicated to the superintendents, who were not present during the berthing. The amended berthing position resulted in the vessel's Suez Canal light mast coming into contact with Crane 4.

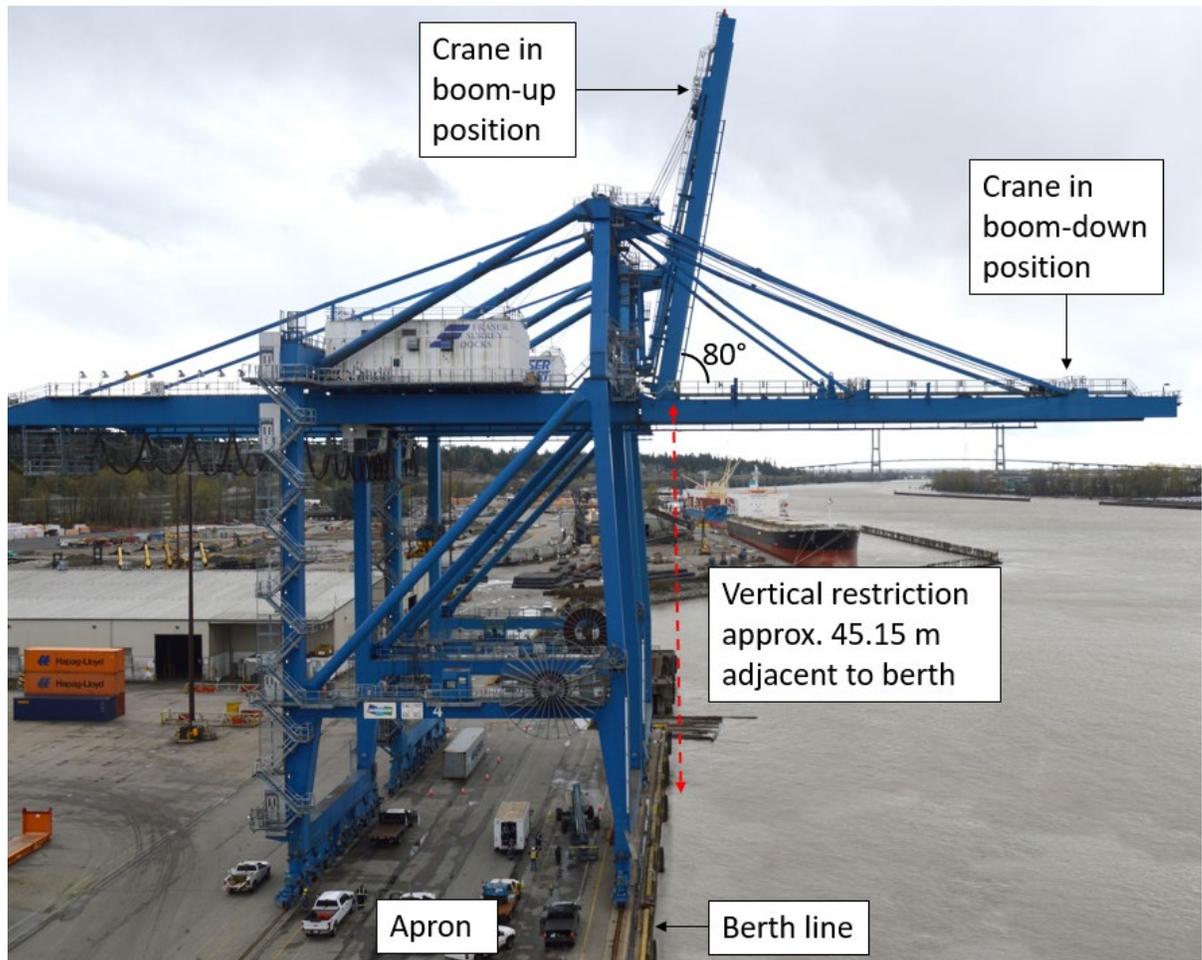
At the Fraser Surrey Docks, when the cranes are in the boom-up position, the booms are not perpendicular to the dock, but extend seaward at an angle of 10° (Figure 6). This results in a vertical

restriction immediately adjacent to the berth of approximately 45.15 m.¹⁵ Most conventional container vessels do not have a mast near the side of the ship and are not impeded by this restriction. However, the restriction does affect the *Oakland Express* and its sister vessels when they are berthed starboard-side alongside because of the proximity of the Suez Canal light mast to the side of the ship.

Figure 6. Gantry crane vertical restriction adjacent to berth (Source: TSB)
