**REPORT INTO AN INCIDENT
INVOLVING THE
'FV DILLON OWEN'
OFF ARDGLASS HARBOUR
23rd OCTOBER 2019**

**REPORT NO. MCIB/295
(No.5 OF 2020)**

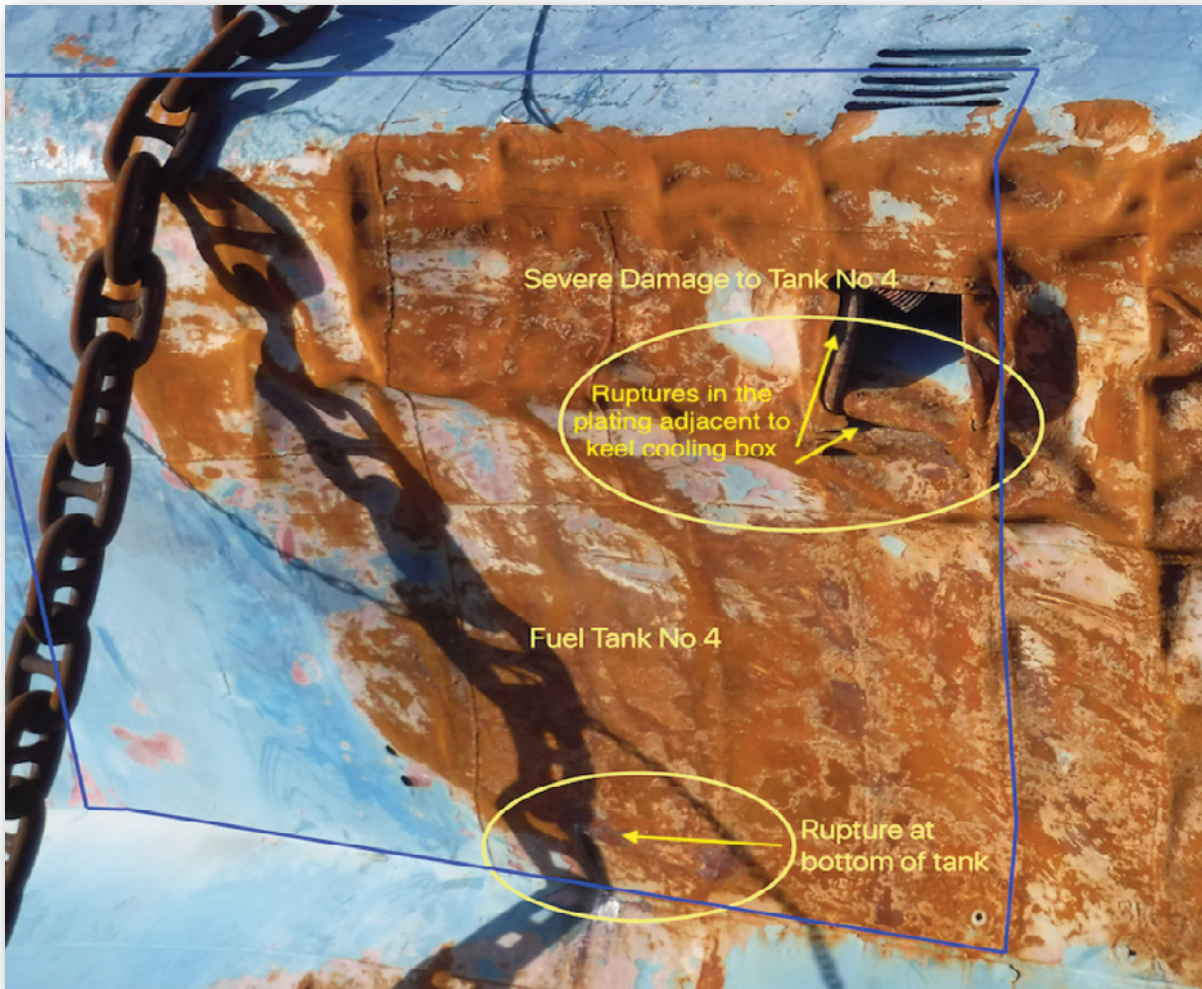
damaged and the plating ruptured in way of fuel tank No.4 adjacent to the keel cooler box. The keel cooler box bottom grid was missing and the keel cooler box bottom aperture through the hull significantly deformed. No.4 fuel tank was open to the sea through the ruptured plating.

frame 14 are integral to No.4 fuel bunker tank and frames 14 to frame 25 are integral to the starboard fish hold. No.4 fuel tank opened to the sea when the tanks hull plating adjacent to the bilge cooler inlets was ruptured at frame 13 to frame 14.

Photograph No.4 - Damage to No.4 fuel tank showing hull plating rupture adjacent to the keel cooler box and at the bottom of the fuel tank.

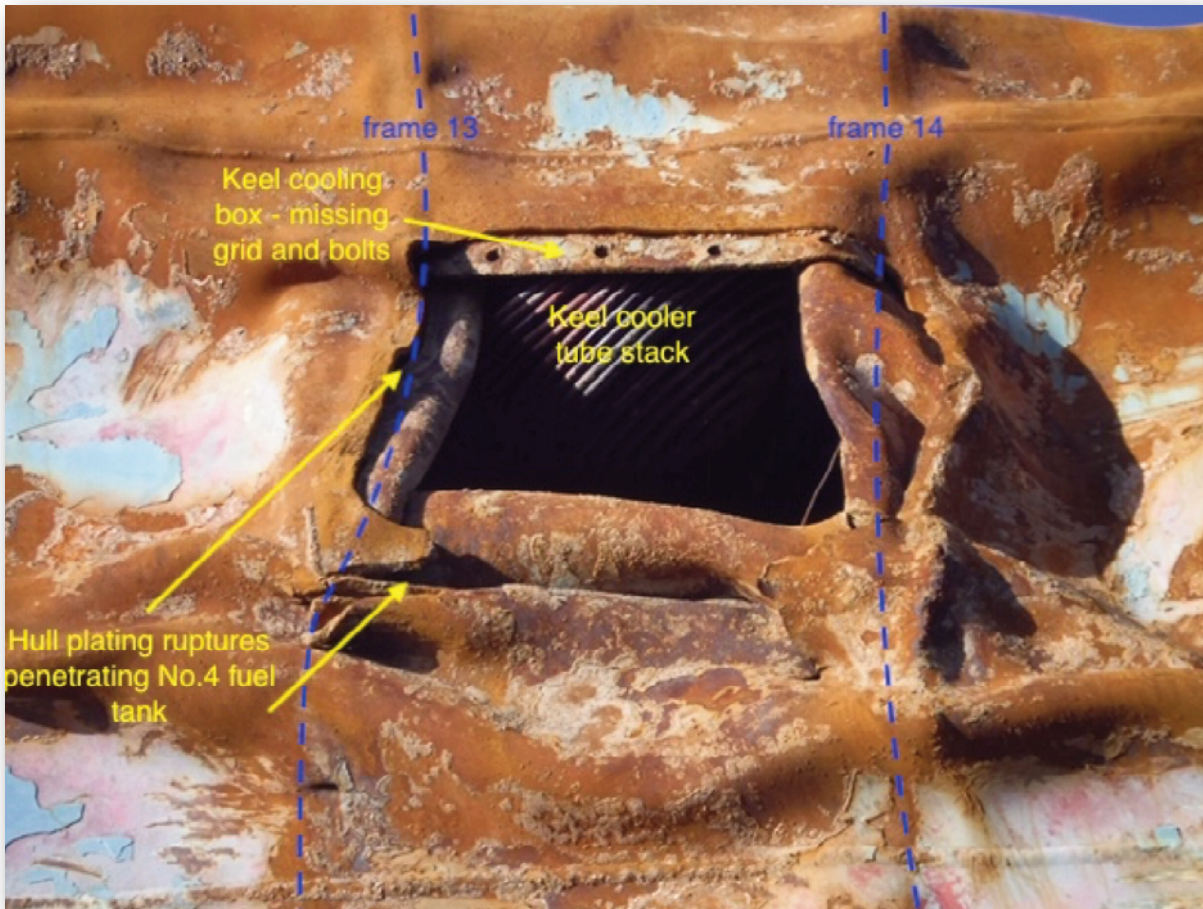
- 4.5 Photographs of the vessel's starboard side shows hull plating damage below the waterline in line with the bilge keel extending lengthways (approximately 12 m long) between frames 6 to frame 25. The damaged plating between frames 8 to

- 5.2 The magnitude of the vessel's impact (as reported by the crew) shortly after 03.54 hrs (UTC), the vessel's AIS track of speed and position and the photographic evidence of damage, indicates that the vessel struck the ground on its starboard side, at or on the shallow water shelf south of Ardtole Beacon, with sufficient force to rupture the hull plating of No.4 fuel tank and open the tank to the sea. There is no evidence to show that the impact of the first grounding event caused the vessel to be fatally damaged at this time.

Photograph No.5 - Hull plating rupture in way of No.4 fuel tank adjacent to the Keel.

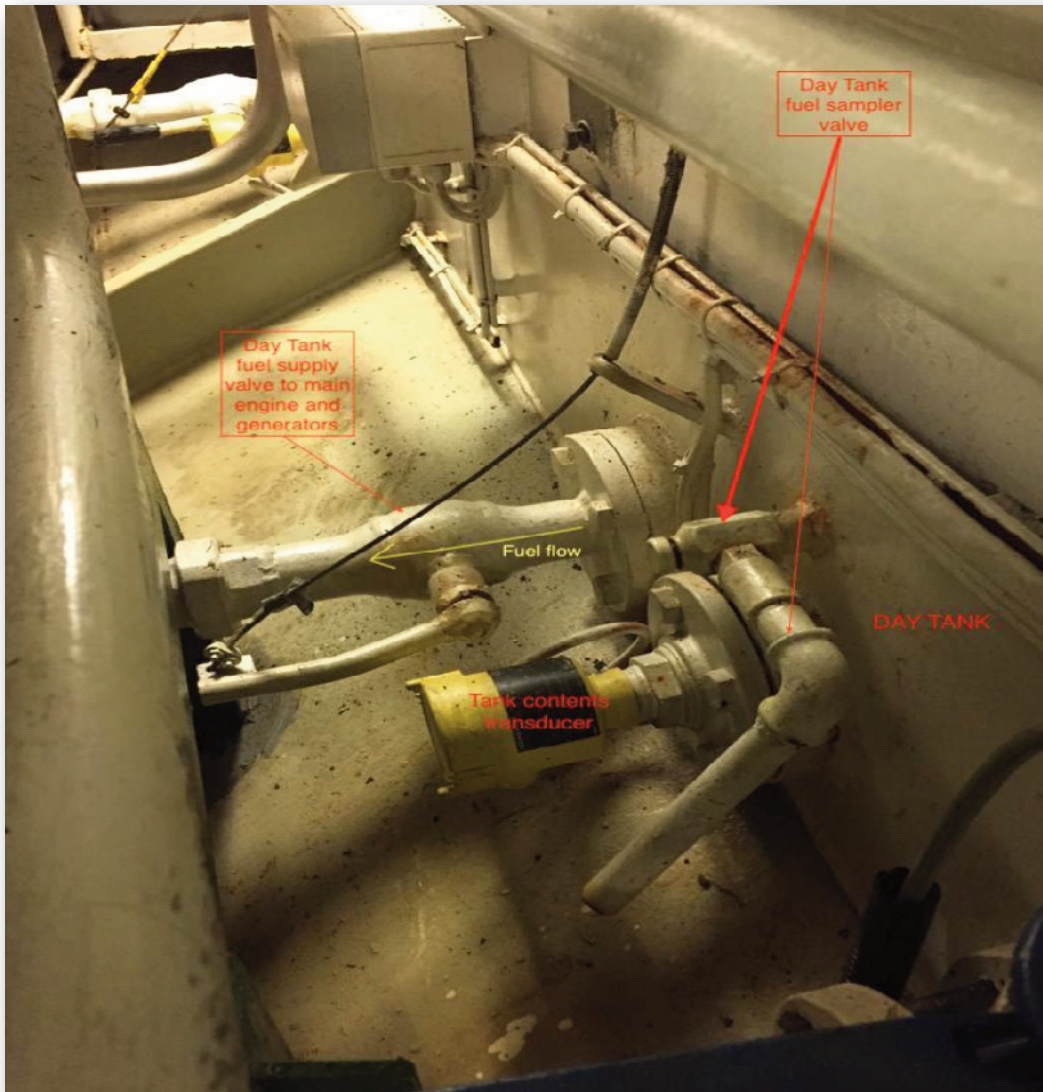
ensured the Day Tank was at its maximum level at all times and also ensured that the generators and main engines were continuously supplied with clean uncontaminated fuel. The fuel suction from the Day Tank to the main engine and generators was connected through a dedicated valve at the bottom of the tank situated immediately adjacent to the Day Tank fuel sampling/drain valve.

- 3.7 The vessel's emergency light systems tripped in and Crewmember No.1 and Crewmember No.2 were able to make checks in the engine room of the fuel system supply to the main engine and generators. They found that opening the fuel Day Tank sampling valve produced copious amounts of water at an abnormally high pressure instead of diesel fuel oil as would be normal. Opening the drain valve on the inline CJC fuel filter/water separator also produced large amounts of water. Crewmember No.1 deduced that the fuel supply system was contaminated with water, which was the reason the generators and main engine had stopped.

Photograph No.7 - Fuel Day Tank bottom valves ('FV Ardent') Cooler Box.

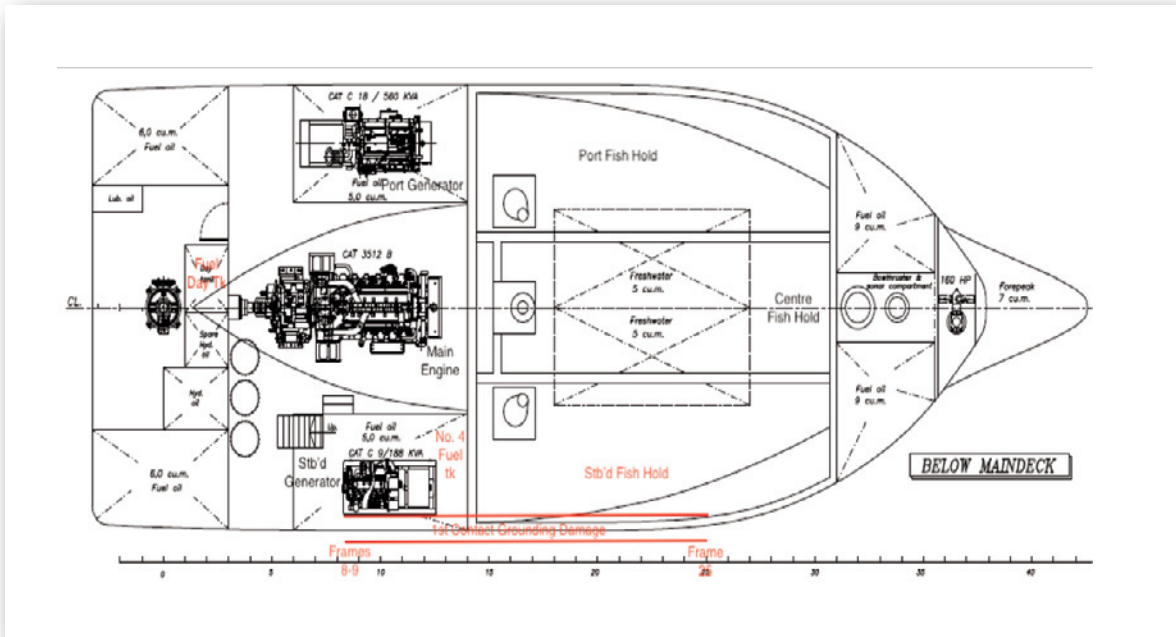
The General Arrangement (GA) drawing 'Below Maindeck' shows the layout plan of the engine room and fish holds. The GA drawing indicates that the engine room has a fuel bunker tank on its starboard side (No.4 bunker tank). The fuel Day Tank (daily service tank) is constructed at the engine room aft bulkhead extending into the steering flat. There are three fish holds (port, centre and starboard) immediately forward of the engine room. Hull damage to the starboard side extended from approximately frame 6 in the engine room along the length of the starboard fish hold to approximately frame 25.

Fig.1. Orientation of hull damage to the vessels compartment(s) (Plan).

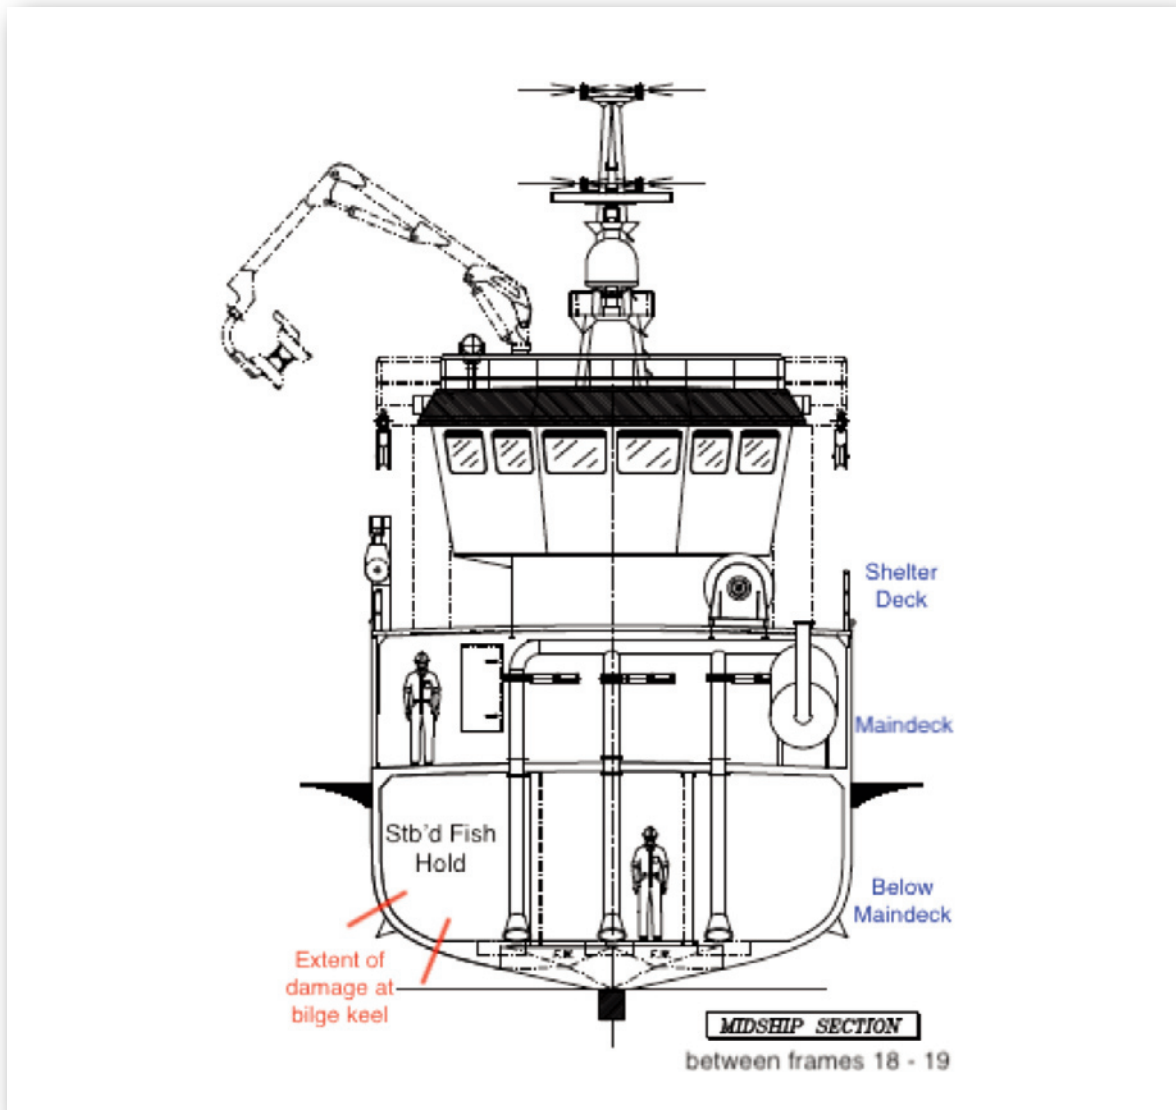
Both No.4 fuel bunker tank and the Day Tank were situated at the 'Below Maindeck' level, within the engine room and below the waterline (on the occasions when the vessel was in the loaded condition). This was the situation as the 'FV Dillon Owen' approached Ardglass Harbour.

The evidence that no water was found in the ships spaces at this time indicates that seawater ingress from the first grounding event was contained to No.4 fuel bunker tank and starboard fish hold only.

Fig.2. Orientation of hull damage to the vessels compartment(s) (Elevation).

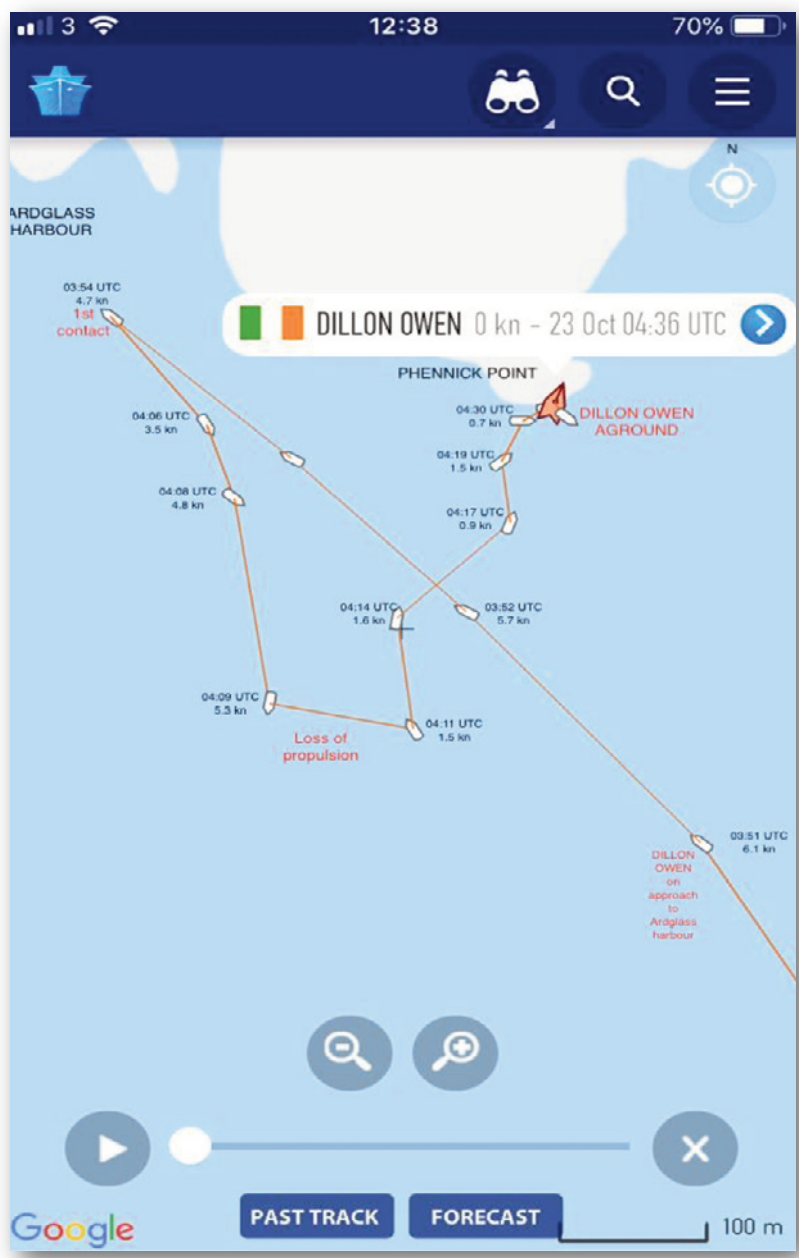
2.3.5 Information from the *'FV Dillon Owen'* Automatic Identification System (AIS) track on the 23rd October 2019 was used to determine the vessel's course and speed from the time of its approach to Ardglass Harbour to the time of its grounding on Phennick Point.

Fig.5. 'FV Dillon Owen' - AIS Track.

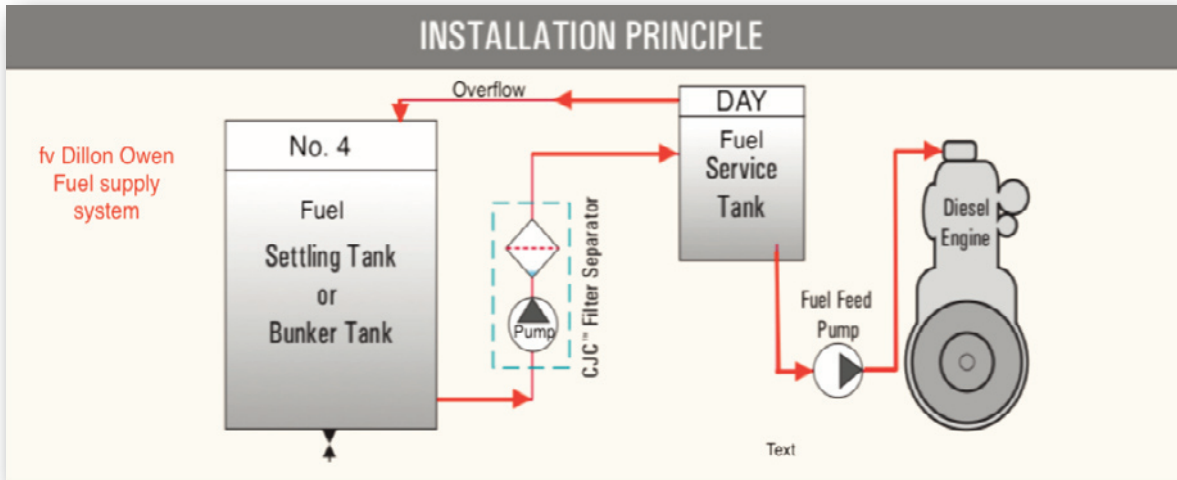
The fuel Day Tank (capacity 2,500 ltr) supplied both generators and the main engine with diesel fuel through a common pipeline. The fuel Day Tank was continually topped up from any of the vessel's six bunker tanks through a combined pump and fuel/water filter separator ('CJC filter'). The function of the CJC filter was to remove contamination particles and water from the bunker fuel (CJC filter throughout capacity 400 litres per hour) and was operating continuously. At the time of the incident the CJC filter was reported to be pumping from No.4 bunker tank. (see Appendix 7.4 Fuel Supply System. Fig.6 and Fig.7)

Fig.6. Fuel Supply and CJC Filter system.

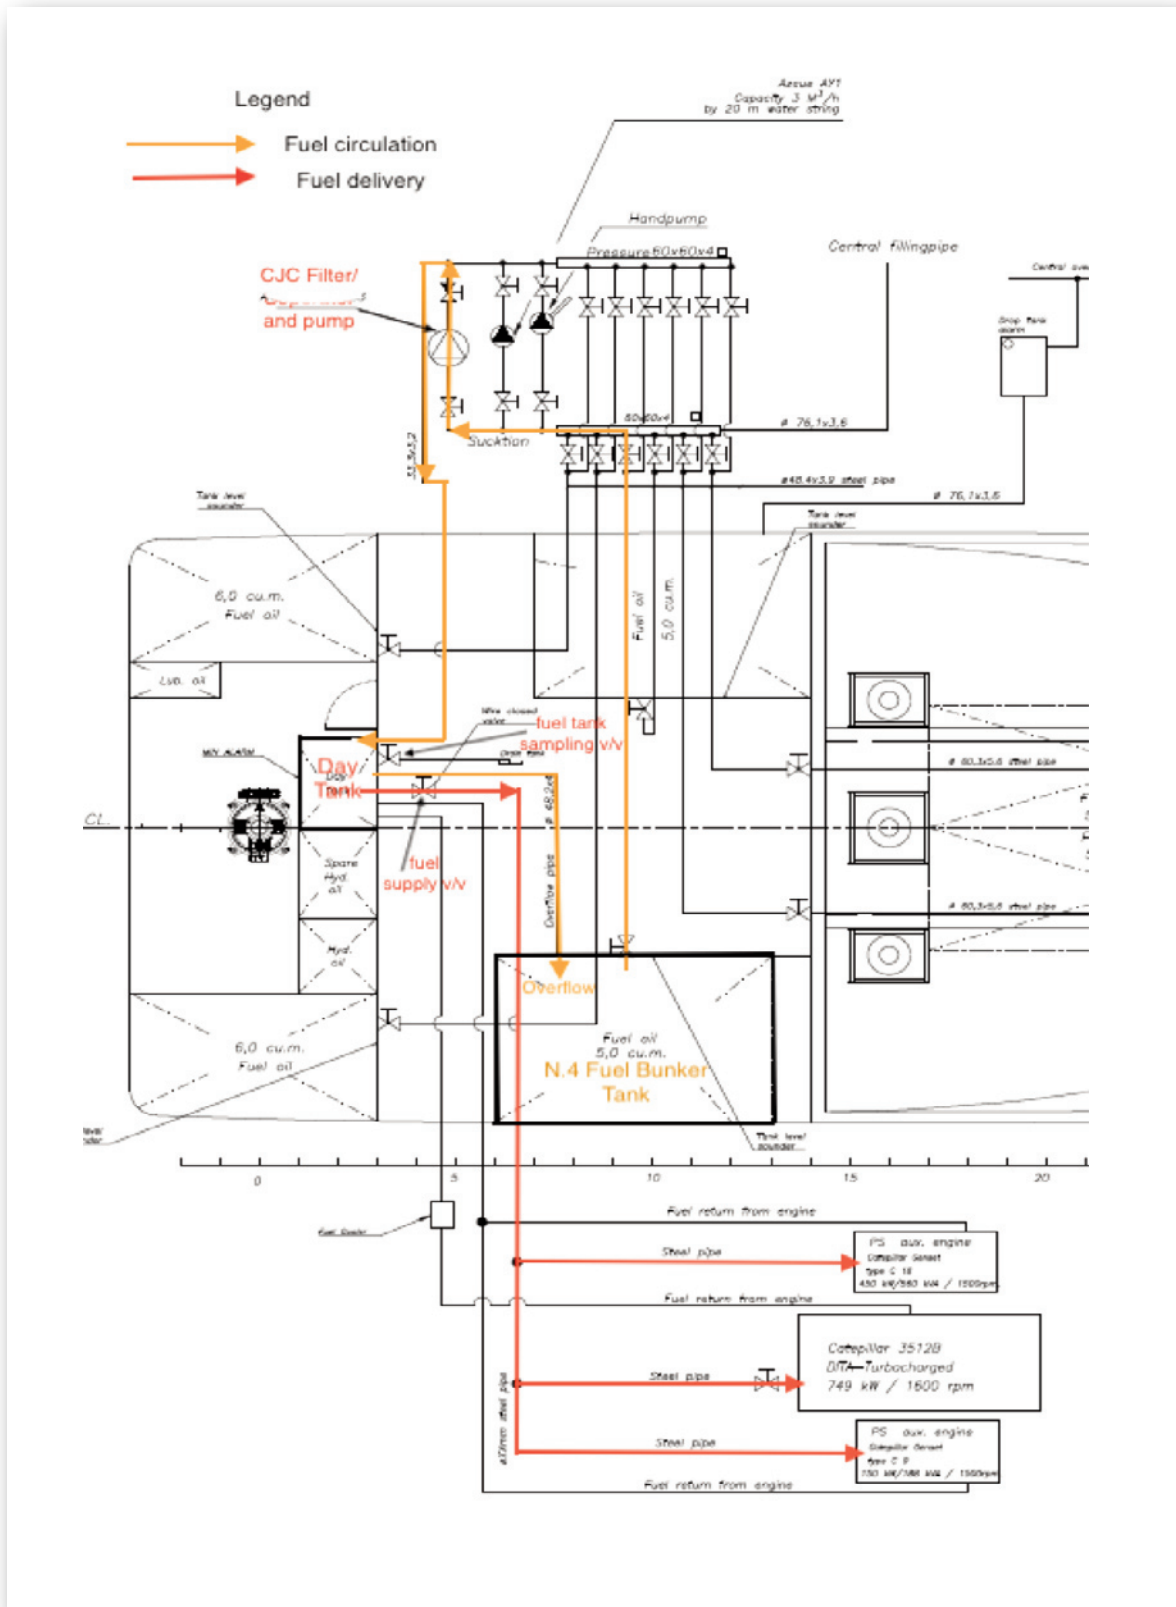
- 4.6.2 The second electrical power failure and the subsequent loss of propulsion power event suggest that the seawater flooding into No.4 fuel bunker tank and the practice of continuous recirculation of fuel from No.4 fuel tank to the Day Tank quickly resulted with inundation of seawater into the fuel pipes supplying fuel to the diesel generators and main engine. This hypothesis is supported by Crewmember No.1 who reported that there appeared to be significantly more pressure than normal in the fuel Day Tank when he opened the sampling valve to test the tank contents and he saw an amount of water issuing out of the sample valve and from the CJC filter drain valve at that time. The hydrostatic pressure of the sea quickly filled and pressurised the ruptured No.4 fuel tank while the CJC filter pump continued to operate, pumping sea water into the Day Tank (until the time of the electrical blackout). The normal overflow of diesel from the Day Tank into No.4 tank would be stopped by the hydrostatic back pressure from No.4 fuel tank. The head of pressure within the Day Tank would thereby increase to a higher head of pressure than when normally overflowing into No.4 fuel tank. Seawater entering the Day Tank would displace the diesel fuel from the lower level of the tank bottom (diesel fuel having a lower specific gravity and therefore lighter than seawater).

- 4.6.3 At 400 litre/hour pumping rate the CJC filter would pass approximately 100 ltr of seawater from the flooded No.4 fuel bunker tank into the Day Tank in the 15 minutes between the initial grounding and the vessel's electrical failure and dead ship condition. Having regard to the proximity of the fuel suction pipe supplying the generator and main engine diesel engines to the lowest level of the Day Tank the water contamination of the fuel supply system would follow shortly after water entered the bunker tank. A small quantity of water into the Day Tank would be sufficient to significantly contaminate the fuel supply lines and quickly stop the generator and main engine.

- 5.3 The rupture of No.4 fuel tank immediately filled the tank with seawater and the practice of continually circulating fuel oil through the CJC filter in turn contaminated the daily service tank supplying fuel to the main engine and the generators, causing the vessel to lose electrical and propulsion power. If the transfer and recirculation of fuel from the bunker tank through the CJC unit into the Day Tank had been stopped as the vessel approached shallow waters and restricted navigation, or if a procedure was in place to stop this pump should a suspected grounding event occur, then the Day Tank fuel contents would not have been contaminated and the vessel would not have lost power after the first grounding.

Fig.7. Fuel Circulation and Supply System (schematic).
