## SAFETY INVESTIGATION REPORT

REPORT NO.: 15/2020

**MV KLIMA**  
**Allision with the Marshall Island**  
**bulk carrier *SPRING SNOW* and the**  
**Singapore registered bunker barge *LIBRA***  
**in the Eastern Special Purpose Anchorage,**  
**Singapore**  
**05 July 2019**

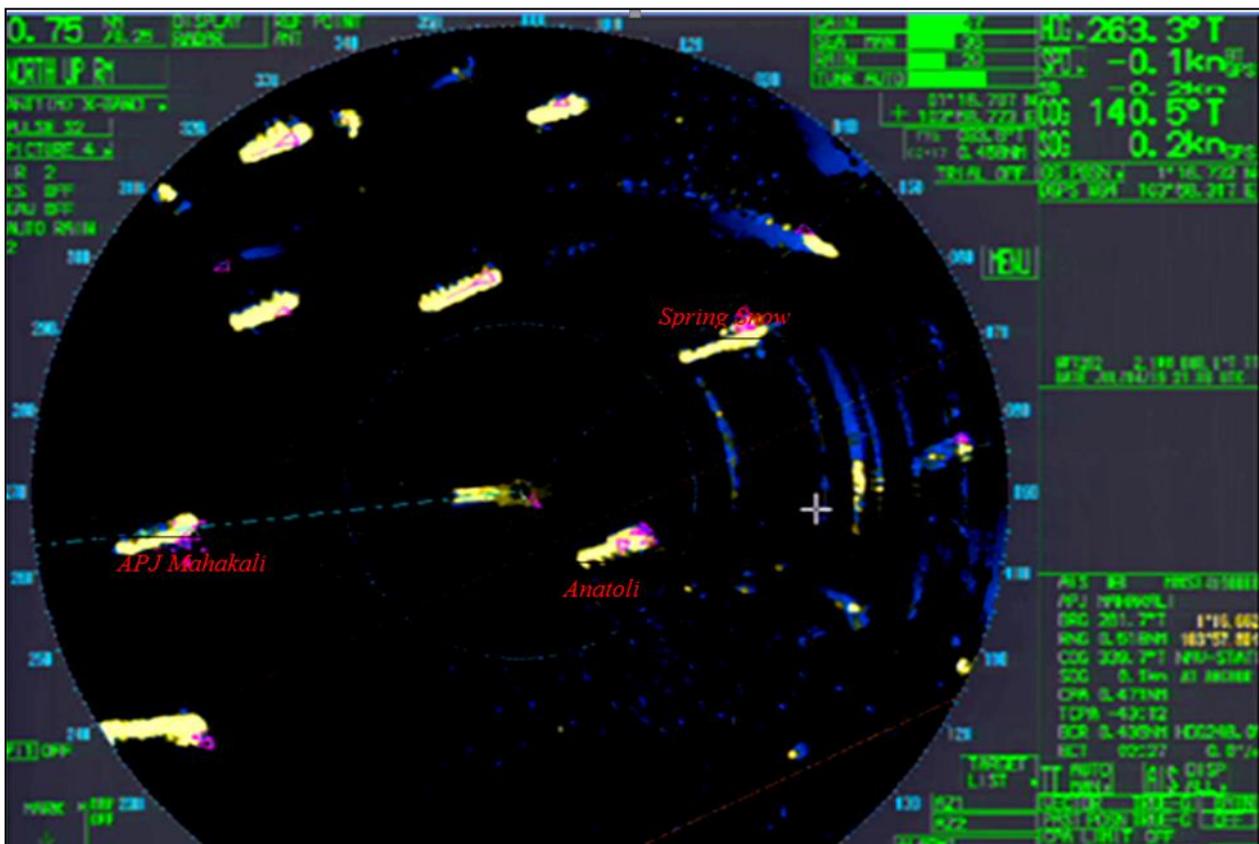
Figure 4: Image from X-band radar (Scale 0.75 nm) showing *Klima*'s anchor position at 0508

Available information suggested that shortly after 0500, severe yaw exacerbated the vessel's rotational motion towards *Anatoli* (Figure 4), which alarmed and induced the OOW to call the master on the bridge. Nonetheless, analysis of the prevailing conditions suggested that although the situation seemed alarming, *Klima* was in no immediate danger and *Anatoli* was nowhere near the 1.2 cables as reported by the OOW.

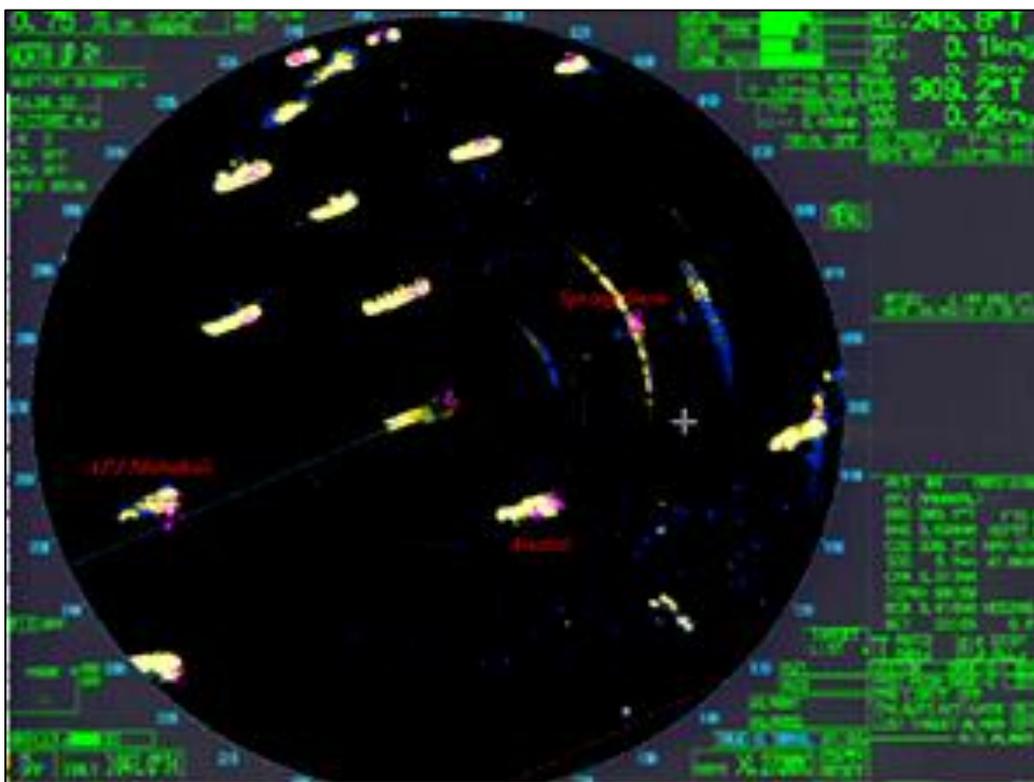
Figure 5: Image from X-band radar (Scale 0.75 nm) showing *Klima*'s position at 0520

Evidence showed that the master observed the vessel's position on the radar and ECDIS upon being called to the bridge. At that moment, *Klima* was about two cables from *Anatoli* (Figure 5). As noted above, there was no immediate danger although yaw and sporadic rotational motion may have brought her unacceptably close to *Anatoli*.

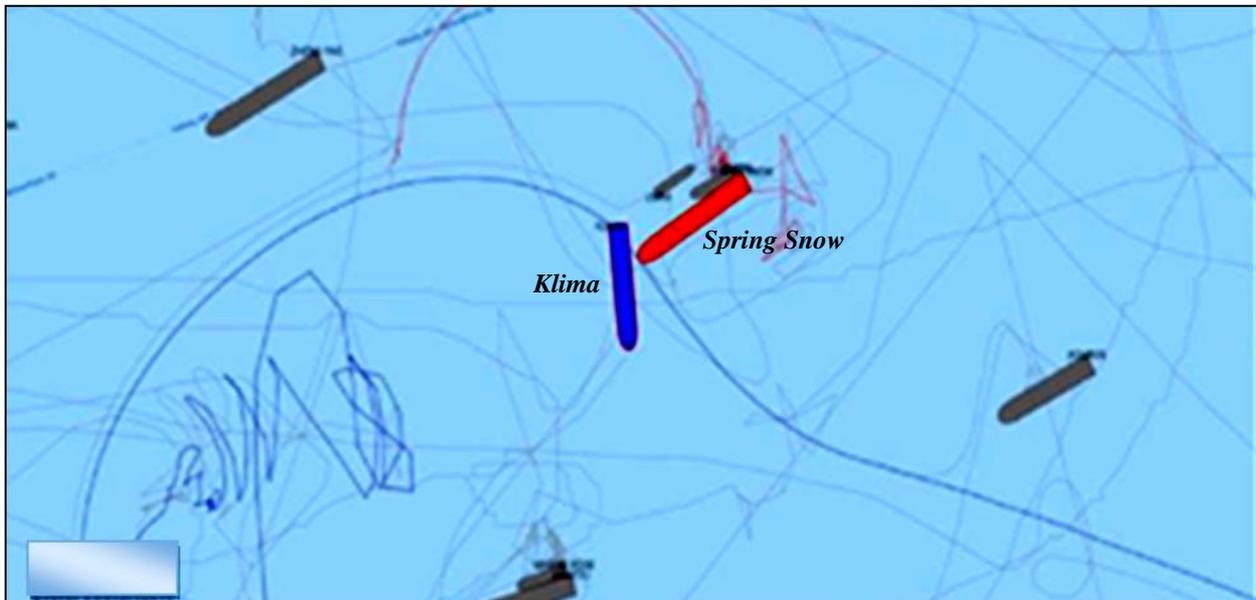
**Figure 6: AIS showing *Klima's* track and collision with *Spring Snow***

Thus, the perceived and actual situations were not aligned, leading to the collision. In particular, the course of *Klima's* movement to secure a suitable anchor position, proximity of anchored vessels, impact of tidal stream on manoeuvrability and the limited options available to the master to counter the vessel's drift towards *Spring Snow* (Figure 6) had contributed to the complexity of the already evolving situation.
