National Transportation Safety Board

Marine Accident Brief

Explosion and Subsequent Sinking of Barge *Alaganik*

Accident type	Fire/Explosion	No. DCA19FM042
Vessel name	<i>Alaganik</i>	
Location	Delong Dock, Canal Passage; Whittier, Alaska 60°46.72' N, 148°39.96' W	
Date	July 7, 2019	
Time	2339 Alaska daylight time (coordinated universal time – 8 hours)	
Injuries	1 fatal	
Property damage	\$700,000 est. (\$300,000 for vessel; \$400,000 for pier damage)	
Environmental damage	1,001 gallons gasoline and 895 gallons diesel fuel consumed by fire or released into environment; light oil sheening observed	
Weather	Visibility 10 miles, overcast, winds calm, seas calm, air temperature 58°F, water temperature 58°F, sunset 2321, evening twilight 0103 ¹	
Waterway information	The Delong Dock is on Canal Passage, a deep narrow protected inlet in Prince William Sound. Tides were mixed and ranged up to 17 feet in July 2019.

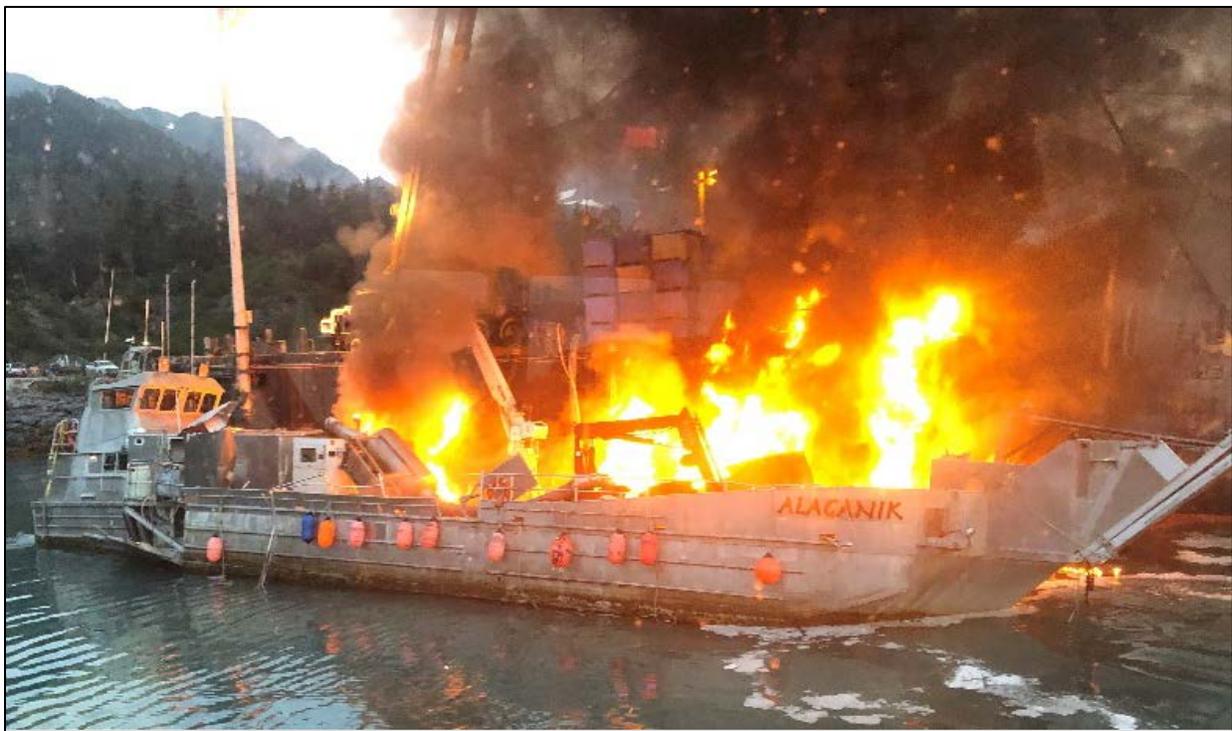
At 2339 that night, an explosion occurred on the *Alaganik*. Witnesses stated that the ensuing fire was initially concentrated on the port side of the vessel, forward. Photographs of the vessel taken just after the explosion show flames concentrated on the port side, with the vessel listing to port. The fire quickly spread to the pier, and fuel that escaped into the water around the barge also burned.

Alaganik on fire after the explosion. (Source: Coast Guard)

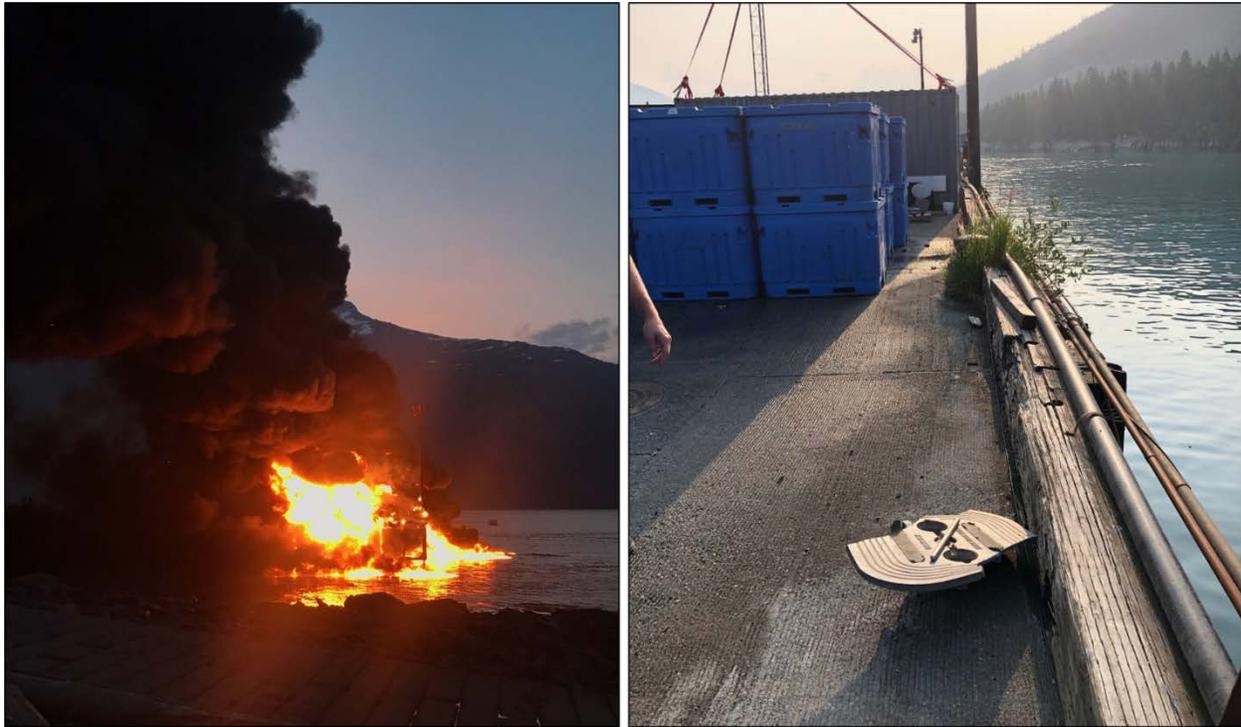
The fire engulfed the vessel, along with three boom-crane trucks and other equipment and gear on the pier. Shore-based firefighters responded to the pier and began fighting the fire. A Good Samaritan vessel that had been moored to the dock near the *Alaganik* got under way, threw a grappling hook over the rail of the barge, and towed the barge away from the pier. The *Alaganik* sank shortly thereafter, at 0229. The firefighters continued to fight the fire on the pier and reported that it was extinguished at 0250 on July 8. A hatch from the port side of the vessel was later found on the dock several hundred feet from the vessel's berth.

At left, fire surrounding the *Alaganik* and the pier. At right, portside hatch from the *Alaganik*, as found on the pier after the explosion. (Source: Coast Guard)

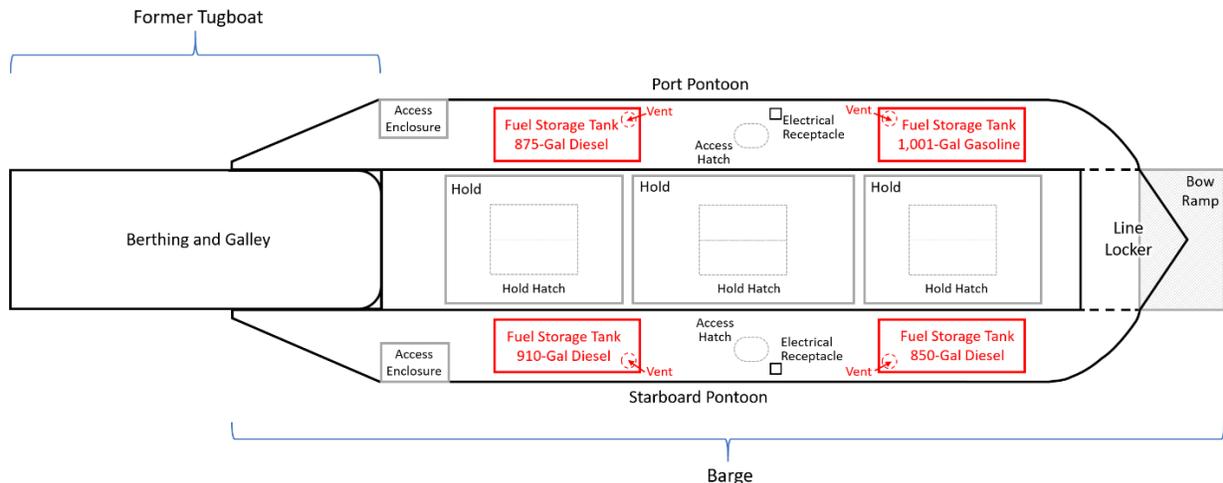
Simplified general arrangement of the *Alaganik*, with fuel amounts in each fuel cargo tank at the time of the accident. Vessel hull dimensions are drawn approximately to scale.

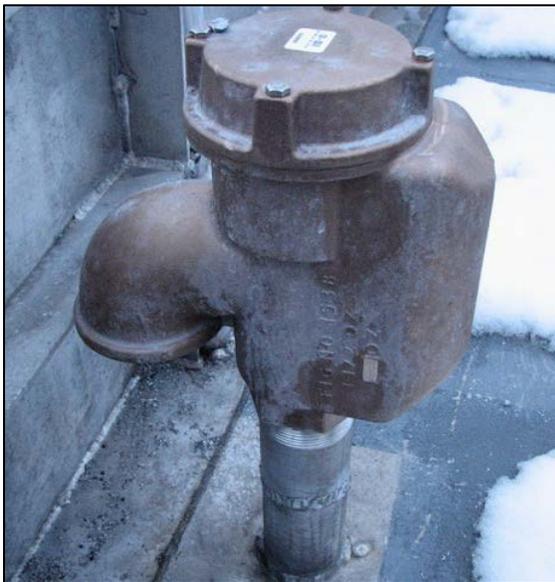
Two-and-a-half-inch anti-flash pressure/vacuum vent installed on the *Alaganik* fuel cargo tanks. (Source: Vessel owner)

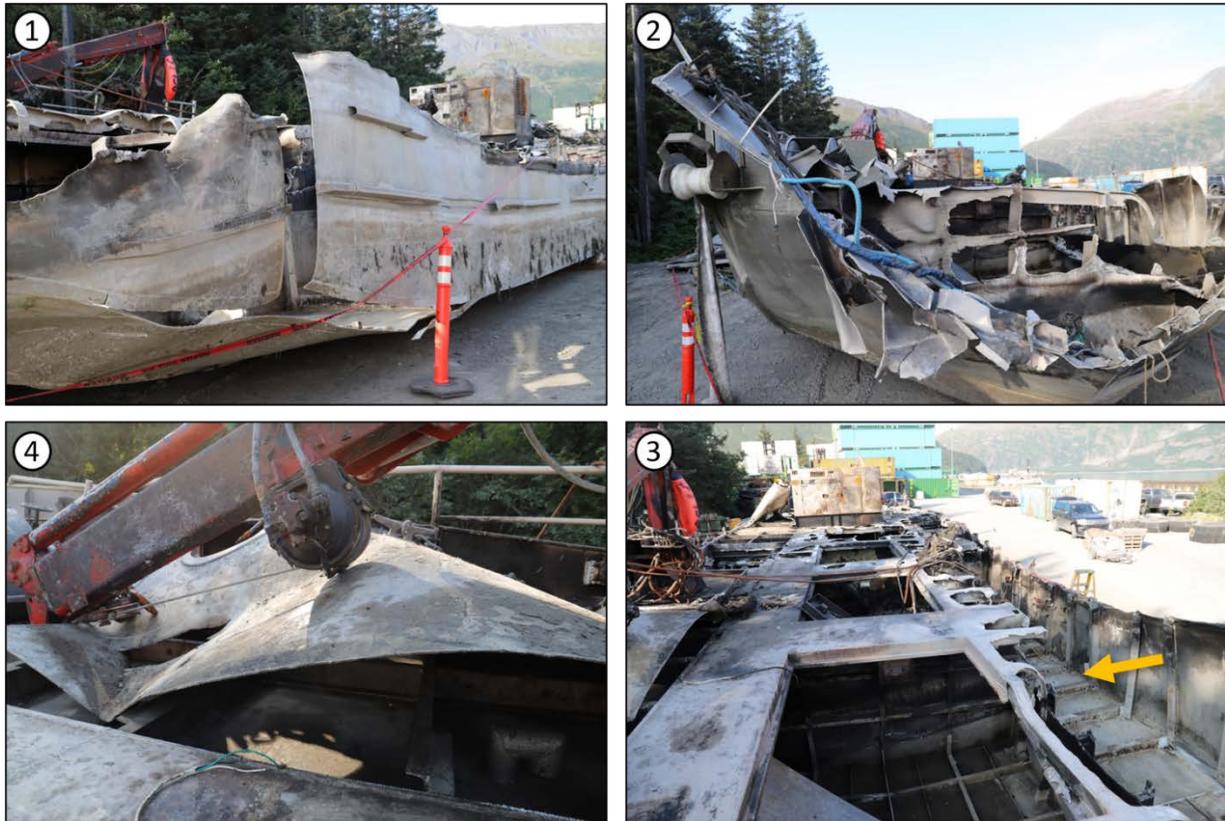
The aluminum hull plating along the forward section of the port pontoon was split and bent outward along weld seams. A significant portion of the hull plating on the bow at the line locker was missing and the remaining plating was cracked and bent outward. A hole in the hull plating midship on the starboard side showed evidence of melted metal.

The deck plating above the port pontoon and the line locker was missing. Deck plating forward on the starboard pontoon was bent or otherwise deformed upward. Deck plating aft on the starboard pontoon was missing, with evidence of melted metal. Deck plating and framing on the center section of the barge had been severely deformed or melted. Much of the deckhouse on the former tugboat section, which was constructed of aluminum, had been melted away or deformed by the heat of the fire.

The fuel cargo tank located forward in the port pontoon (the tank that had been carrying gasoline) was missing. The remaining fuel cargo tanks were in place. The fuel-level gauge tubing for each of the forward and aft fuel cargo tanks in the port pontoon was lying in the pontoon bilge, connected on one end to the discharge piping and disconnected on the opposite end. The end of the gauge line for the forward port tank appeared to be melted.

Salvaged vessel, clockwise from top left: 1) forward side plating of port pontoon; 2) bow at line locker; 3) main deck, looking aft from bow at port pontoon, with arrow pointing to approximate location of forward fuel cargo tank; and 4) bent and deformed deck plating forward on starboard pontoon.

Photographs of the vessel just after the explosion show flames concentrated on the port side, with the vessel listing to port. The midship hatch located aft of the forward fuel cargo tank in the port pontoon was found on the pier several hundred feet from the vessel's position. Following salvage, hull plating forward of the fuel cargo tank on the port pontoon was found to be split along weld seams and bent outward. The port forward fuel cargo tank was completely missing. Hull plating on the bow and deck plating forward on the starboard pontoon were bent outward and upward. Taken together, the evidence suggests that the initial explosion occurred in the port pontoon in the vicinity of the forward fuel cargo tank, expanding aft through the port pontoon and forward through the line locker and into the starboard pontoon.
