# REPUBLIC OF THE MARSHALL ISLANDS

### DELICATA CASUALTY INVESTIGATION REPORT

Bosun's Fall Overboard

Rio de La Plata, Oriental Republic of Uruguay | 17 March 2020

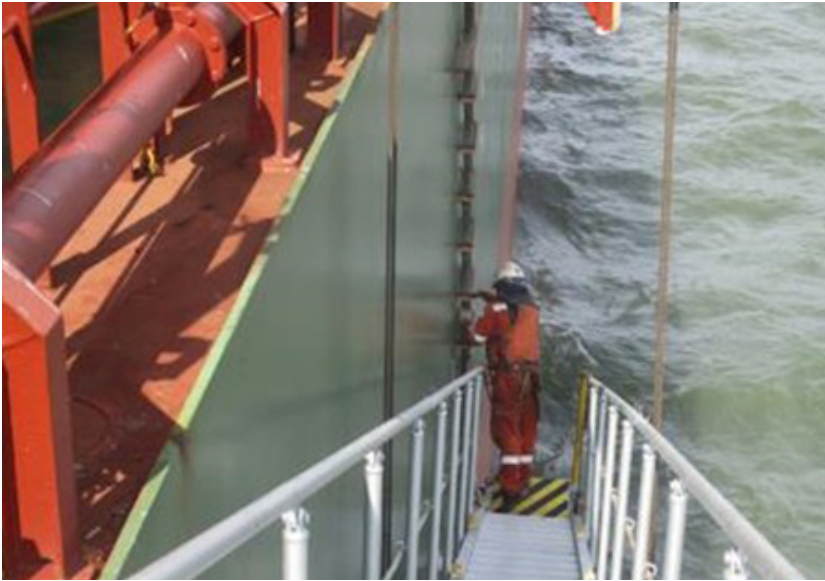
Figure 2: Arrangement of accommodation and pilot ladders at the time of the incident, taken from the top of the accommodation ladder.

13. The OS began loosening the shackles which attached the top of the pilot ladder to the pad eyes on deck. The Bosun attempted to lift the pilot ladder. They were unable to raise the pilot ladder because it was secured to the hull near the accommodation ladder's bottom platform. The Bosun then went down the accommodation ladder to untie the pilot ladder from the hull securing point, while the OS remained at the top of the pilot ladder.

The cause of the Bosun's fall from the accommodation ladder is not known since the fall was not witnessed.
