National Transportation Safety Board

Marine Accident Brief

Fire at Jackson County Park Marina

Accident type	Fire/Explosion	No.	DCA20FM013
Vessel/Marina name	<i>Dixie Delight</i> /Jackson County Park Marina, Dock B		
Location	Lake Guntersville/Tennessee River, Scottsboro, Alabama 34°38.24' N, 086°00.82' W		
Date	January 27, 2020		
Time	0035 central standard time (CST) (coordinated universal time - 6 hours)		
Injuries	8 deaths, 1 serious injury		
Property damage	>\$500,000 est.		
Environmental damage	An estimated 4,000 gallons of fuel and lube oil were released and consumed during the fire.		
Weather	Visibility 3 miles, overcast, calm; air temperature 41°F, water temperature 41°F; morning twilight 0619, sunrise 0645, evening twilight 1734, evening sunset 1707		
Waterway information	A dam on the Tennessee River at mile 349 creates 75-mile-long Lake Guntersville in northern Alabama. The water depth reported around the marina was 8-10 feet.

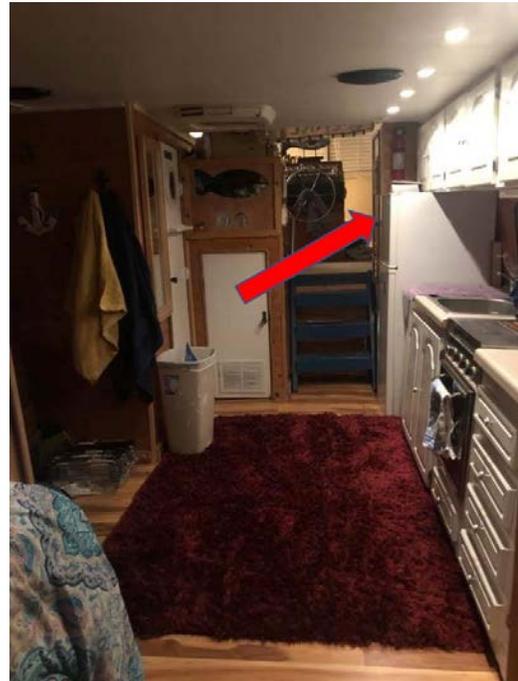
Interior of the *Dixie Delight* prior to the fire, as viewed from the aft bedroom looking forward. The red arrow indicates the location of utility closet adjacent to vessel’s electrical panel. (Source: A. Utech, via Facebook)

The ignition source of the fire aboard the *Dixie Delight* could not be determined because of the scale of fire damage. Considering the owner’s firsthand account and where he first saw flames, it is likely that the fire originated in the bulkhead between the vessel’s electrical panel and storage closet. The fire spread due to the neighboring vessels of similar fiberglass construction, an abundance of combustible lawn furniture on the vessel decks and open dock areas, and the presence of portable liquid propane cylinders used for barbecue grills, which all increased the dock’s fire load.

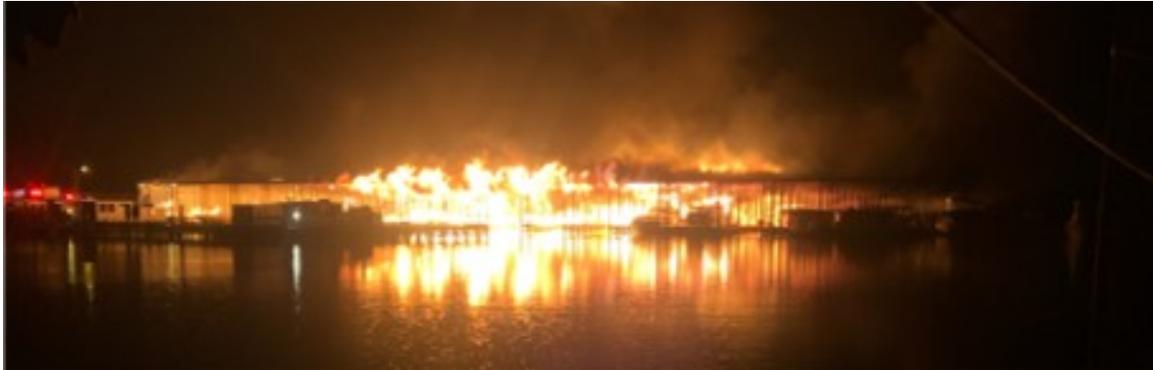
Dock B engulfed in flames at 0054 CST. (Source: J. Lindsey)

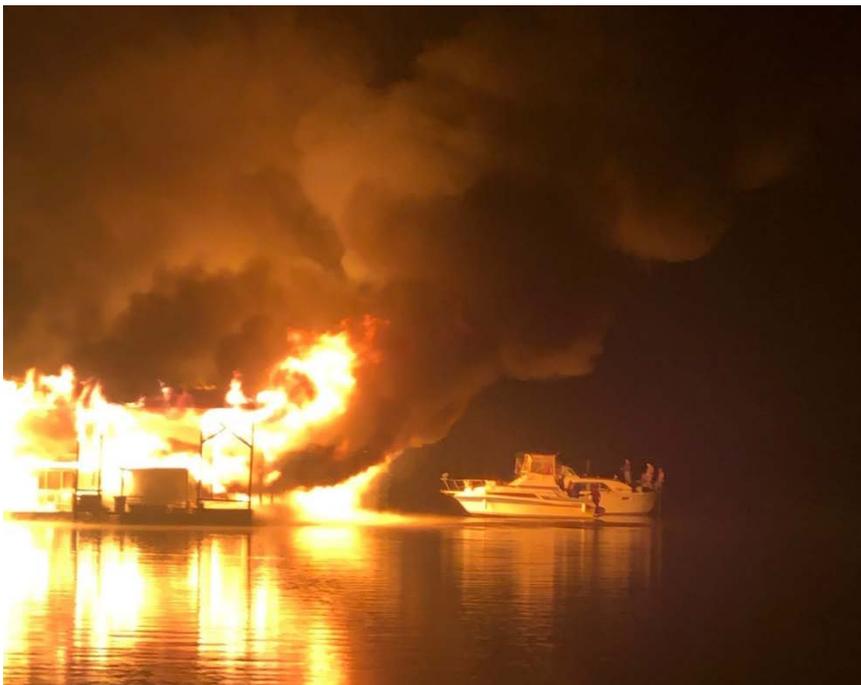
Evacuees aboard the two vessels prior to catching fire, drifting toward the end of Dock B at 0109 CST. (Source: J. Lindsey)

The evacuees aboard the two vessels had been unable to reach shore or any of the other docks at the marina. As the fire fully engulfed the dock, the two boats were drawn back toward the end of Dock B, in what some survivors referred to as a fire-induced draft or vortex. At 0109, an eyewitness photograph captured the two vessels drifting just feet from the end of the Dock B.

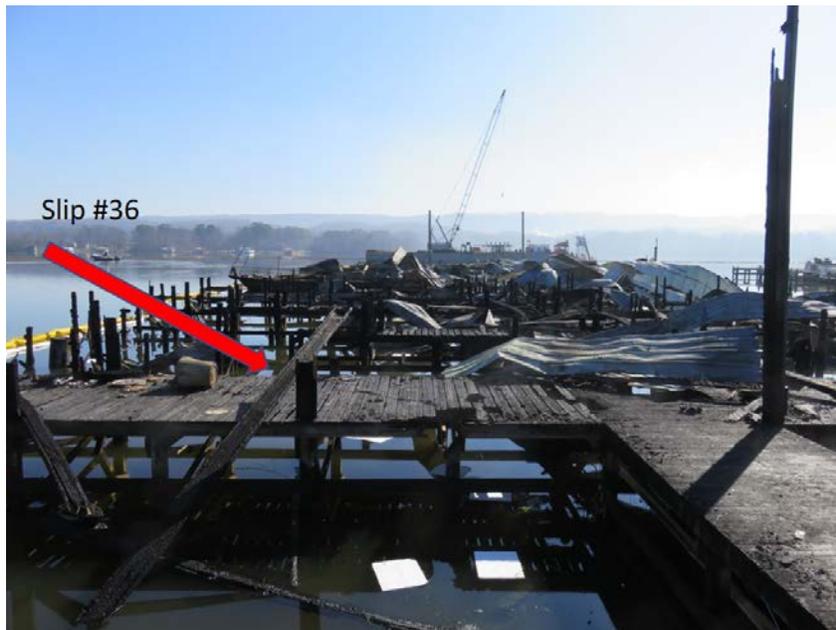
Dock B the day after the fire. The remains of the *Dixie Delight* are submerged in slip #36.

The wreckage of the *Dixie Delight* was located submerged in its original slip. What remained of the vessel was salvaged two days after the fire and examined by state and federal fire investigators. After a thorough and systematic examination of the wreckage, the State fire investigator was “unable to determine an area of origin due to all combustible material being consumed by the fire.” The State’s report also concluded that the fire appeared to be “accidental.”
