REPUBLIC OF THE MARSHALL ISLANDS

CAPE MORETON CASUALTY INVESTIGATION REPORT

Collision with Fishing Vessel

East China Sea | 23 January 2019

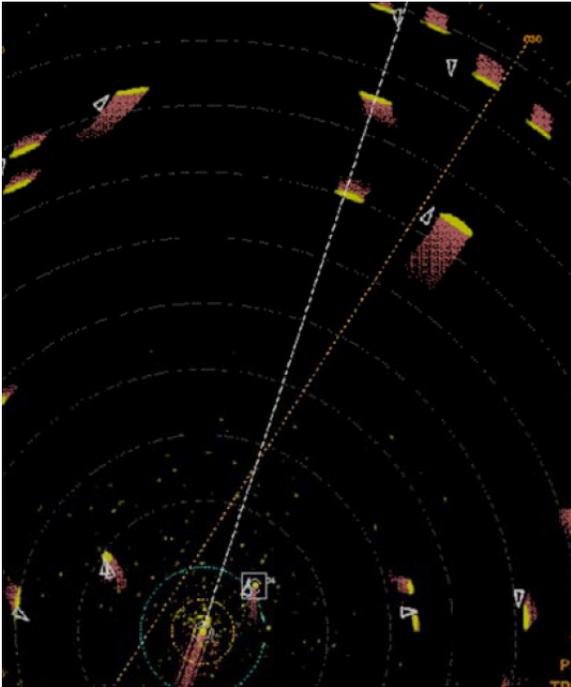
8. At about 0300 on 23 January 2019, MIN XIA YU 04555 began deploying a fishing net with the vessel’s Chief Officer (C/O) at the helm. It was reported that the vessel’s port and starboard sidelights and masthead lights were on. It is also reported that the required lights for a vessel engaged in fishing, other than trawling, were not energized.²
9. At about 0352, CAPE MORETON was steaming on a north-northeast heading at a speed of 16.8 knots when a fleet of fishing vessels was identified by radar directly ahead (*see Figure 1*). The Second Officer (2/O) was the Officer on Watch (OOW) at the time.

Figure 1: Radar image from CAPE MORETON at 0352 showing the fishing vessels ahead.

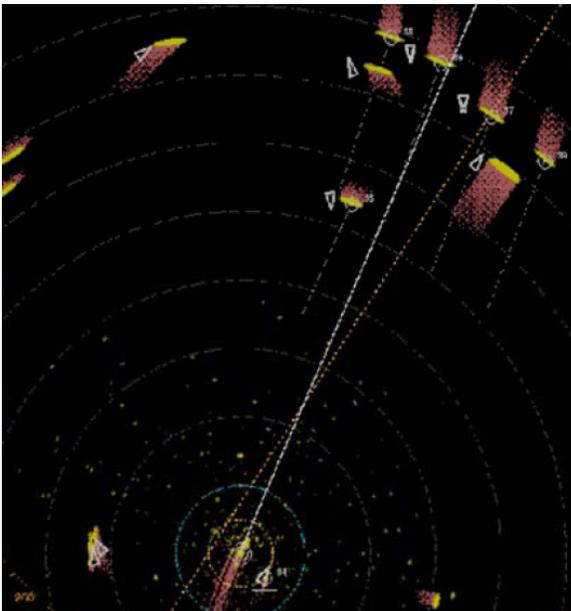
10. At about 0357, the C/O arrived on the Bridge of CAPE MORETON for the 0400-0800 watch.
11. By 0357, CAPE MORETON's automatic radar plotting aid (ARPA) displayed the relative motion of the fishing vessels (see Figure 2).

Figure 2: Radar image from CAPE MORETON at 0357.

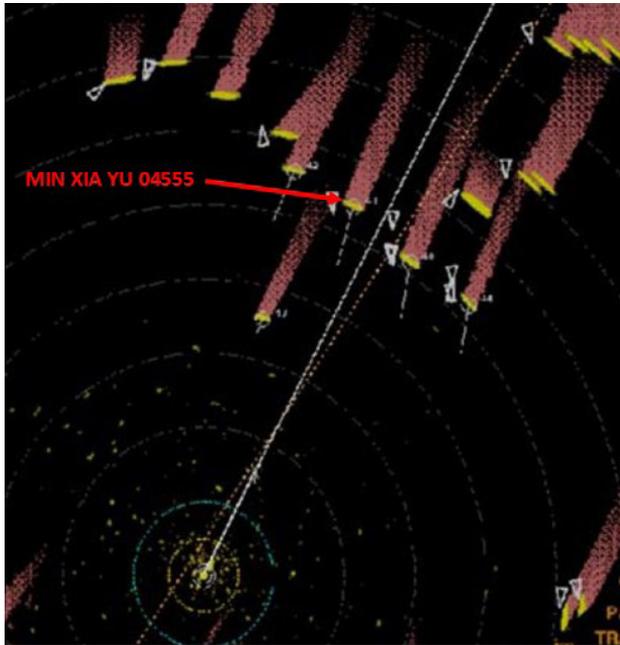
12. At 0403, the C/O relieved the 2/O as the OOW. CAPE MORETON was heading 028 degrees True (°T) at 17.2 knots. The echoes of the fishing vessels, along with their history trail, were visible on the radar. The automatic identification system (AIS) information for MIN XIA YU 04555 was displayed on the radar and automatically acquired by the ARPA at 5.04 NM off CAPE MORETON's port bow. The fishing vessel was reported as heading 177 °T at 8.6 knots. The closest point of approach (CPA) was 0.14 NM (see Figure 3).

Figure 3: Radar image from CAPE MORETON at 0403.

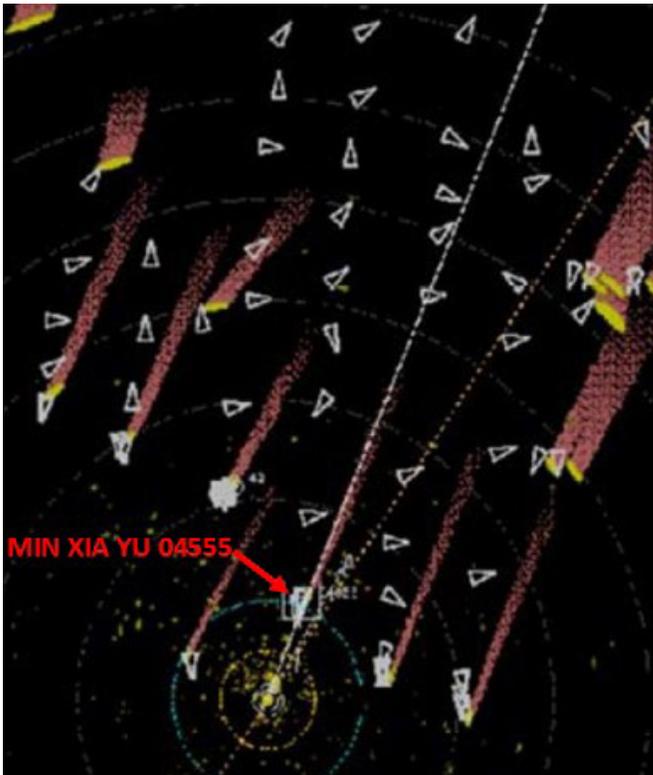
13. At about 0405, MIN XIA YU 04555 finished setting its nets and was no longer actively fishing.³ Seven crewmembers remained on deck to clean. The MIN XIA YU 04555's C/O reported first observing CAPE MORETON off the starboard bow at about 4 NM. He also reported seeing CAPE MORETON's port sidelight and both masthead lights.
14. At 0409, MIN XIA YU 04555 was 2.88 NM from CAPE MORETON, with the same relative position. The CPA was 0.02 NM and the Time to CPA (TCPA) was just under 7 minutes. Both vessels maintained their course and speed.
15. At 0413, MIN XIA YU 04555 was 1.16 NM from CAPE MORETON, remaining off the port bow. The CPA was 0.07 NM and the TCPA was just under 3 minutes (see Figure 4).

Figure 4: Radar image from CAPE MORETON at 0413.

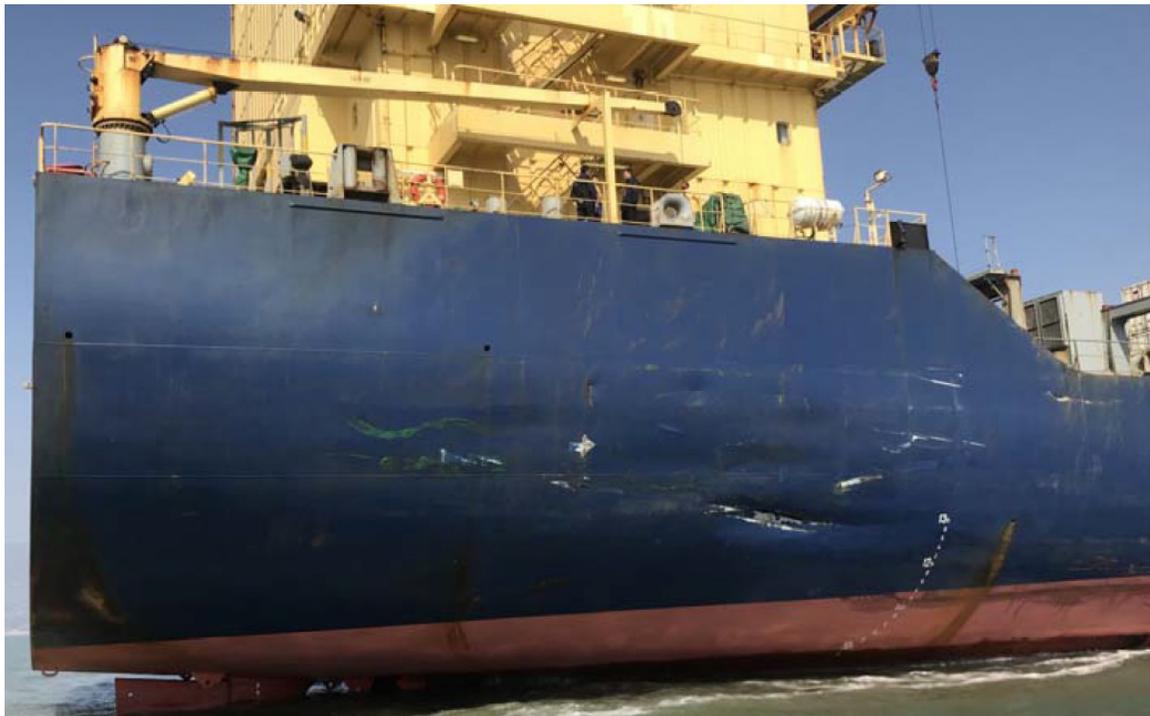
26. As a result of the collision, CAPE MORETON suffered indents and a breach of the side shell along the starboard quarter (see Figure 5).

Figure 5: Damage to hull of CAPE MORETON.

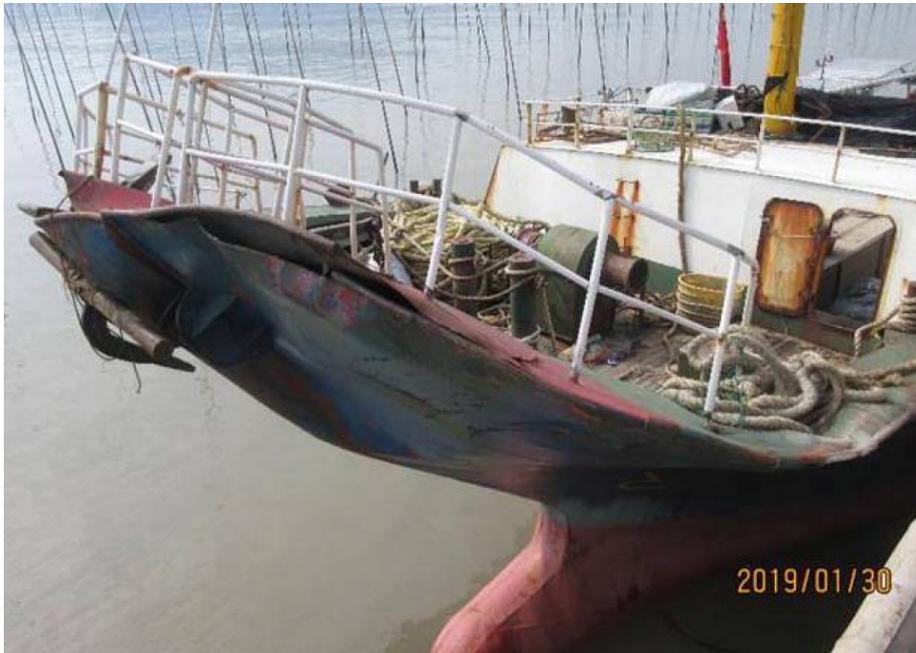
27. MIN XIA YU 04555 suffered damage to the bow but was able to proceed to port under its own power (see Figure 6).

Figure 6: Damage to the bow of MIN XIA YU 04555.
