POLAR COD CASUALTY INVESTIGATION REPORT

Fall from Height in Engine Room

Arabian Gulf | 14 May 2019

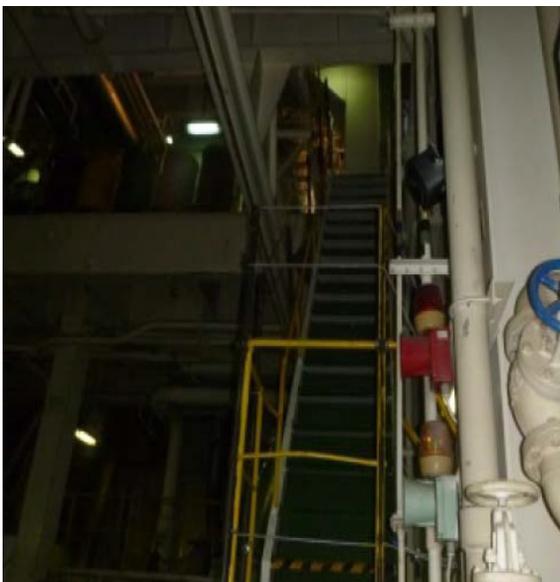
16. The ladder between the Engine Room's second deck and upper deck is inclined at about 56 degrees (°) and is 76 centimeters (cm) in width (*see Figure 1*).

Figure 1: Photo of the inclined ladder, taken from the second deck.

1. The height of the handrail on the involved inclined ladder was immediately raised and an intermediate guard between the stringer and the handrail was fitted. The same modification was also implemented on a sister ship under the Company's management.

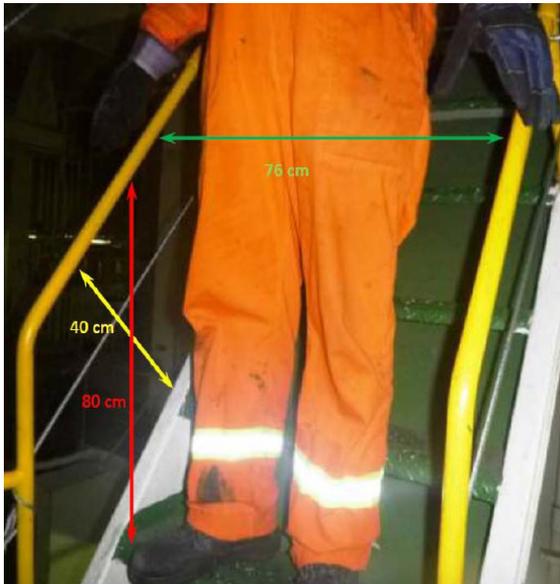
17. The ladder has 28 millimeter (mm) diameter handrails on both sides. These handrails are 80 cm vertically above the ladder treads and 40 cm from the side stringers, when measured perpendicularly (see Figure 2).

Figure 2: Dimensions of inclined ladder between the second deck of Engine Room and the upper deck. (Note: Rope which is affixed in the position of an intermediate railing was not in place at the time of the incident.)

18. The design specification for the railing indicates that the railings on this ladder should be 50 cm from the stringers. An intermediate railing was not included in the design, nor was one fitted during new building. There was not an intermediate railing present at the time of the incident.
19. The treads are parallel, spaced 25 cm vertically from each other, and 20 cm in depth. The treads are made of diamond plate steel with a rounded nose.

The handrails of the inclined ladder that the 3/E likely fell from were only 80 cm above the leading edge of the tread. The design specification of POLAR COD indicated that the perpendicular distance from the stringer to the top of the handrail was supposed to be 50 cm. However, it was found that the handrail of the inclined ladder from the second deck to the upper deck was only 40 cm perpendicularly from the stringer. The railing, therefore, was 80 cm above the ladder treads, lower than designed.
