DUTCH
SAFETY BOARD

Fatal outcome following parting of mooring line

Lessons learned from the accident
on board the RN Privodino

The Hague, November 2020

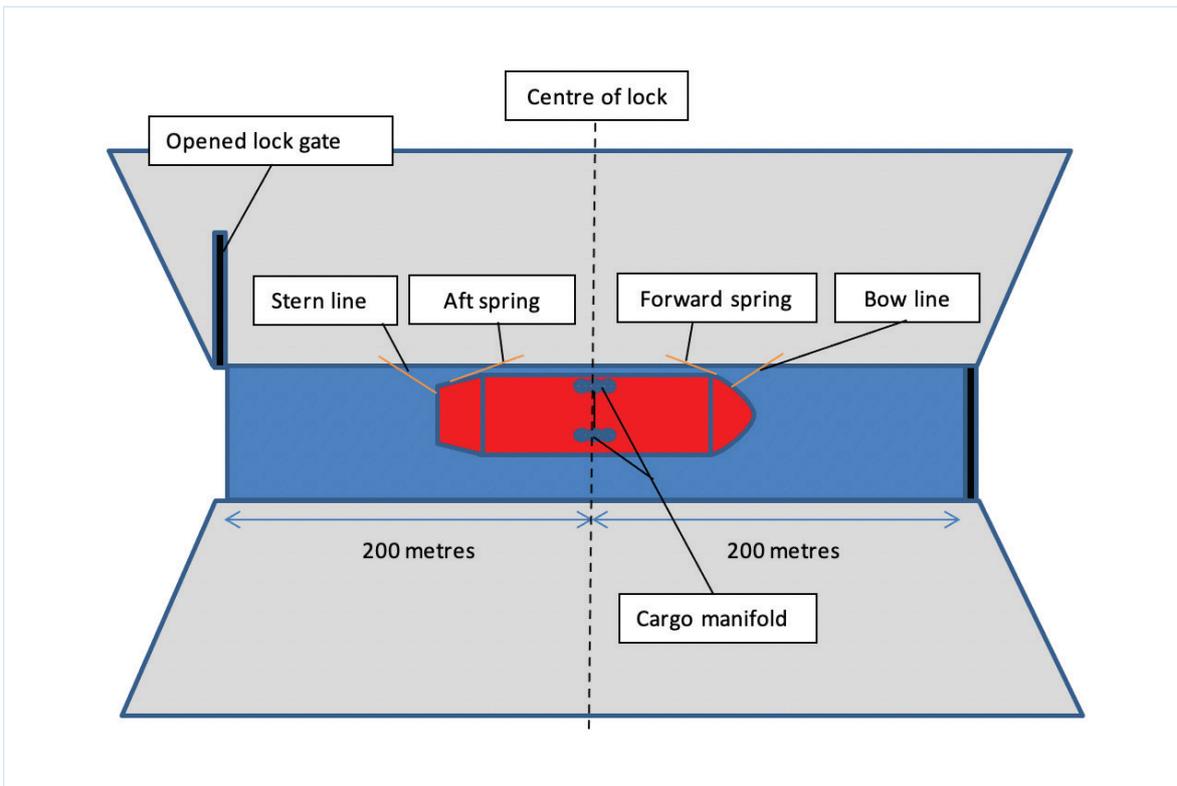
Figure 2: Planned mooring configuration of RN Prividino on 28 June 2018 at the lock in IJmuiden.

Shortly before entering the port of IJmuiden, the two mooring teams were called on deck. Earlier in the afternoon, they had received a briefing from the first officer regarding the passage through the lock and mooring in the Sonthaven. The master instructed the mooring teams via portable radio that the vessel would be mooring in the lock on the port side, with a bow line and a forward spring on the fore part, and a stern line and aft spring on the stern part. On the fore part, the spring would have to be placed first, and on the stern part, the stern line first. Figure 2 shows the planned position and mooring configuration in the lock on 28 June 2018.

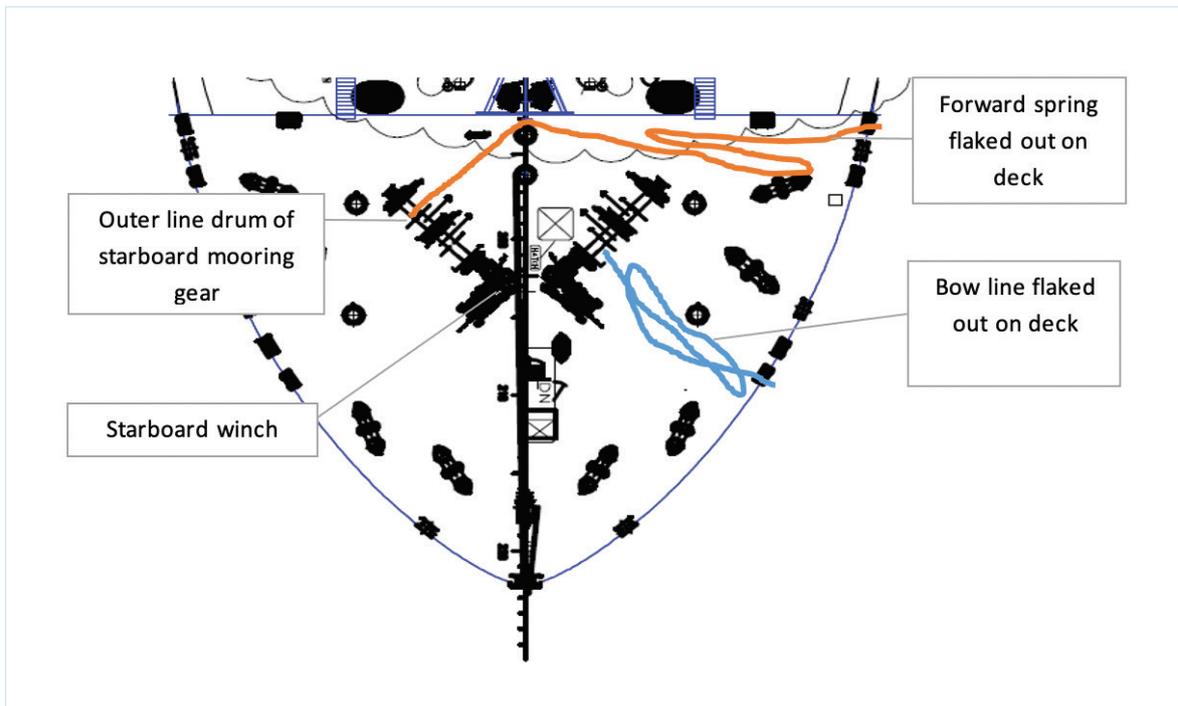
Figure 3: Situation on foredeck upon entering the lock.

The two mooring teams then took all the necessary preparatory measures. On the foredeck, the bow line and forward spring were flaked out on the deck in several bights, so that as they were paid out to shore, length was available. The winches and mooring line drums were engaged and prepared for use.

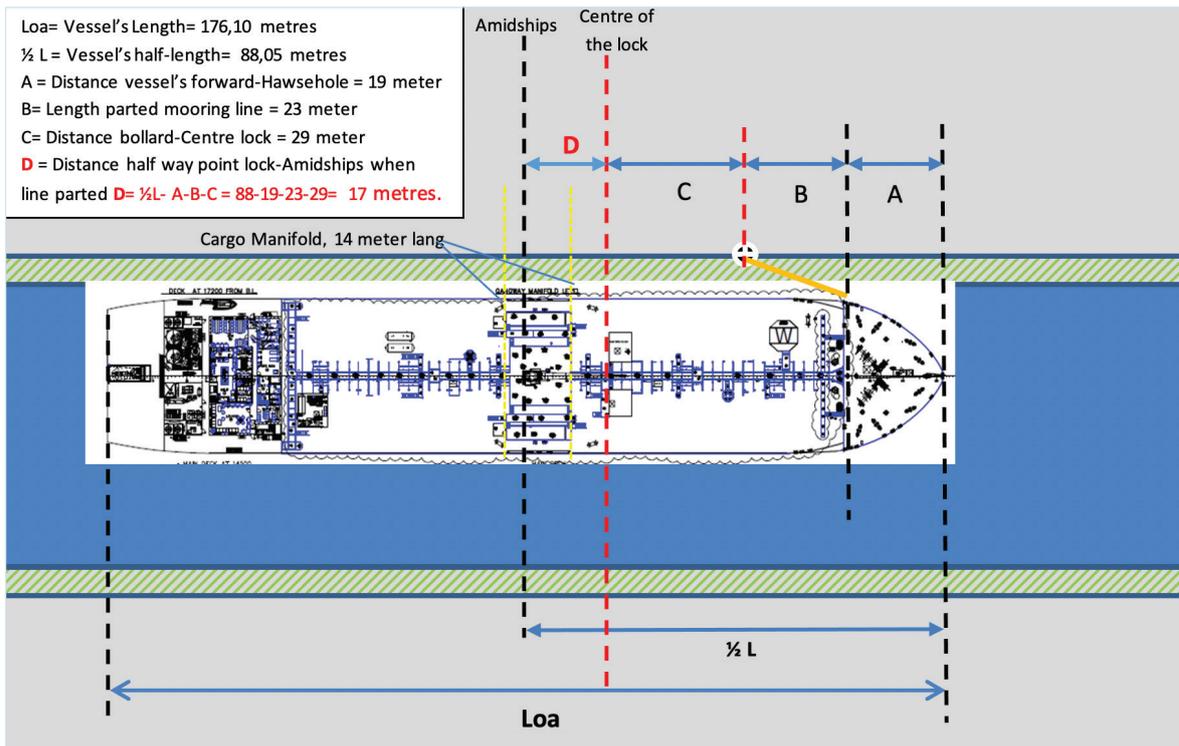
Figure 4: Position RN Privodino at the moment the mooring rope parted broke.

The investigation revealed that the mooring line parted at the hawsehole it was running through. The Amidships of the RN Privodino was, at that moment still about 17 metres away from the halfway position in the lock. This distance was, as been shown in figure 4, calculated by taking together the distance between used bollard and centre of the lock, the length of the parted shore side section of the mooring line and the distance between most forward point of the vessel and the hawsehole, and compare this total distance with the half-length⁵ ($\frac{1}{2} L$) of the vessel. This calculation revealed that the vessel should have proceeded 17 metres more in order to let the vessel's Amidships end up more or less in the halfway position of the lock, as discussed between master and pilot.

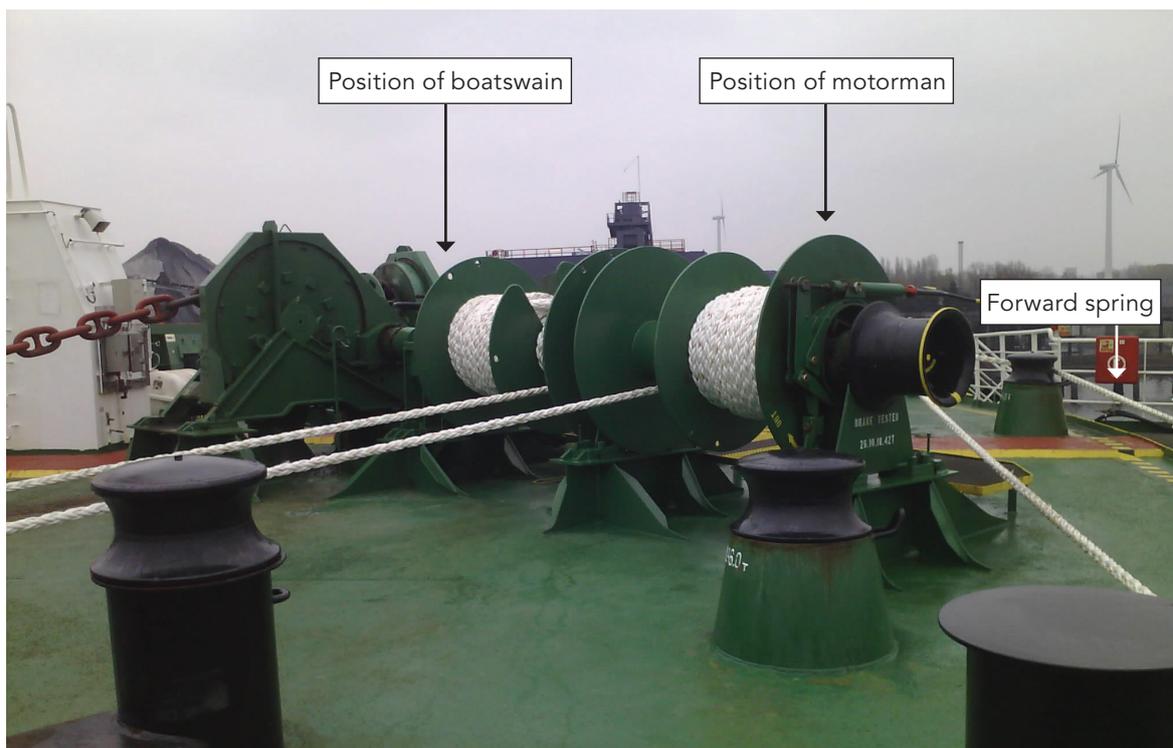
Photograph 6: View from the position taken up by the third officer (Source: Dutch Safety Board)

When the forward spring was sent ashore, and up to the moment the accident happened, the third officer stood on a raised position near the port railing, close to the point where the spring left the vessel, via a fairlead. From that position, he had a clear view of the quayside, the lock gate, the transfer of the forward spring to shore, and the two deckhands who stood close to him, waiting until the bow line could be passed over. From this position, his view of the boatswain, who was operating the winches and who stood at a raised point, was hindered by the port mooring gear. He was able to partially see the boatswain, but could not see what the boatswain was doing. The third officer had no view whatsoever of the motorman, who was located on the starboard side of the foredeck (see photograph 6).

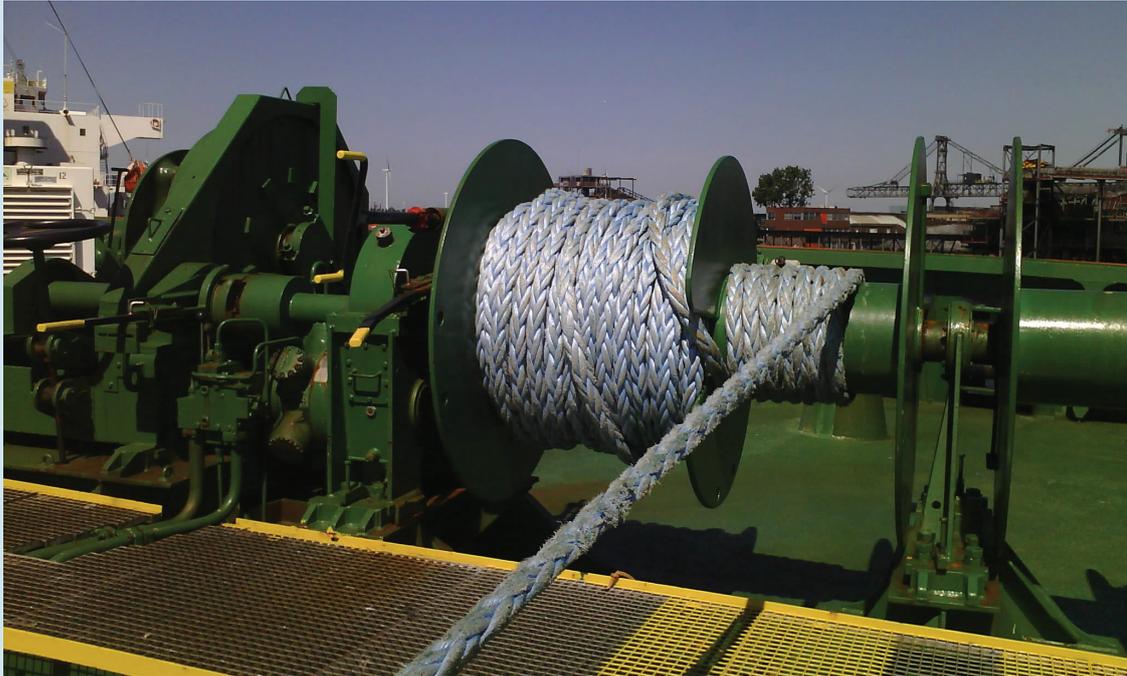
Photograph 7: Mooring line drum with split drums on the foredeck of the RN Privodino (Source: Dutch Safety Board)

The mooring line drums on the foredeck of the RN Privodino are therefore each split into two separate drums. The example in photograph 7 shows that the storage drum is located on the left, with many layers of stored mooring line. The mooring line runs from the storage drum to the tension drum on the right. It is the role of this tension drum to maintain the force of the mooring line at a pre-set tension. The precondition, as shown on the photograph, is that only a single layer of mooring line may be wound around the tension drum. The tension drum is large enough for a maximum of ten turns in each layer.

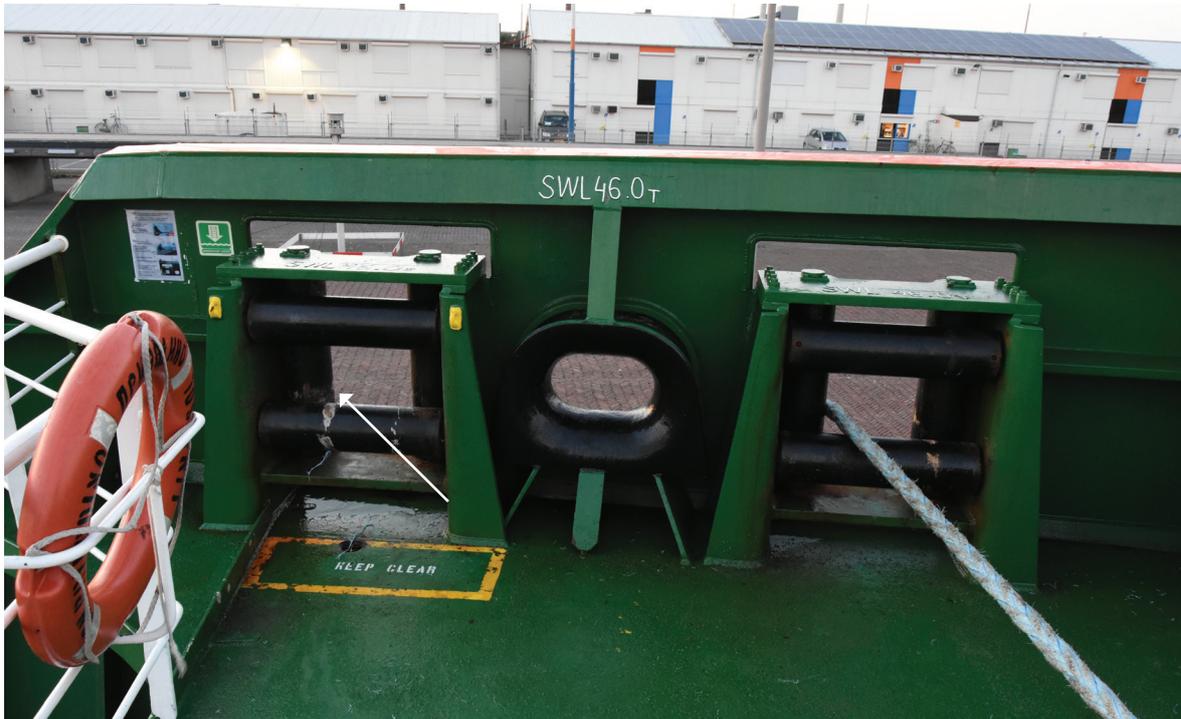
Photograph 8: Location where the forward spring broke (Source: Police).

The direct cause of the death of the motorman was the parting of the forward spring. The spring parted because, with the spring already wrapped around the bollard on shore, the vessel was still moving forward when the forward spring on the mooring line winch was transferred from the storage drum to the tension drum and paid in for 3 turns. After that, the forward spring could not be paid out quickly enough anymore. The transfer of the forward spring to the tension drum was executed without any given orders to do so.

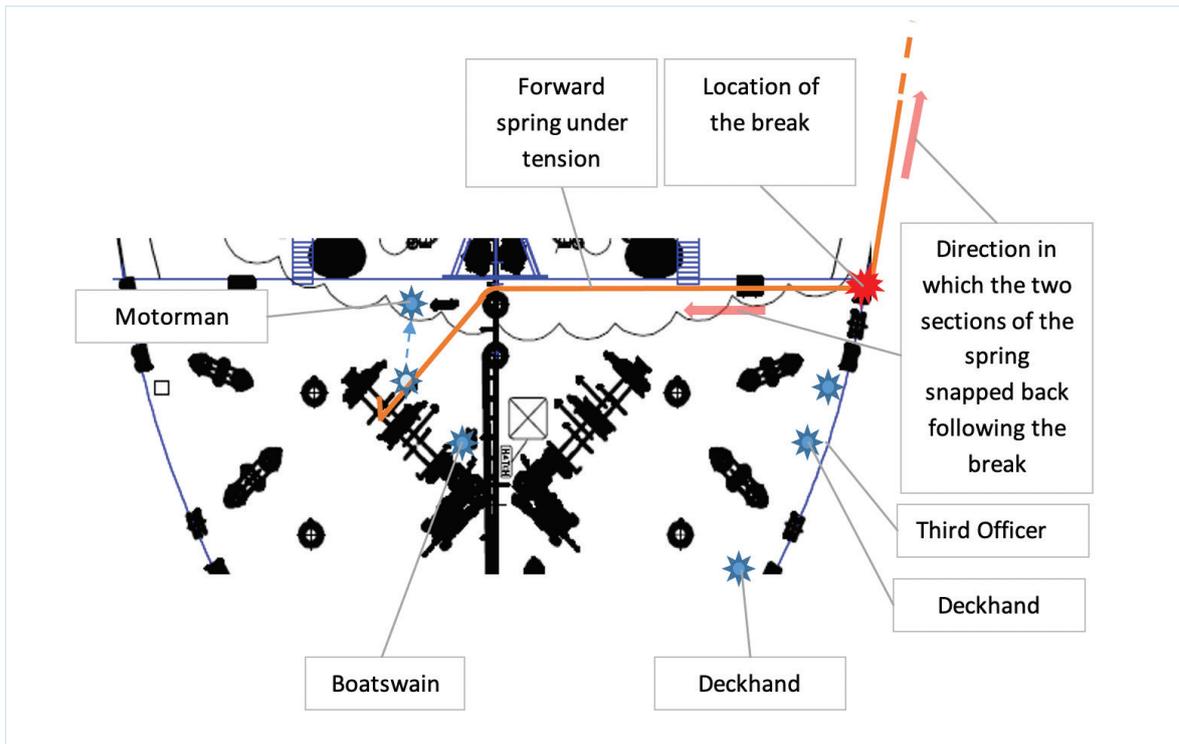
Figure 9: Situation on the foredeck at the moment the forward spring broke.

After completing three turns around the drum, the boatswain observed that the spring line was becoming far too tight. While attempting to release the spring as quickly as possible, with the winch, he received warnings both in the form of a shout from the third officer and via a call from the master on the portable radio. Within three seconds of these warnings, the spring line parted at the position of the fairlead. The section of the mooring line between the fairlead and the drum whipped back across the deck and hit the motorman full in the head. Figure 9 shows the situation on the foredeck at the moment when the spring broke.

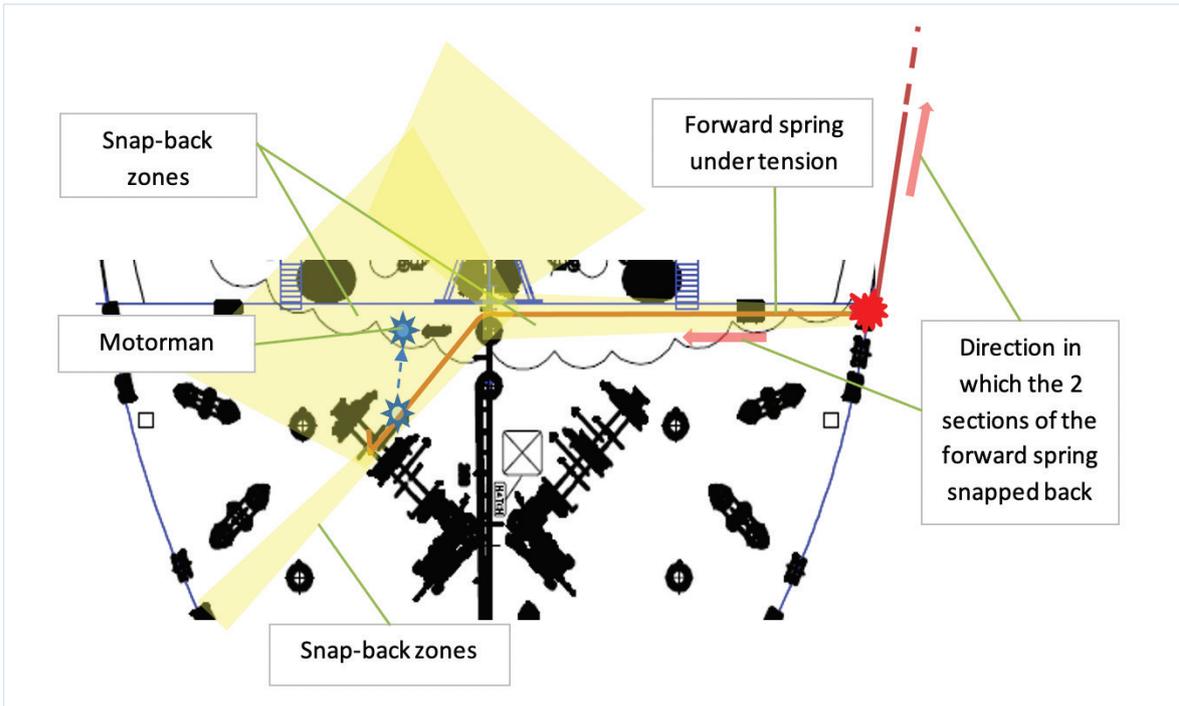
Figure 10: Snap-back zones of the forward spring at the moment when it broke.

Parting of mooring lines have always been recognized as a source of danger in the shipping sector. A mooring line under tension has absorbed a huge amount of energy, and this energy is 'stored' in the line, as it were. If the mooring line breaks, this energy is suddenly released. The breaking ends of mooring lines therefore recoil or snap back violently, covering large distances at high speed. In shipping, this phenomenon is referred to as snap back. It goes without saying that being present in a snap-back zone is very dangerous, in particular if a mooring line breaks. However, during mooring and unmooring, it is impossible to not work in or in the immediate vicinity of these zones. In Figure 10, the areas marked in yellow broadly indicate the snap-back zone of the forward spring at the moment when it broke. The motorman was located within this zone. Photograph 11 shows how crew members are warned about the snap-back zones when they enter the foredeck.

One important barrier for preventing accidents due to a breaking mooring lines involves working with snap-back zones. Snap-back zones are marked zones within which broken mooring line can whip backwards. However, these zones were not marked as such on the deck. Instead, the entire foredeck was identified as a hazardous zone and marked accordingly. The vessel manager supported this approach in the SMS by arguing that due to the various different possibilities for passing a mooring line to the winches and the fact that multiple mooring lines are (or are placed) under tension at any one time, snap-back zones would in fact have to be marked out on large parts of the deck. Because of the many different situations, this would not provide increased clarity for the crew members at work on the deck, and in the judgement of the vessel manager, a false sense of safety would be created. For that reason, the decision was made to identify the entire foredeck as a potential snap-back zone, and to mark it accordingly.

7. In areas with snap-back zones, identify or create safe workstations where those aboard cannot be hit by mooring lines and ropes if they snap back; mark these safe workstations in a recognizable manner and organize the work processes involving mooring lines and ropes in such a way that operations are always undertaken from these safe workstations.

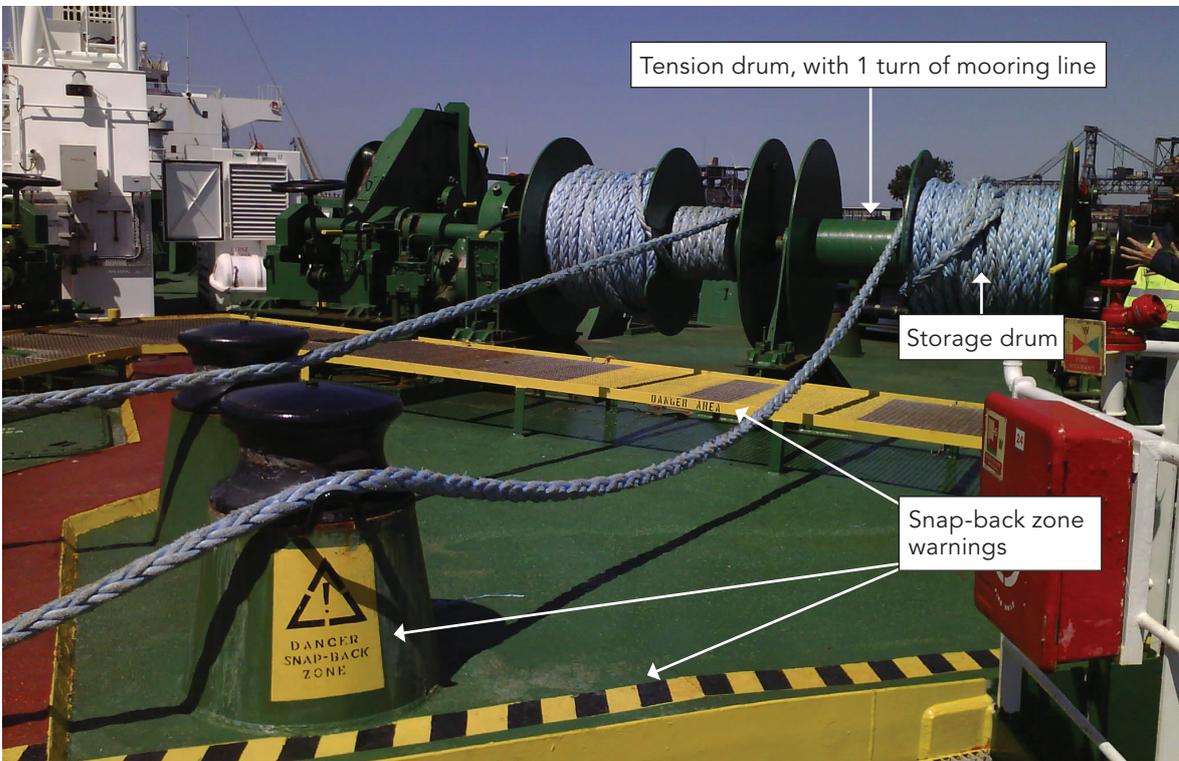
Photograph 11: Reconstruction and snap-back zone warnings on the foredeck (Source: Dutch Safety Board)

Photograph 11 shows the situation of the mooring line drum at the moment the spring line broke (right-hand mooring line winch on the photograph) This shows that there was only 1 turn around the tension drum at the time.

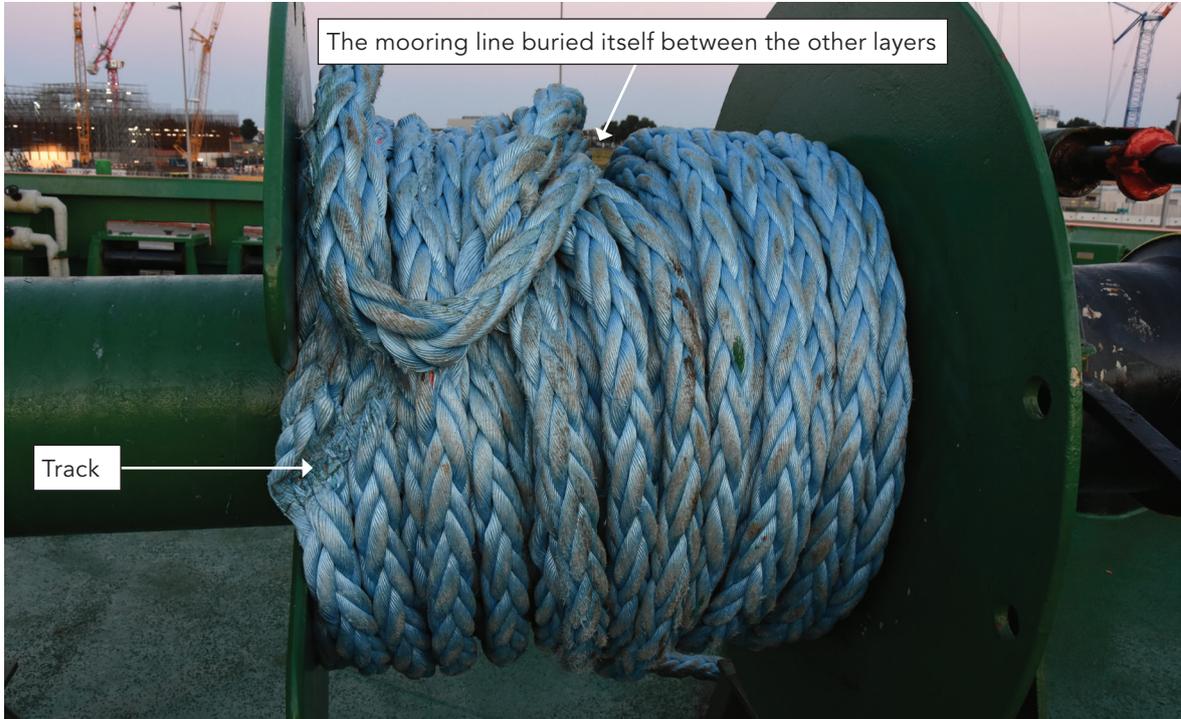
Photograph 12: SStorage drum with the mooring line that was used as the forward spring (Source: Police).

Photograph 12 shows that the mooring line on the storage drum left a clear mark where the line was pulled tight from the tension drum, over the other layers. In addition, the mooring line had been pulled between the layers on the storage drum. It can be concluded from these observations that the mooring line was pulled very tightly around the storage drum, from the tension drum, before the mooring line broke.

The boatswain attempted to prevent the accident by releasing the mooring line as *quickly as possible*. This failed because the winch was not able to turn quickly enough to release sufficient mooring line.

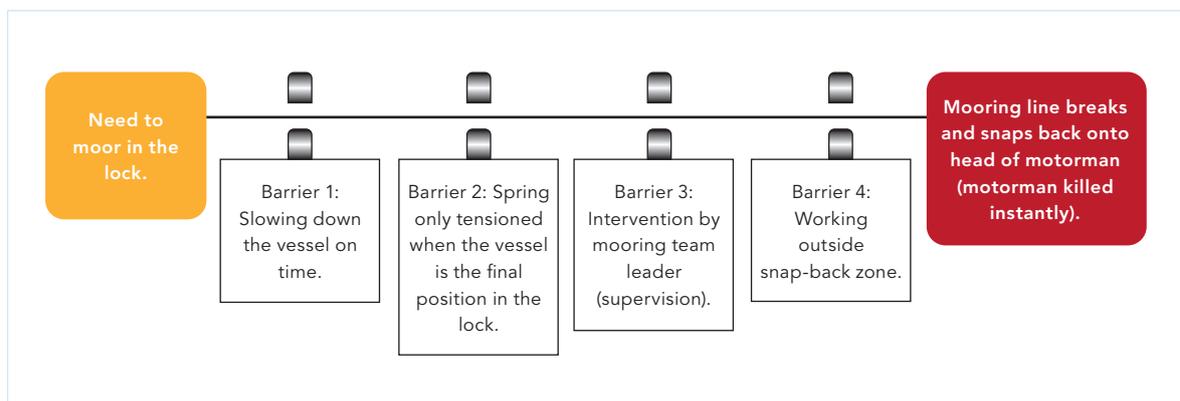
Figure 13: Overview of failed barriers.

The master's decision not to make use of a tugboat has not been identified as a failing barrier to the accident. It is impossible to conclude that the accident would have been prevented if a tugboat was being used during the passage through the lock.
