Fire Aboard Small Passenger Vessel *Conception*  
Platts Harbor, Channel Islands National Park,  
Santa Cruz Island, 21.5 miles South-Southwest of  
Santa Barbara, California  
September 2, 2019

**Marine Accident Report**

NTSB/MAR-20/03  
PB2020-101011

National  
Transportation  
Safety Board

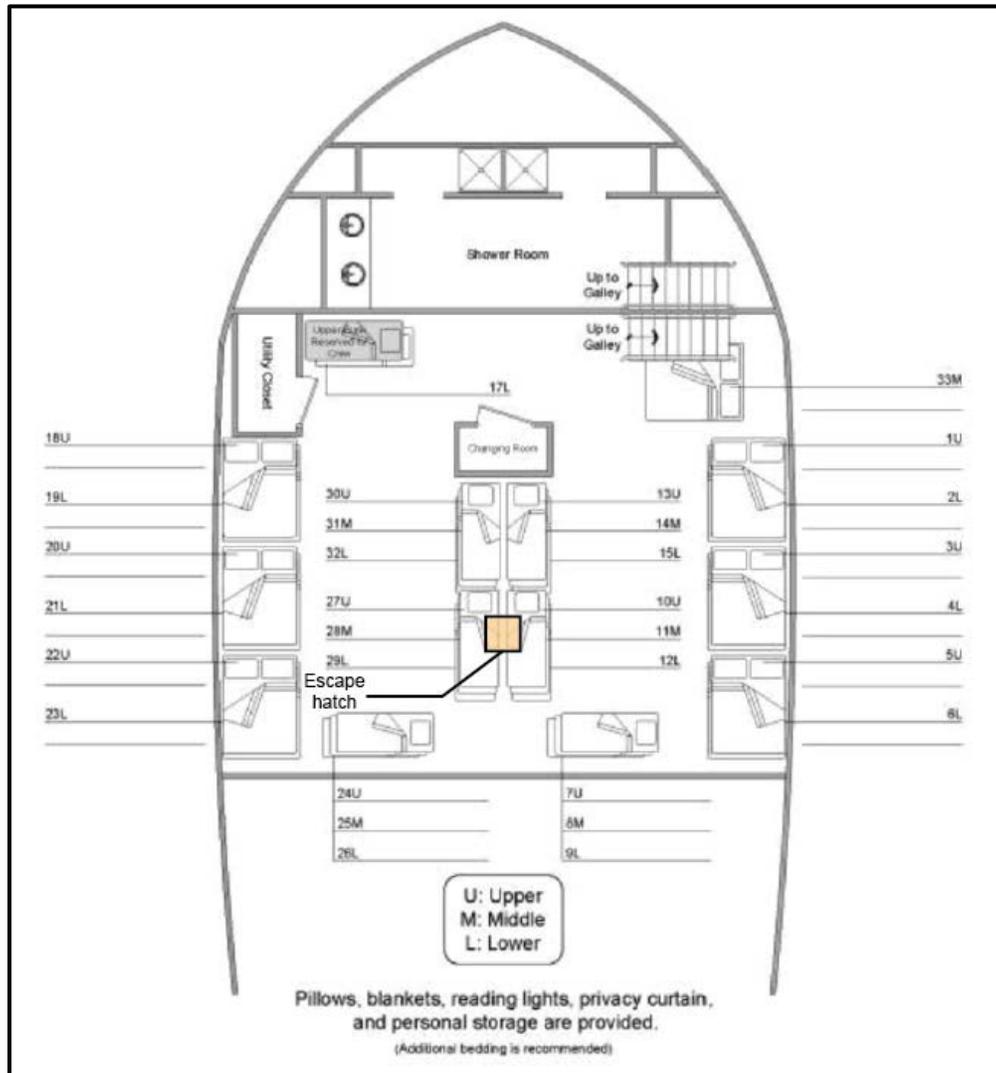
**Figure 5.** *Conception* bunkroom arrangement, with escape hatch location added by NTSB. (Source: Truth Aquatics; annotated by NTSB)

salon, and thus both escape routes from the bunkroom exited into the salon. The upper bunks nearest the emergency escape hatch had passengers assigned to them during the accident voyage.

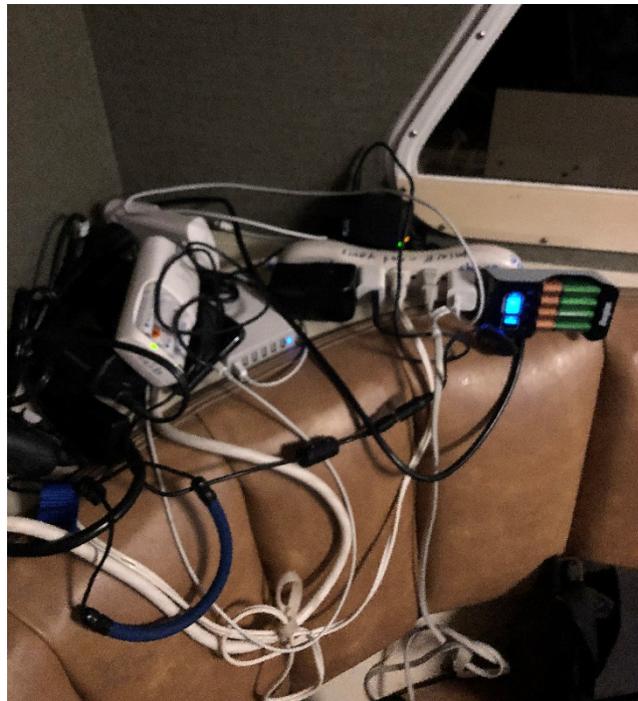
**Figure 8.** Photo taken during accident voyage (August 31, 2019) of devices plugged in to charge at the port side aft corner of the salon on the *Conception*. (Source: J. Dignam).

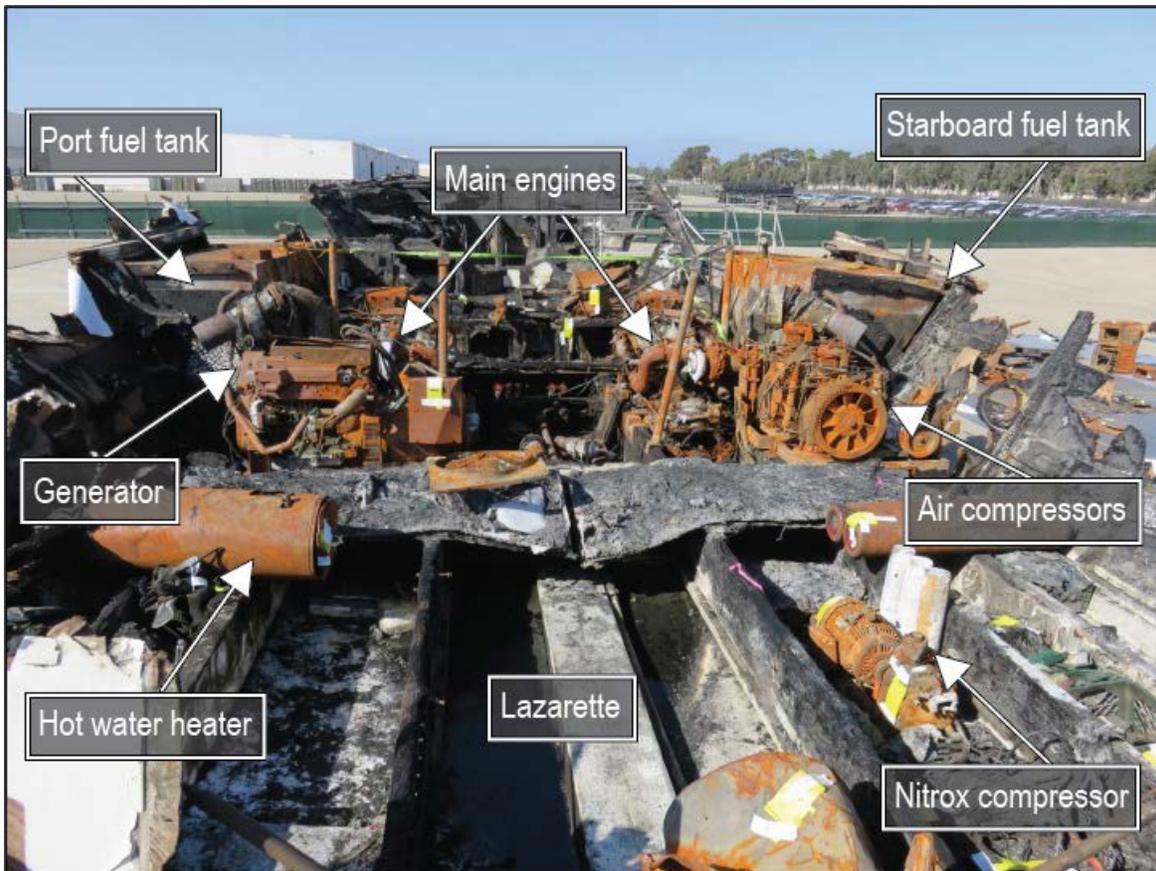
**Figure 13.** The salvaged hull of the *Conception*, looking from aft to forward, with recovered engine room and lazarette equipment placed in their original installed location (with the exception of the water heater, which was located on the starboard side).

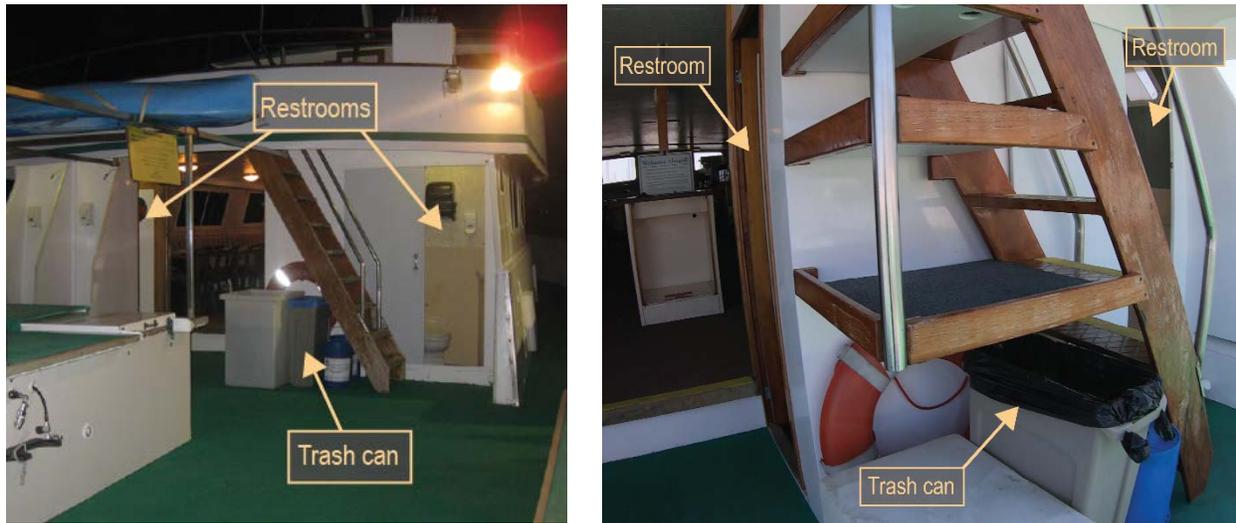
In eyewitness photos and videos of the *Conception*, large polyethylene trash cans can be seen throughout the interior and exterior areas of the vessel, including the bunkroom. The trash cans were manufactured by Rubbermaid from 2016 onward. Neither the Old T nor the New T regulations allow for these types of trash cans to be used in passenger bunkrooms and instead require that trash cans be constructed of non-combustible materials. New T regulations extend the prohibition on combustible trash cans to all compartments, but only apply to existing (Old T) vessels when the trash cans are replaced. Throughout the inspection history of the *Conception*, there were no remarks or deficiencies related to the waste receptacles on board.

**Figure 18.** Left: Photo from a previous voyage of stairway to the upper deck and restrooms of the *Conception*. Note the regular stowage of a polyethylene trash can under the stairway aft of the salon. Right: Still image from a 2019 video taken of the stairway on board the *Conception* with shelving installed. (Source: M. Ryan [left], R. Clevenger [right])

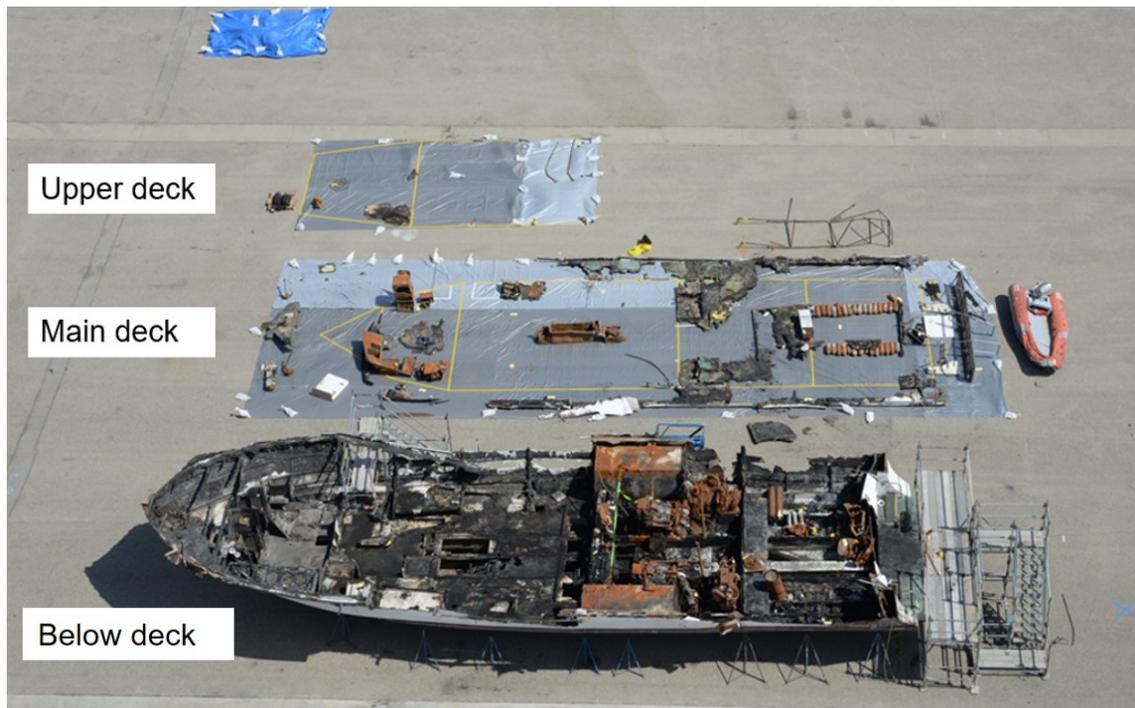
outlines in the areas where they belonged. Very little structural material remained from the upper deck and the main deck.

**Figure 19.** *Conception* wreckage layout at Port Hueneme. (Source: FBI Evidence Response Team)

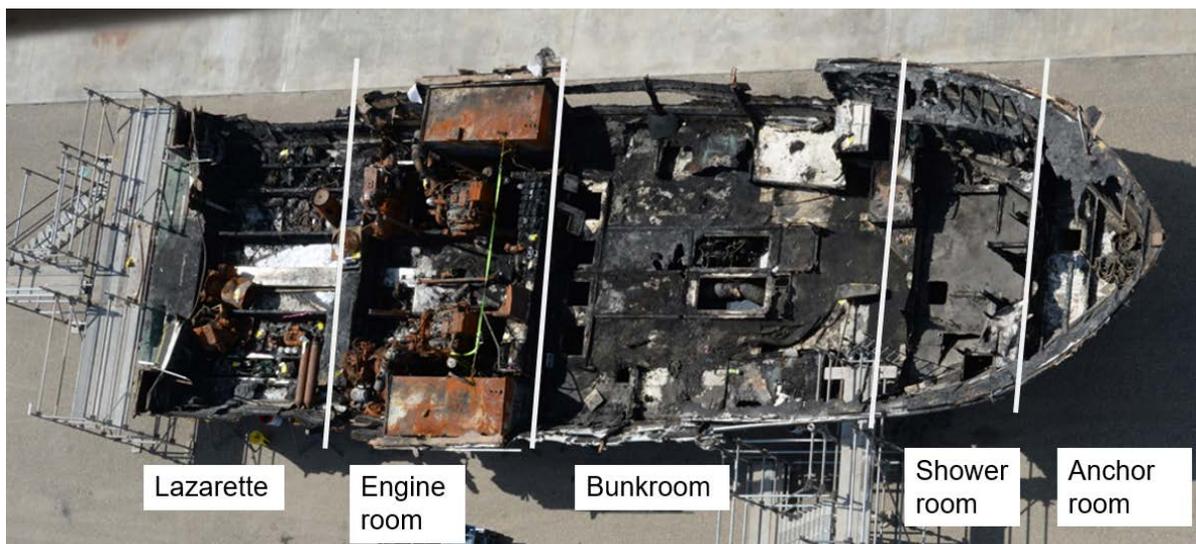
The hull of the *Conception*, where the below-deck compartments had been located, represented the bulk of the remaining structure. The transverse bulkheads were severely fire damaged, eliminating the separation of the below-deck compartments between the anchor room, shower room, bunkroom, engine room, and lazarette from forward to aft. The entire interior of the below-deck space was charred. Overall, the interior of the below-deck compartments had burned all the way down to the floor in the bunkroom and shower room and had consumed the floor, exposing the longitudinal frames, in both the engine room and lazarette ([figure 20](#)).

**Figure 20.** Below-deck areas of the *Conception*. The solid white lines mark the approximate boundaries of each compartment. (Source: FBI Evidence Response Team)

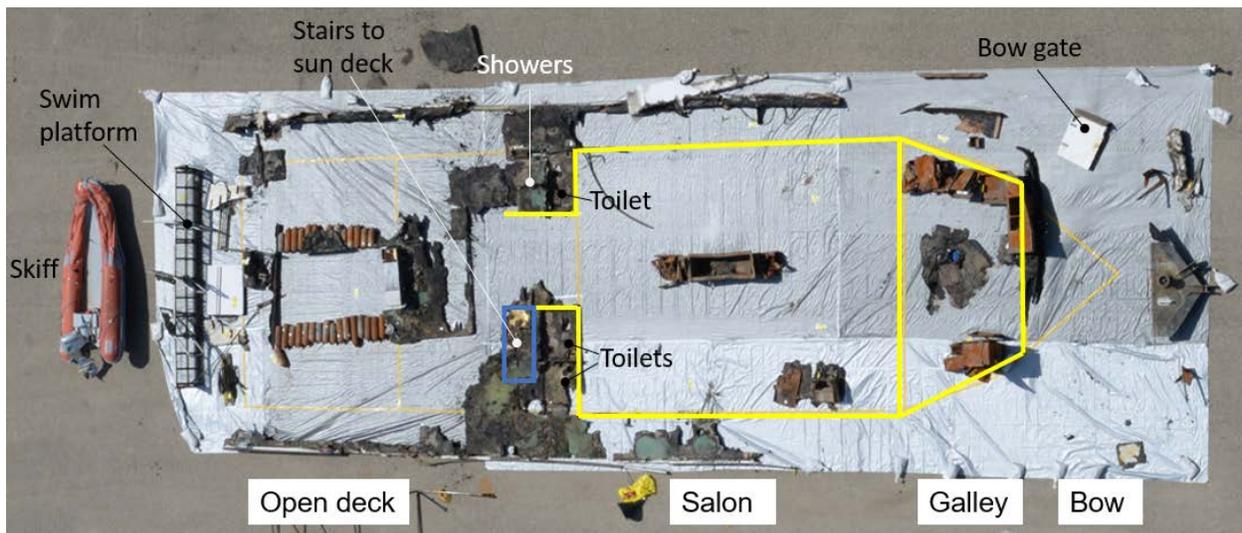
The structure and items recovered belonging to the main deck of the vessel consisted mostly of a few pieces of partially charred deck material and the noncombustible remains of the galley and salon equipment ([figure 21](#)). The decking material that remained belonged to the three restrooms on the main deck and small portions of the port and starboard walkways that were adjacent to them.

**Figure 21.** Wreckage belonging to the main deck of the *Conception*. Solid yellow lines indicate the enclosed spaces on the deck. The blue box marks the location of the stairway to the sun deck. (Source: FBI Evidence Response Team)

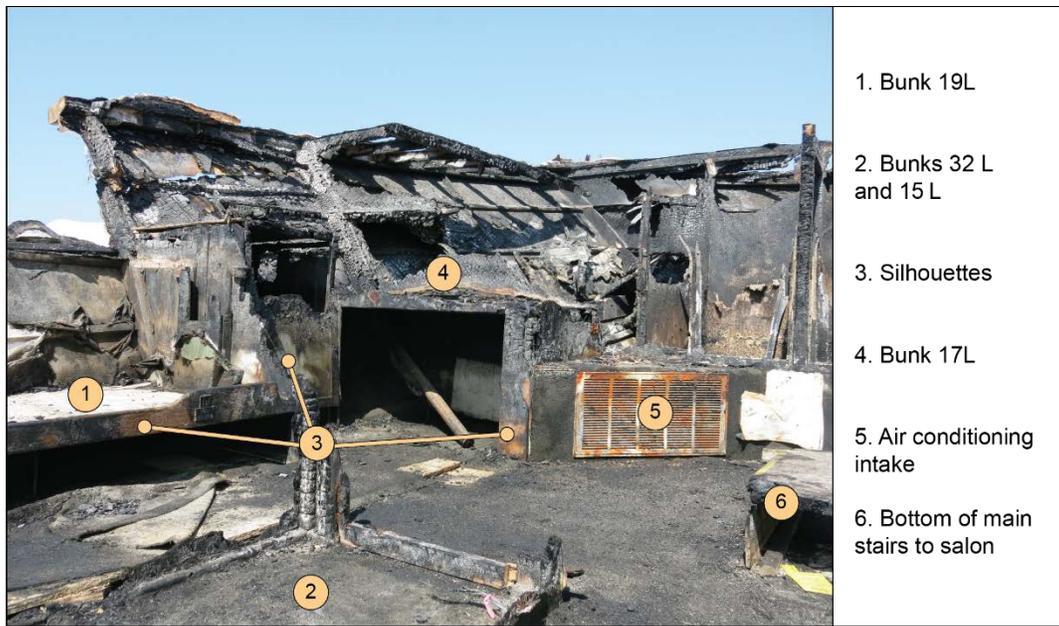
**Figure 22.** Postaccident photo of the bunkroom looking from the starboard aisle forward and to port.

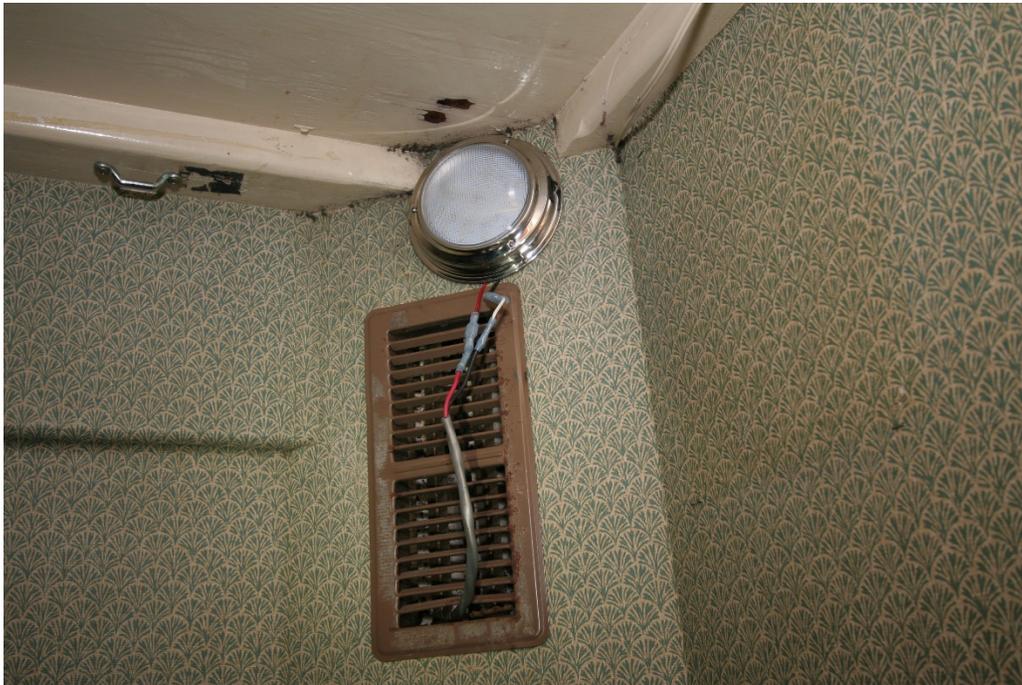
Investigators examined the *Vision's* salon for potential ignition sources. There were cable runs located behind the seatback of the bench-type seating and receptacle drops just under the seatbacks. The electrical cable runs were not enclosed in protective conduit, were often not supported, and did not have the appearance of a professional installation. Similar installations were also observed in the bunkroom ([figure 23](#)).

**Figure 23.** Power cable for lighting routed through ventilation grille in the *Vision's* bunkroom.

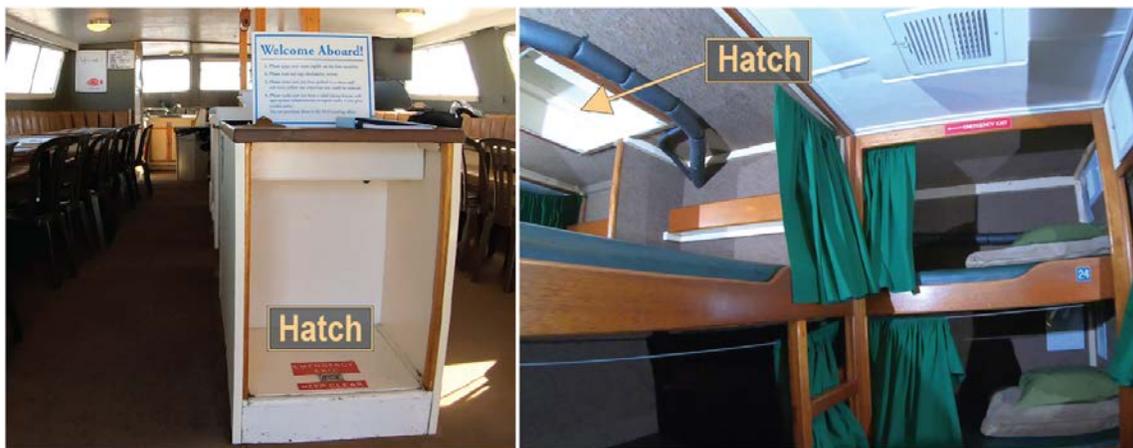
From the *Conception*'s bunkroom, there were two means of escape, both leading to the salon above: (1) the spiral stairs forward in the bunkroom ([figure 28](#)), and (2) the escape hatch installed centerline at the aft end of the bunkroom ([figure 29](#)). The hatch, marked with a two-inch plastic sign, was accessible from either aisle by climbing a wooden ladder, located in the corner where the aftermost middle and aft athwartship tiers of bunks were, onto the upper bunk; crawling to the centerline; and then pushing the plywood escape hatch up and out of the way. The hatch opened below the centerline countertop in the salon. Investigators measured the *Vision*'s escape hatch, which, according to the owner, was similar to the *Conception*'s escape hatch. The opening dimensions were approximately 22 inches by 22 inches through the main deck, with the aft-facing vertical opening having a clearance of about 35 inches from the main deck to the countertop above, or 28 inches from the top of the 7-inch main deck coaming. The two means of escape were at opposite ends of the bunkroom (so as to minimize the possibility of one incident blocking both escapes) and did not pass through a watertight door, thereby fulfilling the regulations applicable to the *Conception*. In the available documentation and inspection history of the vessel, no deficiencies or modifications were found related to the emergency escape hatch or the bunk ladders to the hatch.

**Figure 29.** The *Conception* bunkroom escape hatch from above in the salon (left) and in the bunkroom from the port side (right). (Source: R. Clevenger [left]; Truth Aquatics [right], annotated by NTSB)

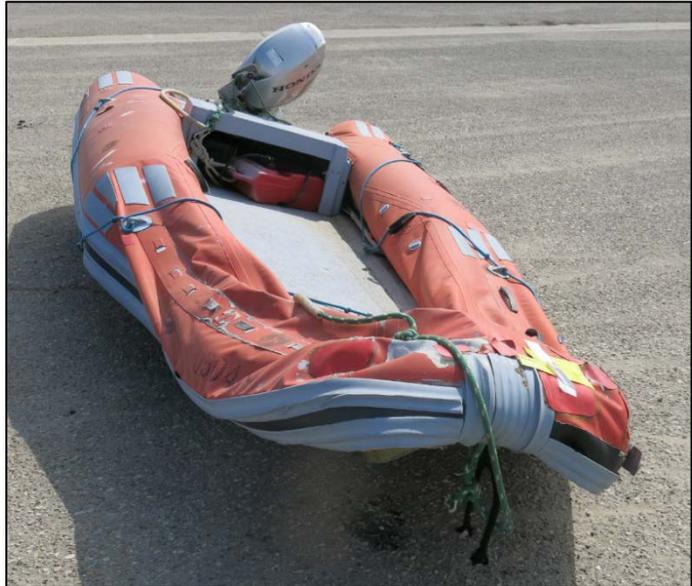
Figure 31. Postaccident photo of the *Conception* skiff.

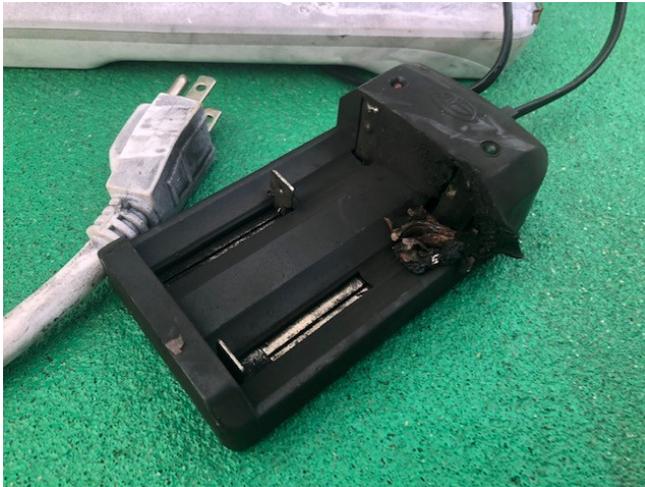
A small fire involving the charging of a lithium-ion battery took place on board the Truth Aquatics small passenger vessel *Vision* about a year before the fire aboard the *Conception*. On October 8, 2018, between 0415 and 0430 in the morning, a passenger, who was awake and in the galley, heard a “hissing” noise and then a loud “bang” that came from the bookshelf located at the aft starboard side of the salon (the *Conception* did not have a bookshelf in the same area). Another passenger, who was returning to the bunkroom after using the restroom on the aft deck, also heard the noise, which drew his attention to a fire on the bookshelf. He stated that the fire looked like a “torch” flame, and a battery charger (which was charging two lithium-ion batteries) was emitting smoke. The passenger in the galley grabbed a dry chemical extinguisher from the galley, and both passengers went to the battery charger. The passenger without the fire extinguisher unplugged the charger, grabbed the unburnt end of the charger, brought it out to the main deck, and threw it in to the rinse bin located under the stairs to the sun deck. The passenger with the fire extinguisher stated he discharged one “shot” on the bookshelf after the battery charger had been removed to extinguish the smoldering paper books on the shelf. He then grabbed a sponge and wetted the bookshelf and items on it to prevent reignition.

**Figure 33.** Photograph taken of the battery charger that caught fire on the *Vision* (with the batteries removed).
