SAFETY INVESTIGATION REPORT

REPORT NO.: 22/2020

MV ALMA Fatal fall from the accommodation stairway in position 47° 38.1' N 008° 51.8' W, 22 November 2019

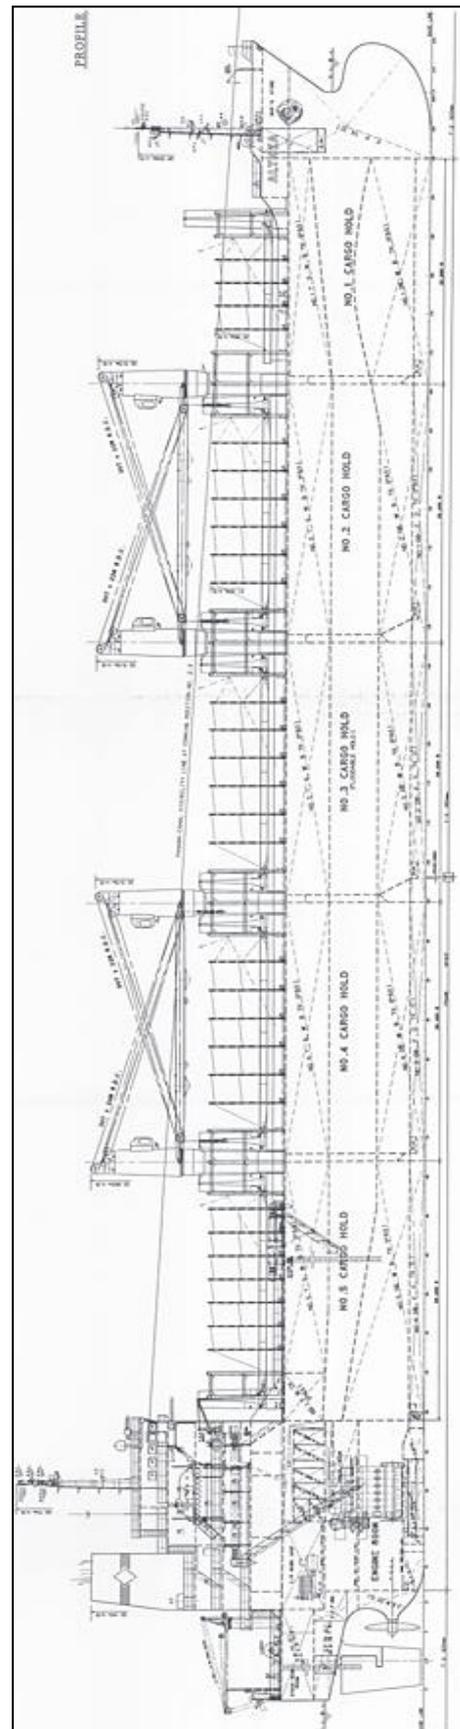
Figure 1: MV *Alma* General Arrangement

Alma (Figure 1) was a 17,697 gt bulk carrier, owned by Thalia Maritime Co. Ltd. and managed by Alloceans Shipping Co., Greece. The vessel was built in 2002, by Shina Shipbuilding Co. Ltd. and was classed with the American Bureau of Shipping (ABS). The vessel had a length overall of 169.61 m and a moulded breadth of 27.20 m. At the time of the occurrence, she was drawing a maximum draught of 10.00 m.

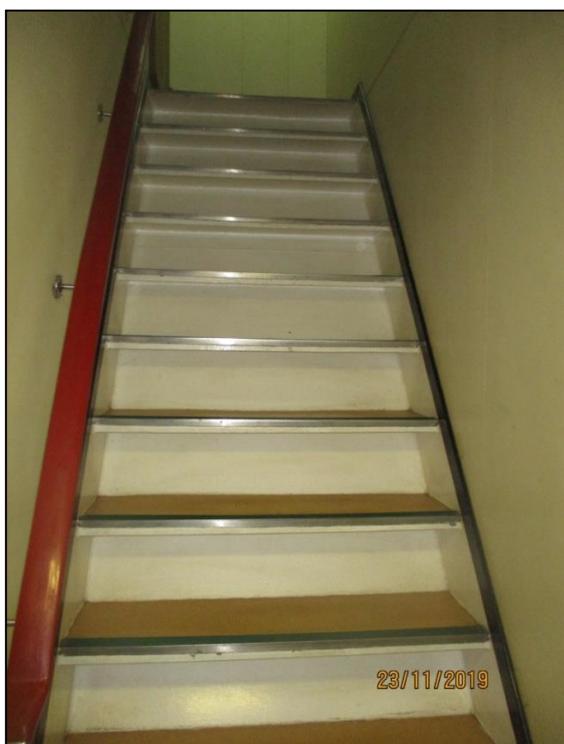
Figure 3: Section of the stairway, seen from the bottom (poop deck level)

The section of the stairway, at the bottom of which the fatally injured electrical engineer was found, was inclined at an angle of 50° to the horizontal. This section of the stairway consisted of 10 steps, with a riser height of 250 mm and fitted with a handrail on one side (Figures 3).

Reportedly, the stairway was well lit and free of defects and slippery substances.

The safety investigation hypothesized that the fatally injured crew member either lost his stepping or balance, while walking down the stairway, as a result of the rolling and pitching motions of the vessel. The safety investigation did not rule out the possibility that the crew member was not holding on to the handrail, while going down the stairs. It is highly likely that he subsequently toppled down to the bottom of the stairway, fracturing his skull at some point during this fall.

The investigation report emphasised the importance of serving crew members to exercise caution while using the vessel's stairs, especially when the vessel is experiencing rolling and pitching motions, and to hold onto the handrails for support.

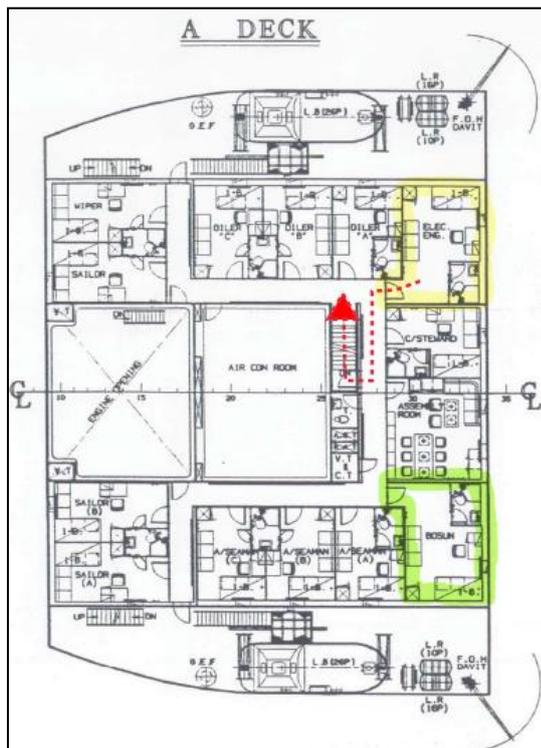
Figure 4: Reported path followed by the fatally injured crew member

Reportedly, the crew member was walking down the stairway from his cabin on deck 'A' to the poop deck (Figure 4), when the bosun heard him falling down the stairway.

In the absence of any witnesses, the safety investigation could not identify the reason why the fatally injured crew member was heading towards the poop deck. However, it was possible that he had intended to go down to either the mess room or the recreation room.

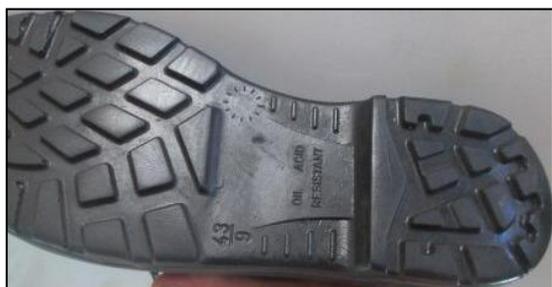
Figure 5: Sole of the fatally injured crew member's shoe

No items were found in the vicinity of the stairway, which could have indicated that the fatally injured crew member was carrying any items in his hand while walking down the stairway. The shoes worn by the fatally injured crew member were in good condition, with the treads on the soles free of wear (Figure 5).
