National Transportation Safety Board

Marine Accident Brief

Contact of *William C* Tow with Rock Island Railroad Bridge Protection Cell

Accident type	Contact	No. DCA20FM010
Vessel name	<i>William C</i>	
Location	Des Plaines River, mile 287.6, Joliet, Illinois 41°31.13' N, 88°05.14' W	
Date	January 1, 2020	
Time	0032 central standard time (coordinated universal time – 6 hours)	
Injuries	None	
Property damage	\$500,000 est.	
Environmental damage	None	
Weather	Clear, visibility 10 miles, winds west at 5.1 mph, air temperature 29°F, water temperature 33°F	
Waterway information	The Chicago Sanitary and Ship Canal is a waterway linking the south branch of the Chicago River with the Des Plaines River at Lockport, Illinois. The canal is 30 miles long and has a minimum width of 160 feet and a minimum depth of 9 feet. The Des Plaines River is a 133-mile-long river that flows southwest from Southern Wisconsin to Northern Illinois. The river is part of the Illinois Waterway, which connects the Great Lakes to the Mississippi River.

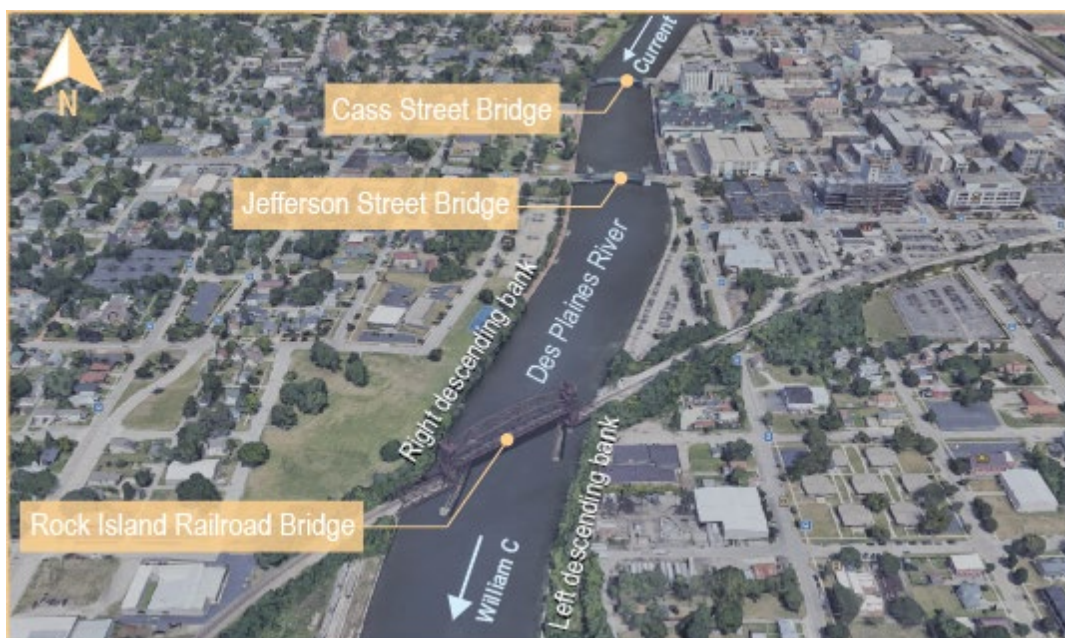
Bridges through which the *William C*'s tow transited. (Background source: Google Earth)

At the time the tow was passing through the Cass Street Bridge and approaching the Jefferson Street Bridge, the following current in the bend would have been impacting the vessel's starboard quarter, pushing the tow over to port and the left descending bank. When the pilot approached the Jefferson Street Bridge, he realized that he had oversteered to port, so he moved the rudders to maneuver the tow to starboard to line up the vessel with the center of the bridge. Once the pilot believed the vessel was lined up, he returned the rudders to midships, but the current pushed the vessel back to port. Since the bow of the tow was already approaching the Jefferson Street Bridge, the pilot continued his course until the *William C* had passed the bridge.

Once the vessel had passed through the bridge, there was only about 1,200 feet for the pilot to maneuver the approximately 662-foot-long tow back to the center of the channel before reaching the Rock Island Railroad Bridge protection cell near the left descending bank. The pilot attempted to move the tow to starboard, but, since the following current was pushing against the tow, it continued toward the left descending bank. When the pilot determined there was not enough time to move the vessel in order to avoid striking the bridge, he reversed both engines to slow the vessel, which reduced the force of the impact but did not prevent the barges from hitting the bridge's protection cell.

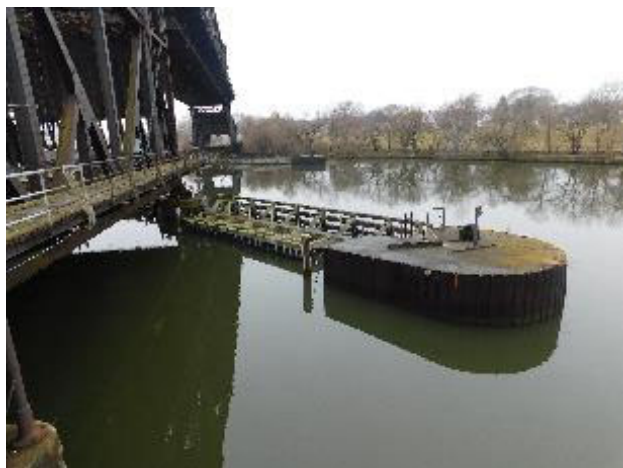
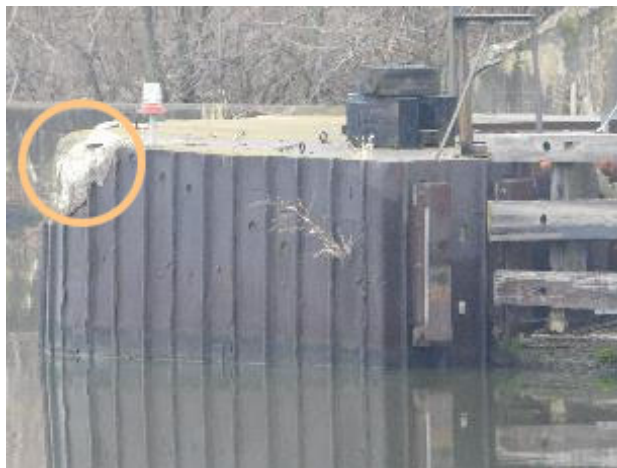
On January 10, 2020, a damage survey was conducted on the Rock Island Railroad Bridge to determine the extent of the damage to the protection cell and floating fenders. The damage survey found cracks and minor spalls across the cap (or top) of the protection cell, and the steel sheeting from the cap was separated in many locations. The cell had shifted 18 inches back (toward the bridge) from its original position. The walkway was bent, and minor damage was discovered on the fender.

Left: Northeast protection cell for Rock Island Railroad Bridge. Right: View from across the river of damaged protection cell with impact location circled. (Source: CSX Transportation)
