Report on the investigation into a serious injury on board

mv MINERAL TEMSE

at the South Atlantic Ocean with one victim on May 5<sup>th</sup> 2020.

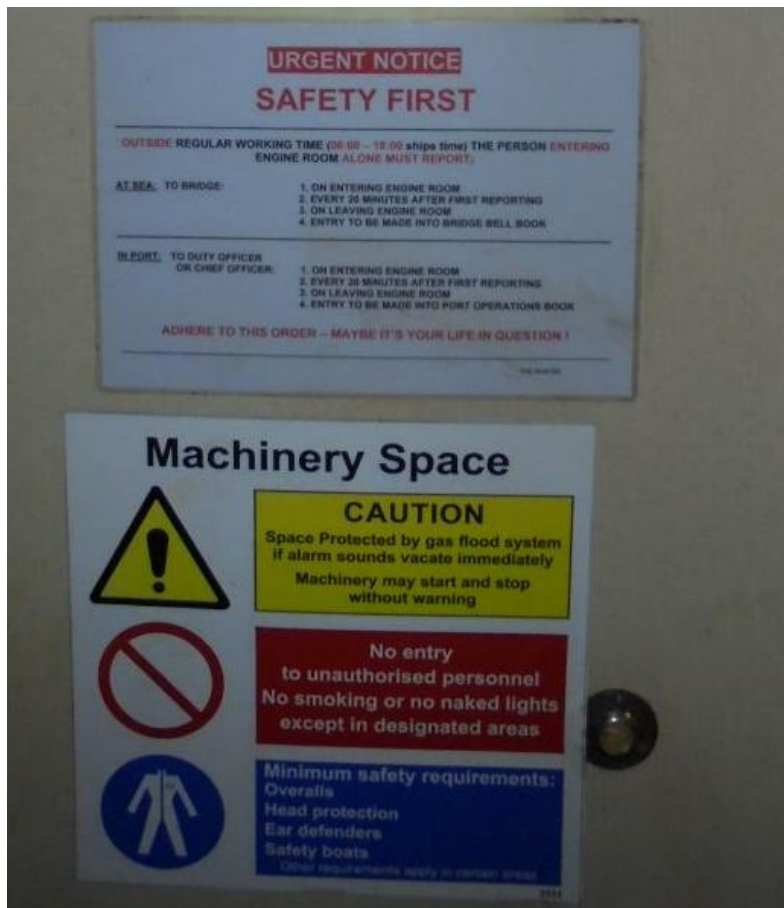
Figure 1 - Entrance door to engine room with instructions

Safety instructions on the door to the engine room, as indicated in Figure 1, were showing these instructions.

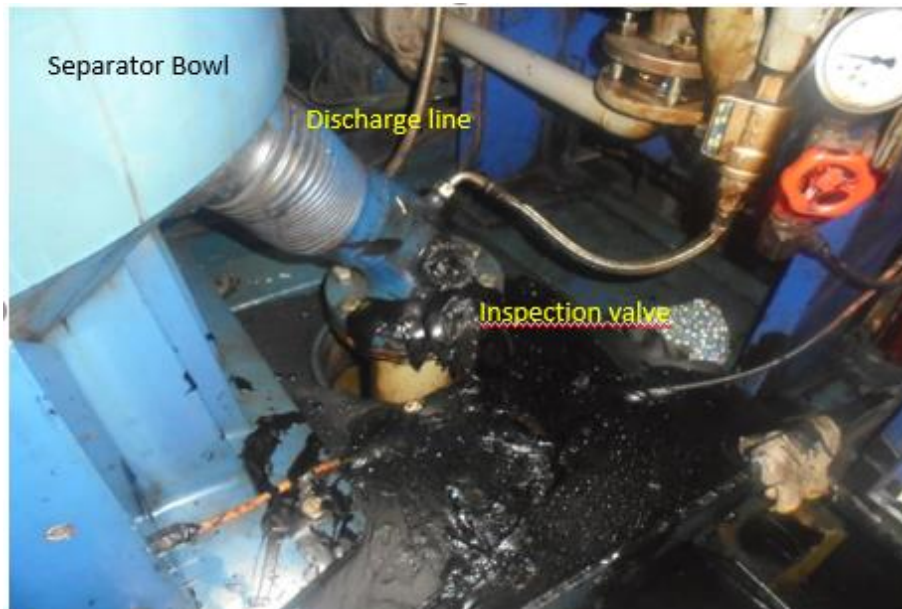
Figure 2 - Fuel oil separator and sludge discharge line after the accident

In Figure 2, the sludge discharge line is represented after the accident had taken place.

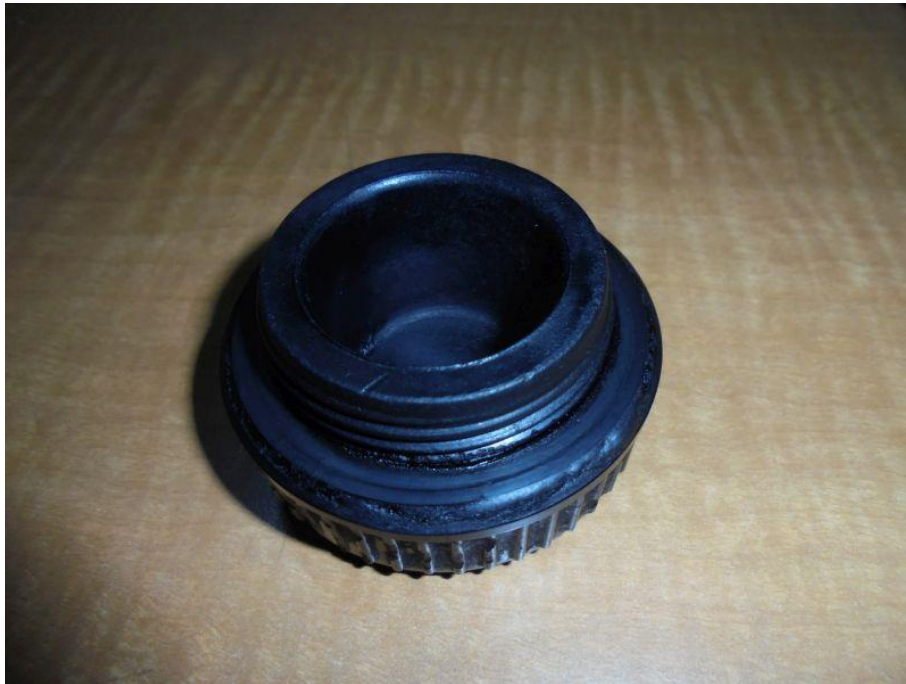
*Figure 3 - Plastic plug covering the inspection hole of the sludge discharge line*

An inspection opening covered by a plastic cap, as shown in Figure 3, made it possible to verify the condition of the discharge line.

Thereafter, he opened the plug of the inspection hole of the sludge discharge line in order to verify the condition.

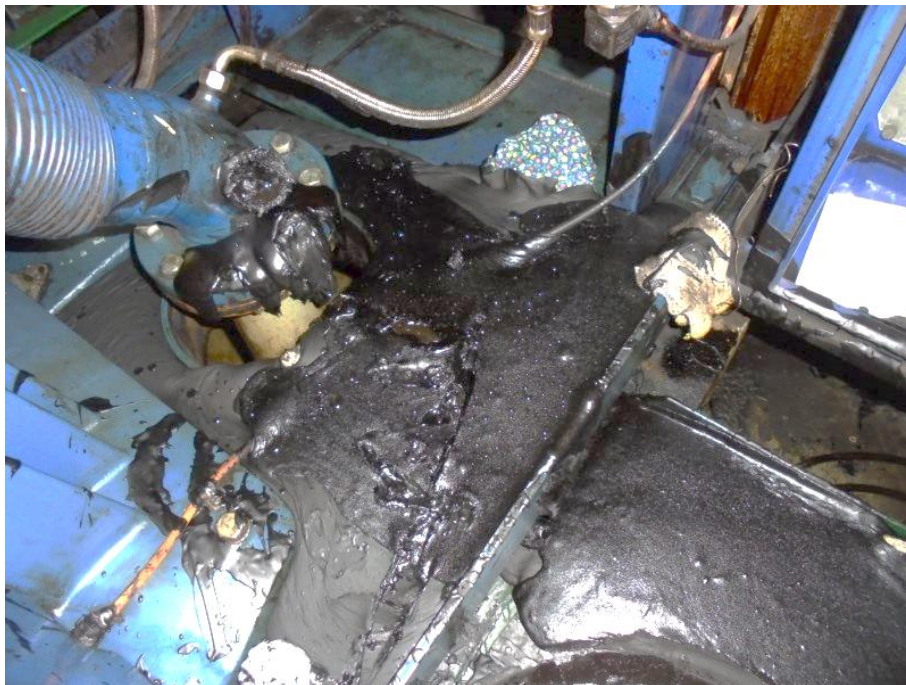
*Figure 4 - Sludge gushed out of the inspection opening*

Upon opening the plug, hot sludge oil gushed out of the inspection hole and covered the arms and legs of the engineer.

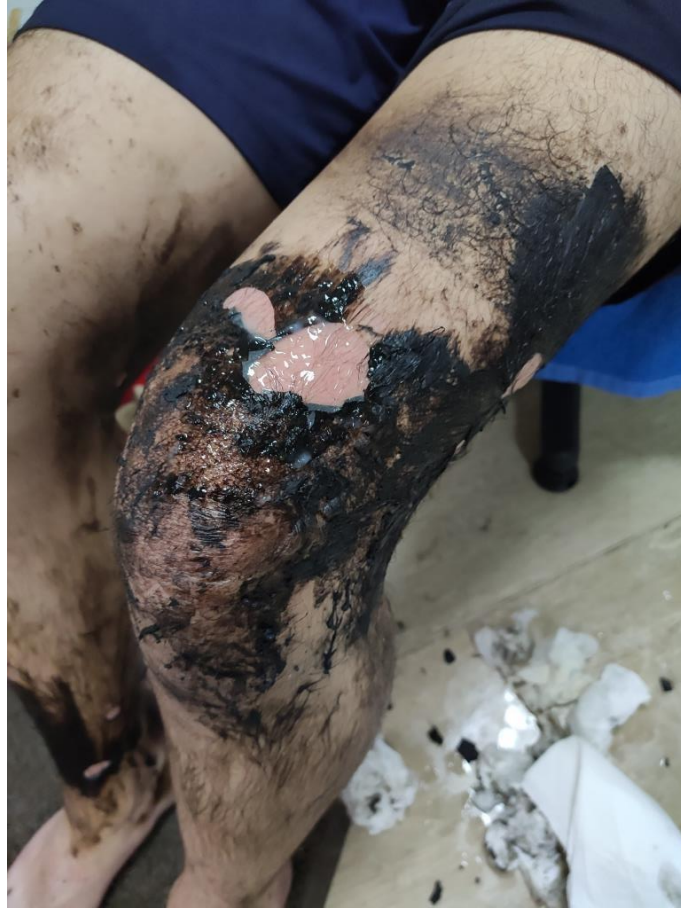
*Figure 5 – Legs of the engineer covered with sludge*

Large parts of his hands, arms and legs were covered with hot sludge, causing burns on 12% of the engineer's body surface.

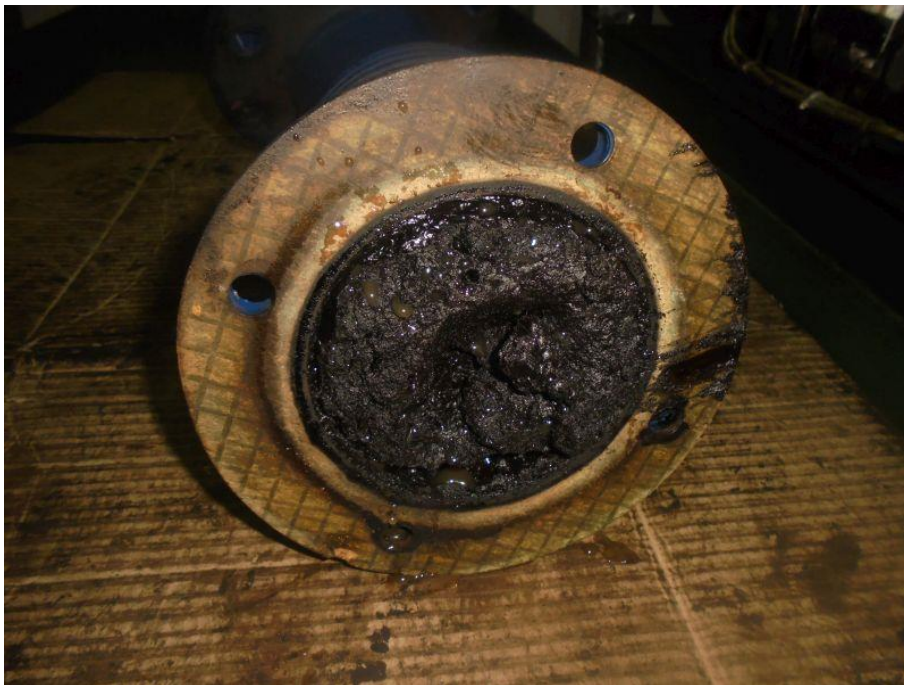
*Figure 7 - Completely blocked sludge discharge line of separator N°1*

From April 15<sup>th</sup> 2020 onward, the vessel was consuming this fuel and during the consumption the sludge discharge line of the fuel oil separators was clogged regularly. Figure 7 shows the clogged sludge discharge line.

Due to the cold flow characteristics of a certain blend of RMG 380 VLSFO, the separation of this fuel at +-40°C caused a blockade of the sludge discharge line.

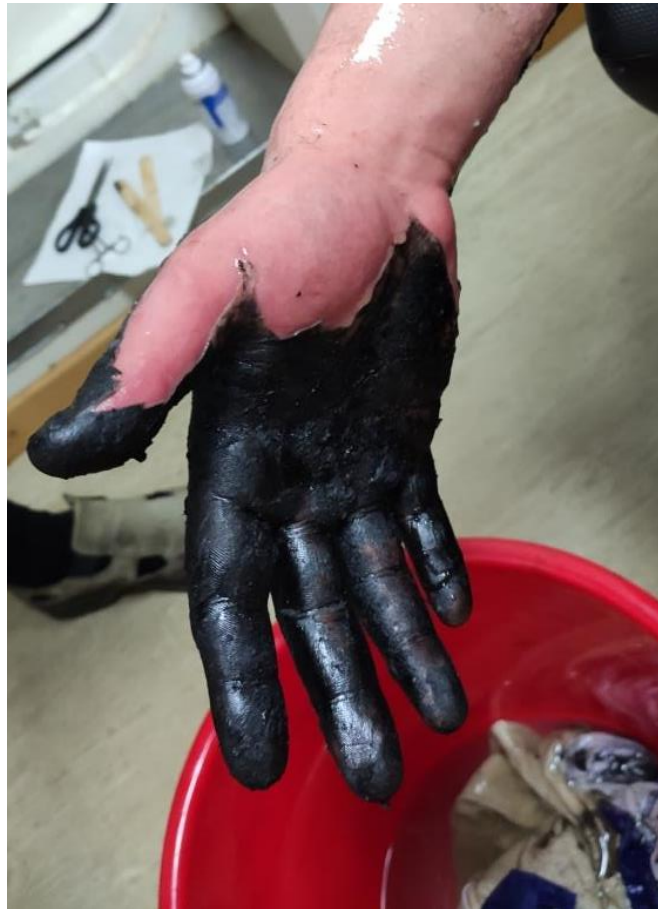
*Figure 11 - Hand of victim covered with sludge*

According to medical advice, prolonged direct skin contact with sludge derived from this fuel, could cause chemical burns as well, even at temperatures around 40°C.

It can be assumed that the direct skin contact with sludge during several hours, or even days for some parts where it was not possible to remove the sludge from the skin, contributed to the severity of the burns.

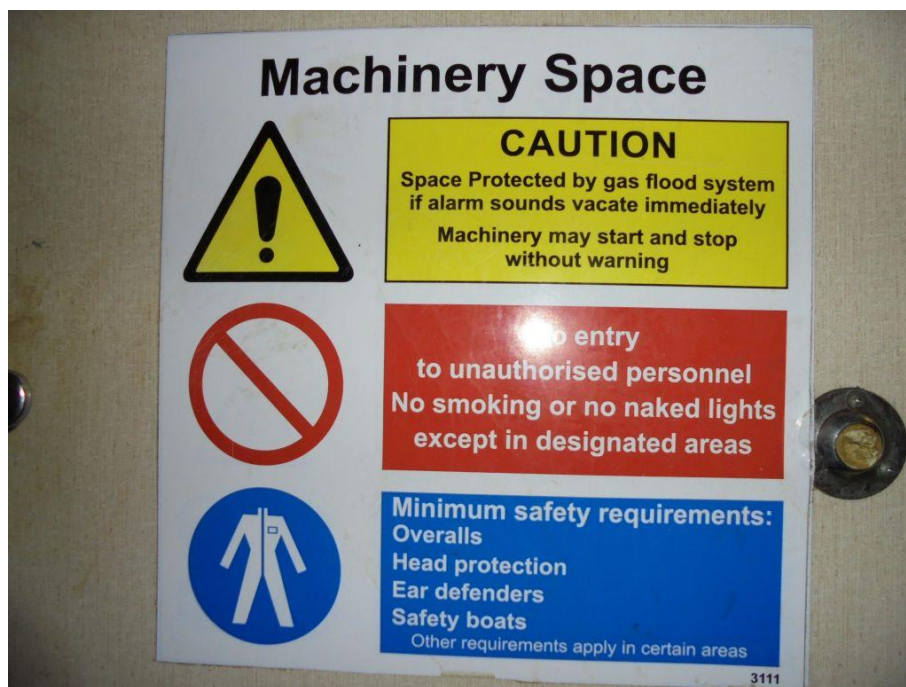
Figure 12 - PPE zone identification

The engine room was identified as a PPE zone. This means a zone where personal protective equipment needed to be worn all the time.

Figure 12 shows the label on the entrance door of the engine room indicating that appropriate PPE has to be worn.

At the time of the accident, the victim was wearing loose short pants and a t-shirt, no gloves, no overall and no helmet.

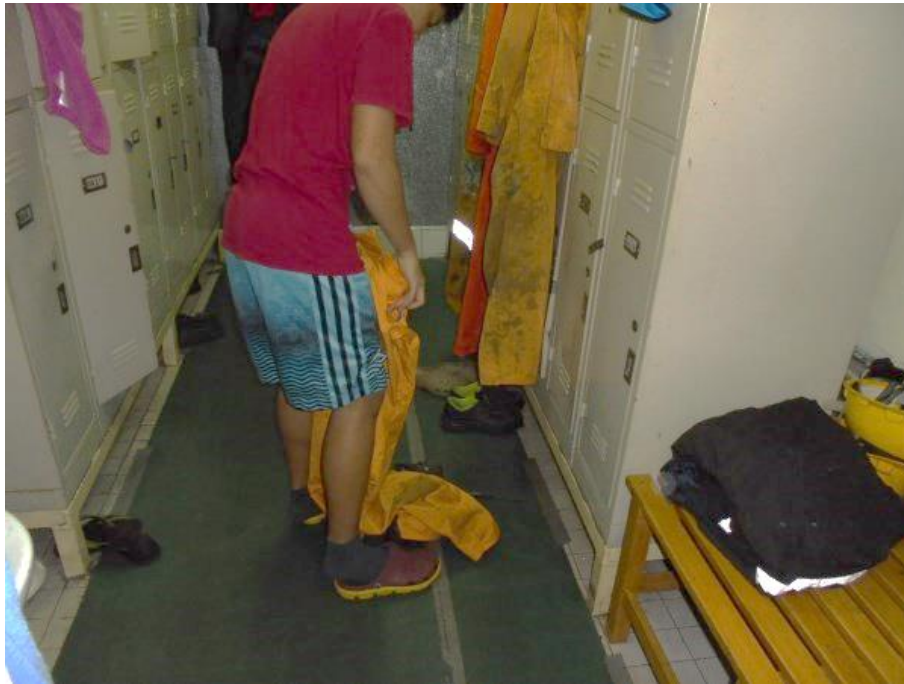
*Figure 13 - Engine changing room*

The engine changing room is the place where every engineer has a personal locker containing the necessary PPE, as indicated in Figure 13 .

A simulation on board indicated that putting on an overall, gloves and head protection only takes 20 seconds extra time.

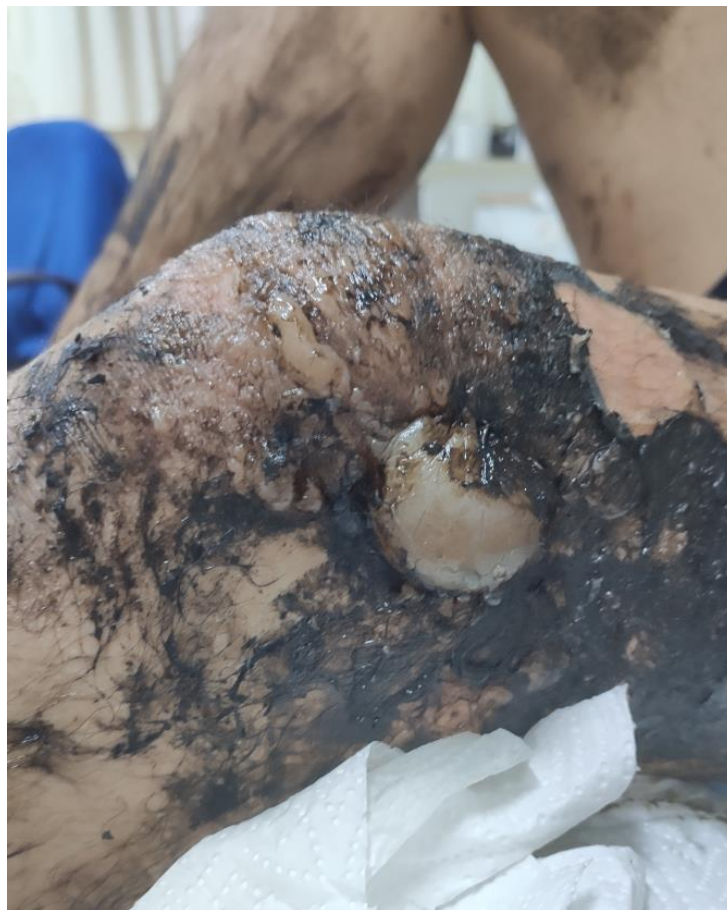
*Figure 14 - Burns on left knee*

Left knee: 3% TBSA MPT burn. Lateral aspect of knee had a deep partial thickness burn.
