## MARINE TRANSPORTATION SAFETY INVESTIGATION REPORT M19P0029

### GROUNDING

Search and rescue vessel (*Spirit of Sooke*)

Christie Point, Sooke Harbour

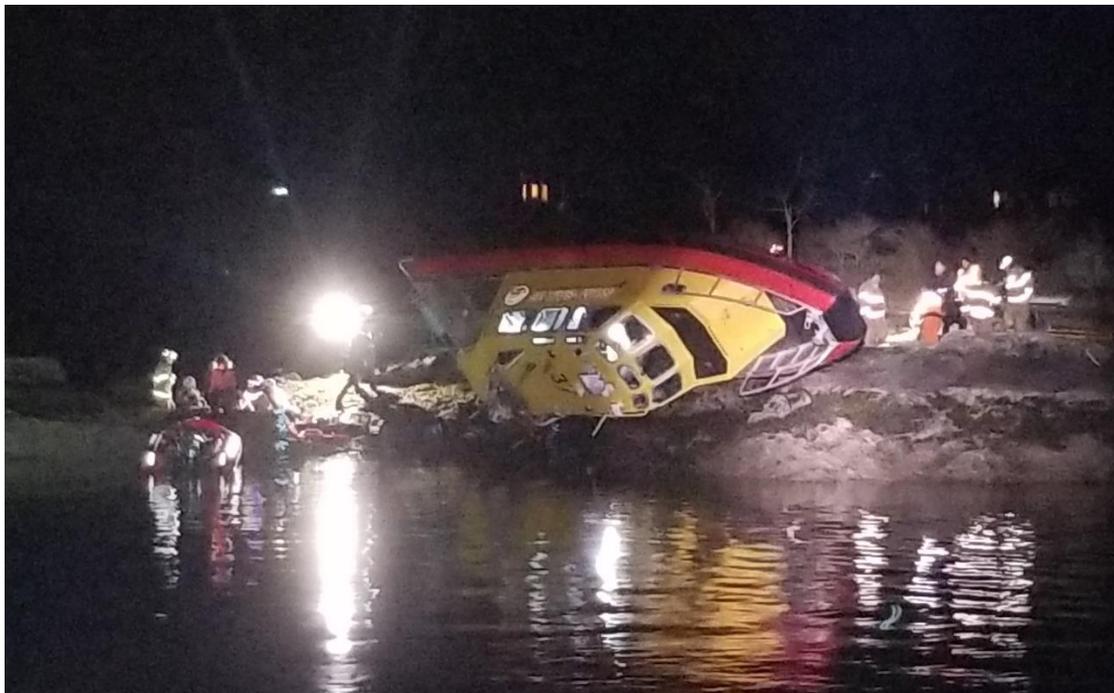
Figure 4. *Spirit of Sooke* after grounding (Source: Canadian Coast Guard)

The *Spirit of Sooke* was damaged as a result of the grounding and the subsequent salvage operations. The vessel's hull had various scrapes, deformations, and indentations below the waterline, and the vessel's hybrid-foam collar fender was damaged. One of the cabin windows was broken, and some electrical wiring inside the cabin had water damage, as did the 2 inboard diesel engines. The *Spirit of Sooke* has since been repaired and RCMSAR is in the process of putting the vessel back in service.

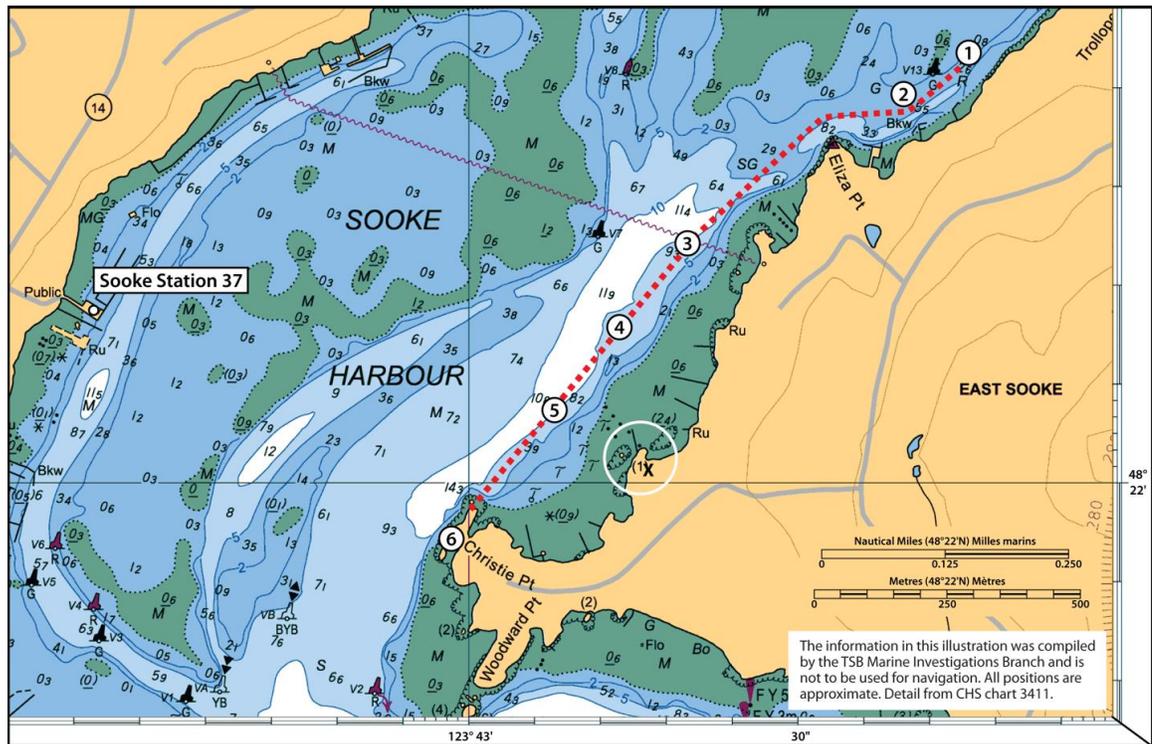
Figure 8. Simulated vessel track leading up to occurrence (Source: Canadian Hydrographic Service with TSB annotations).

Examination of the vessel's radar showed that the radar range setting was at 0.125 NM and the display was in head-up mode when the vessel ran aground. The vessel speed and the radar ranges were varied throughout the various simulations for comparison purposes. A simulated vessel track depicts the 1.5 minutes leading up to the grounding, based on a vessel speed of approximately 27 knots (Figure 8).

Position	Event
1	Last AIS signal sent before grounding at 2131:53; vessel speed is 14.2 knots
2	Coxswain asks the crew member to select speed and course to return to base
3	Vessel speed reaches approximately 27 knots
4	Vessel is 0.25 NM from Christie Point, and coxswain indicates course is good
5	Vessel is 0.125 NM from Christie Point, and vessel speed is about 27 knots; northernmost tip of Christie Point appears on the radar display
6	Vessel grounds on Christie Point at approximately 2133:30

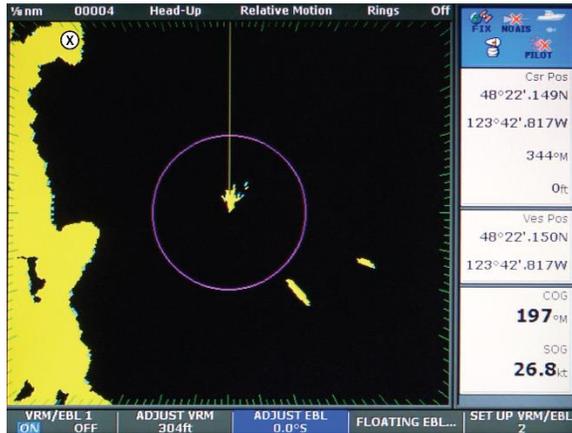
Figure 9. Vessel at 0.25 NM from Christie Point; coxswain indicates course is good (Source: TSB screenshots of RCMSAR simulation videos; annotations by TSB)

Figures 9 and 10 show screenshots of the radar display from simulations of the vessel at different positions, with the radar range set at 0.125 NM. RCMSAR noted that the small point of land before Christie Point (marked with an X on Figure 9) appears similar in shape to Christie Point (marked as Position 6 on Figure 10).

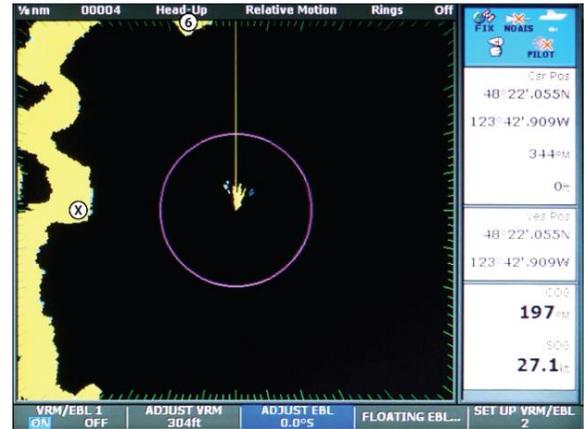
Figure 10. Vessel at 0.125 NM from Christie Point (Source: TSB screenshots of RCMSAR simulation videos; annotations by TSB)

Christie Point would have appeared on the radar display when the vessel was 0.125 NM away from it. When a vessel's speed is 27 knots, it will travel 0.125 NM in approximately 16 seconds.

When Christie Point became visible on the radar display, it likely did not conform to the coxswain's understanding of the vessel's position and probably caused momentary confusion. Given the speed of the vessel and the time required for the radar and the chart plotter displays to update, the vessel was even closer to Christie Point than indicated by the navigational equipment. Once the impending grounding was detected, there was insufficient time to respond, given the vessel's high speed.
